# Water level fluctuations drive bank instability in a hypertidal estuary

**Abstract.** Hypertidal estuaries are very dynamic environments characterized by high tidal ranges ( $> 6$  m) that can experience rapid rates of bank retreat. Whilst a large body of work on the processes, rates, patterns, and factors driving bank erosion has been undertaken in fluvial environments, the process mechanics affecting the stability of the banks with respect to mass failure in hypertidal settings are not well-documented. In this study, the processes and trends leading to bank failure and consequent retreat in hypertidal estuaries are treated within the context of the Severn Estuary (UK) by employing a combination of numerical models and field-based observations. Our results highlight that the periodic fluctuations in water level associated with the hypertidal environment drive regular fluctuations in the hydrostatic pressure exerted on the incipient failure surfaces that range from a confinement pressure of 0 kPa (at low tide) to  $\sim 100$  kPa (at high tide). However, the relatively low transmissivity of the fine-grained banks (that are typical of estuarine environments) results in low seepag

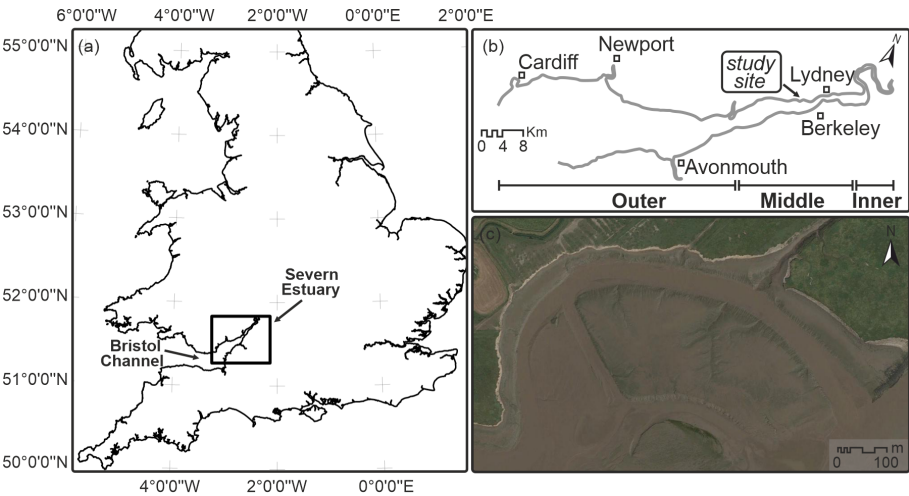
**Figure 1.** Location: (a) the Severn Estuary in south-west Britain (map © Ordnance Survey 2021). (b) Subdivision of the estuary into inner, middle, and outer sectors based on geomorphological features. (c) Google Earth image of the study site in the middle estuary (image © Google Earth July 2021).

The focus of this research is centred on a site located in the middle estuary south of Lydney in the Plusterwine area (UK National Grid reference: ST 612995) (Fig. 1b and c), where erosive trends have been well-documented in recent decades (Allen, 2001). To elucidate the detailed mechanics governing these observed mass wasting events, a combination of high-resolution monitoring and numerical modelling was implemented. A summary of the techniques used for the quantification of the parameters used in the bank stability modelling, the monitoring periods, and the identification and validation of the bank failure mechanics contributing to the observed bank retreat are reported in Table 1.

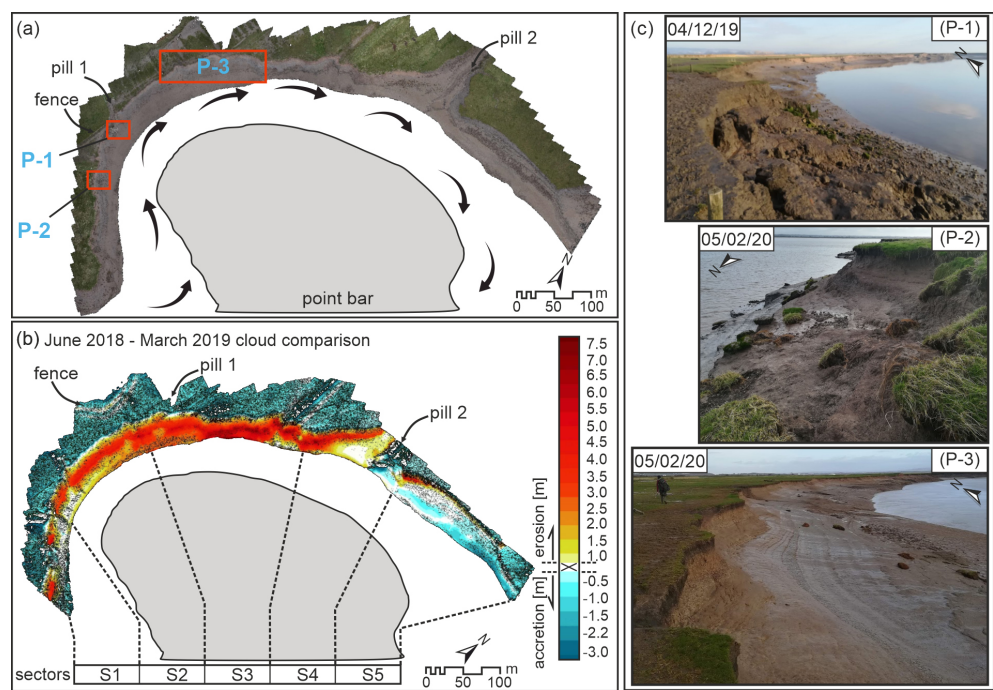
**Figure 2.** Embayment details: **(a)** studied embayment (mosaic of images), with inferred flood tidal flow represented by the black arrows; **(b)** point cloud difference between the June 2018 and March 2019 surveys and site subdivision into sectors; **(c)** photographs of three representative areas of the study site shown in the black boxes in **(a)**.

Point cloud comparison analysis (Fig. 2) highlighted intense bank mobility across the whole study area, both in terms of erosion and accretion. Areas dominated by accretion are mainly localized within sectors S4 and S5 (Fig. 2b), which are located in the eastern portion of the study area, a zone that is most protected from the tidal currents. This protection is granted by the presence of coastal defences (rock armour made by large boulders) at the eastern limit of the embayment and by the presence of a large sand bar in the centre of the embayment that acts to protect and deflect the flows (Fig. 2a) decreasing the erosion and, in turn, favouring the accretion and the redistribution of the sediments delivered by the pill (pill 2 in Fig. 2a) sited in the central eastern part of the site. The deflection of the tidal-flood currents may also help to explain the intense erosion identified in sectors 1–4 (Fig. 2b, central and western part of the site), where bank retreat of up to  $7\text{ m a}^{-1}$  was identified. Here, erosive events are mainly caused by mass wasting. Hydraulic entrainment is a factor contributing to the removal of deposited sediments from the toe of the bank slope. In the central part of the study site, the erosion is spread along the entire bank (this is the area with the highest levels of bank retreat), while on the western portion of the site erosive trends are mainly localized in the top part of the bank. This spatial pattern may reflect the distribution of flow in the study area and is also reflected in the presence of several collapsed blocks (Fig. 2c) along the bank slope (not present in the central part of the embayment where slumped blocks are quickly removed), which may act to provide partial protection against further erosion. Slump blocks have been confirmed as having the effect of reducing erosion rates in other bank line environments (Motta et al., 2014; Hackney et al., 2015; Thorne and Tovey, 1981; Wood et al., 2001).

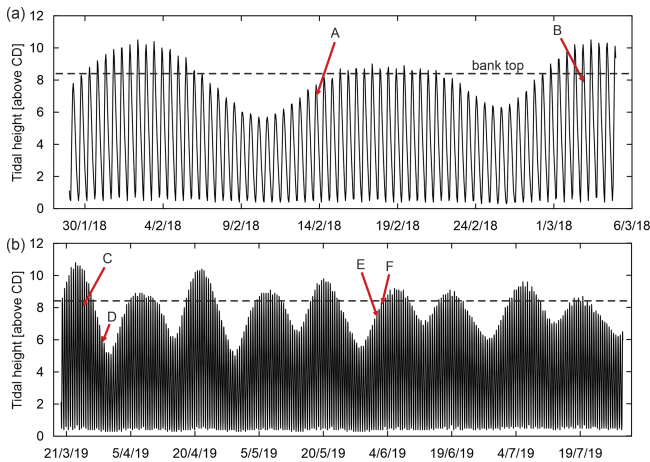
**Figure 3.** Tidal cycle for the two fixed-camera survey periods: (a) 30 January–5 March 2018; (b) 19 March–28 July 2019 (data from UK Admiralty TotalTide software). Red arrows indicate the most substantial bank collapse events (A to F) identified during the monitoring periods (see Fig. 4).

The photographs were also used to validate the variations in tidal water stages obtained from the Admiralty TotalTide tables and their association with both timing and nature of discrete mass wasting events. A clear identification of all the mass wasting events that occurred during the monitoring period was not possible because minor failures (smaller than  $\sim 40 \text{ m}^2$ ) could not be identified on the images. Also, large collapses located farther than 20–30 m from the location of

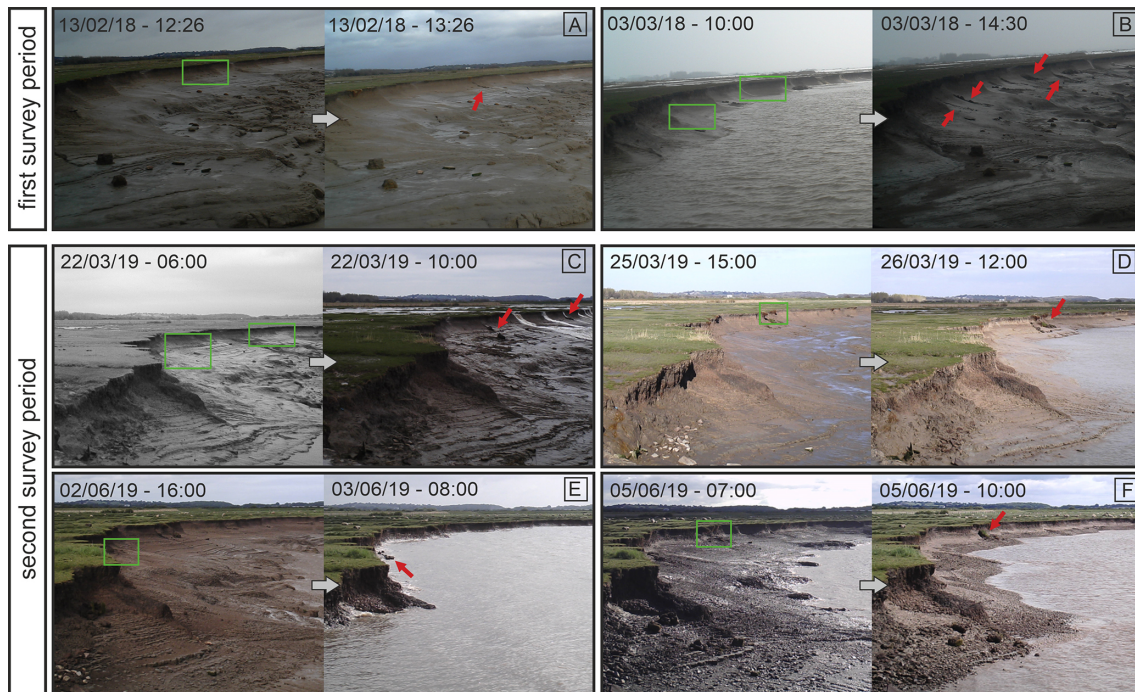
**Figure 4.** Time sequences of notable mass failure events identified at the study site during the two periods of deployment of the fixed camera. Red arrows in the photographs indicate the collapse events; green boxes highlight the site of the bank where successive collapses occur. Photographs connected by grey arrows are successive (very close) in time. The failure events are also highlighted in the tidal range charts in Fig. 3.

the camera were not identifiable. In total 25 major failure events were identified and some of the most substantial are shown in Fig. 4.

flows are clearly visible in some of the images (Fig. 4 photograph C) and they not only prepare the face for successive large block failures, but they also directly affect the detachment and transport of bank materials toward the bank toe (Fig. 8). Gullies, such as those observed here, have been mentioned before in earlier studies of the Severn Estuary (Crowther et al., 2008), but they were never directly recorded and linked to other erosive mechanisms in the bank destabilization process. The photographs reveal that such gullies overlap with other failure mechanisms such as toppling and cantilever bank failures (Fig. 8). Toppling occurs in the earlier stages of the collapse process when the top portion of the bank line slides along the critical slip surface during the tidal ebb phase; in a second phase of the collapse, the bank line is characterized by a reshaping of its face whereby the uppermost part of the bank slope forms a cantilever. This specific style of failure likely reflects the specific stratigraphy of the studied area where two layers of fine material are stacked. The nature of the layers and specifically the positioning of

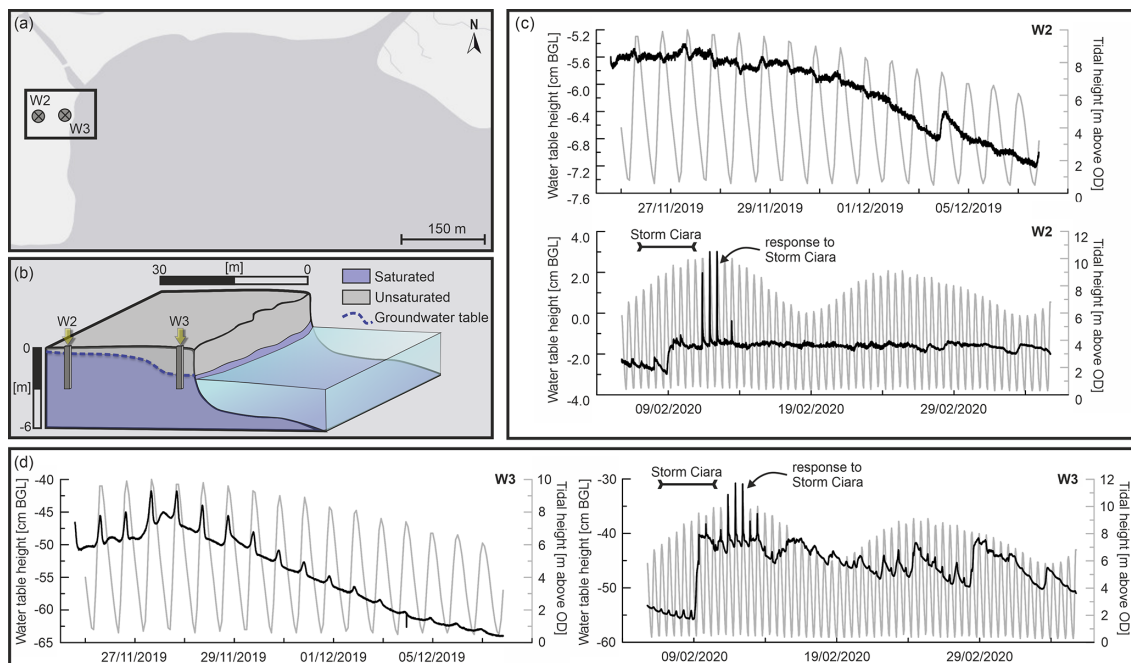
**Figure 5.** Groundwater monitoring: (a) location of the groundwater monitoring system (image © Esri World Light Gray Base July 2021). (b) Material layering and position of wells on the bank (bank top level: 8.4 m above datum). (c) Groundwater table fluctuations for the first and second monitoring periods for the bank-distal monitoring well W2 (d) and the bank-proximal monitoring well W3. High peaks in the water table level present in the February/March 2020 plots are linked to storm Ciara, which affected the western UK in early February 2020. The two monitoring wells (W2 and W3) were used in the modelling. (Storm data: Met Office, 2020.)

The groundwater fluctuations recorded during the monitoring periods (Fig. 5) confirm that the sediments of the studied bank have a relatively low level of transmissivity such that the groundwater response to the tidal oscillations is damped relative to the variations in hydrostatic confining pressure driven by the tidal level fluctuations. While the distal monitoring well (i.e. W2) is much less affected by variations in the tidal water level attaining an average water table elevation (below local ground level) of ca. 6 cm, the bank-proximal monitoring well (i.e. W3) shows a higher responsiveness to tidal oscillations (average water depth 50 cm). The system is therefore affected by tidal variations predominantly in the bank face fringing zone (within a distance of 3–5 m from the bank face).

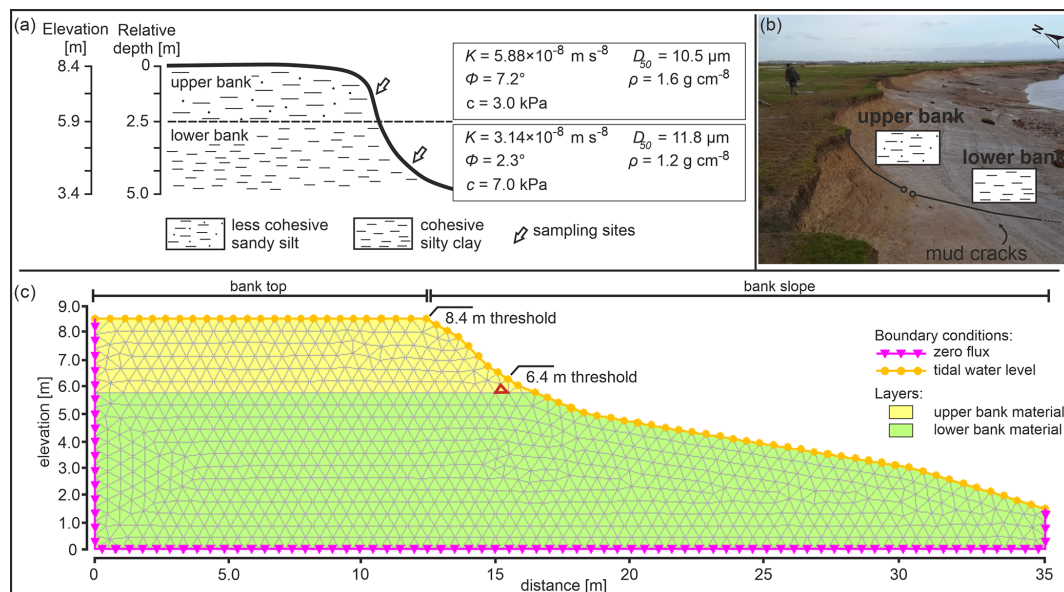
**Figure 6.** (a) Representation of the investigated bank at the study site illustrating the most important geotechnical characteristics of the two sedimentary layers ( $K$  conductivity,  $\Phi$  angle of internal friction,  $c$  cohesion,  $D_{50}$  geotechnical grain size distribution, and  $\rho$  dry bulk density). (b) Photograph of the central part of the study site showing the progressive change in grain size. (c) Representation of the mesh characteristics used in the bank stability model. The cell used to represent the temporal variations in the pore water pressure (see Figs. 9 and 10) is highlighted in red. The different boundary conditions employed in the simulations are indicated. Note that the boundary condition indicated in yellow indicates the surface at which the tidal level interacts with the bank (with the entire bank slope in this specific example of high tide).

In interpreting the results of the model simulations it may be noted that, based on topographic and SfM surveys, two important topographic controls influence the behaviour of seepage flows into and out of the bank as well as the hydrostatic confining pressure exerted by water against the bank

face (Fig. 6). Specifically, the elevation at which the flow in the channel overtops the bank (allowing potential seepage into the bank from the floodplain surface) is 8.4 m at the study site, whereas the 6.4 m elevation represents the limit below which the tidal waters no longer exert any direct influence on the simulated incipient failure block (vertical face of the bank). Also, note that the bank geometry remains constant throughout all the simulations reported here, even after mass failure events are predicted ( $\text{FoS} < 1$ ). This constrained geometry is a recognized limitation because in reality, after the incipient failure block is translated downslope, the post-failure bank surface (usually of the order of  $35\text{--}45^\circ$ ) will be much less steep than prior to failure (typically  $\sim 85^\circ$ ). Thus the model is conservative as the factor of safety after simulated bank collapse events would, in reality, be higher (i.e. more stable) than simulated here.

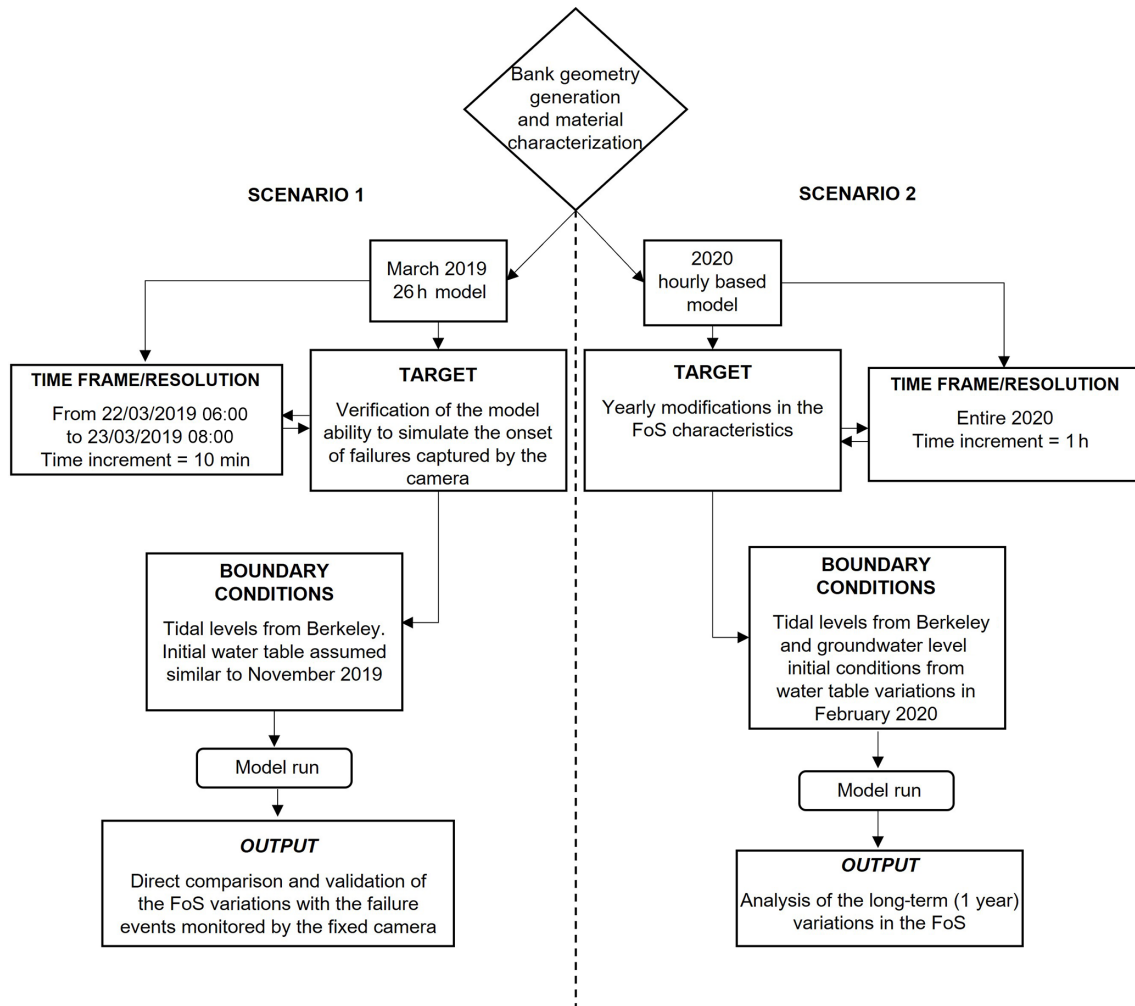
**Figure 7.** Summary of the two modelling scenarios.

Two separate simulation scenarios were defined (Fig. 7). The first scenario employs a 10 min time increment for a shorter duration simulation (22 March 2019 06:00–23 March 2019 08:00), and a second scenario simulates the entire calendar year of 2020 at a 1 h time step. The first scenario was selected to ensure an overlap with the field monitoring observations and focused on seeking to understand the factors (these factors include gullying, basal removal, and tidally driven fluctuations in pore water and hydrostatic confinement pressures, as summarized in Fig. 8) triggering the observed mass wasting events in this specific period and as a form of model validation. The initial groundwater table conditions were defined using the water table level from the bank-edge-proximal monitoring well W3 data from November 2019, when conditions were not dissimilar to those in March 2019. The second simulation scenario was used to study the factors influencing seasonal variations in bank stability (as indicated by the FoS). This second simulation scenario was initialized based on water table conditions observed in the monitoring well W3 in February 2020 and was forced using the time-varying tidal water levels as observed at Berkeley.

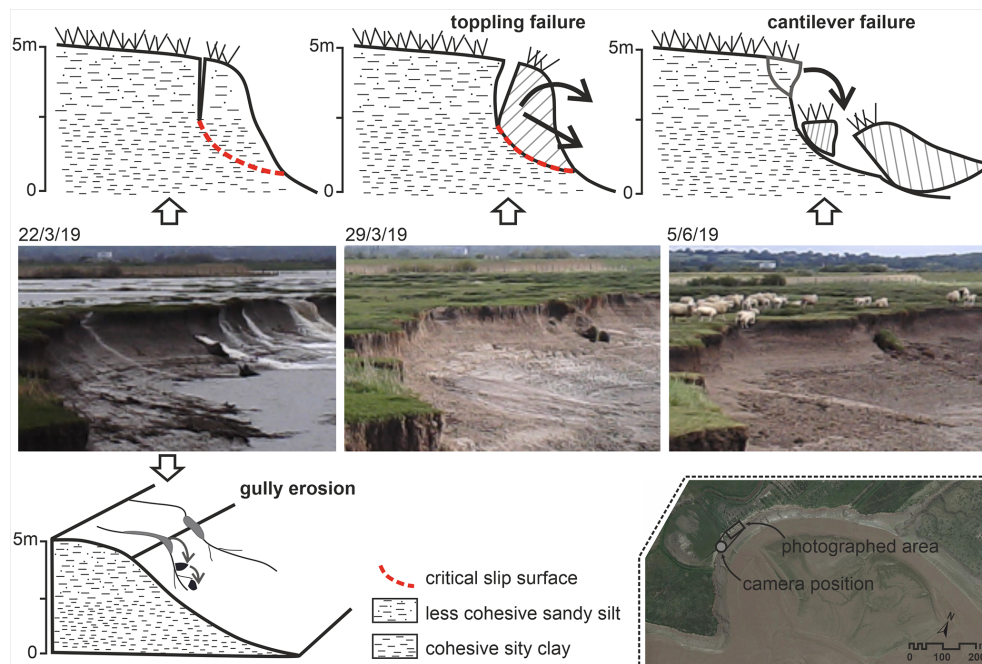
**Figure 8.** The typical collapse mechanisms observed at the study site (note that the photographs presented here refer to those also presented in Fig. 4). Image © Google Earth July 2021.

the incipient failure plane at the interface between the layers suggest that these stratigraphic discontinuities can play a key role in the failure modalities.

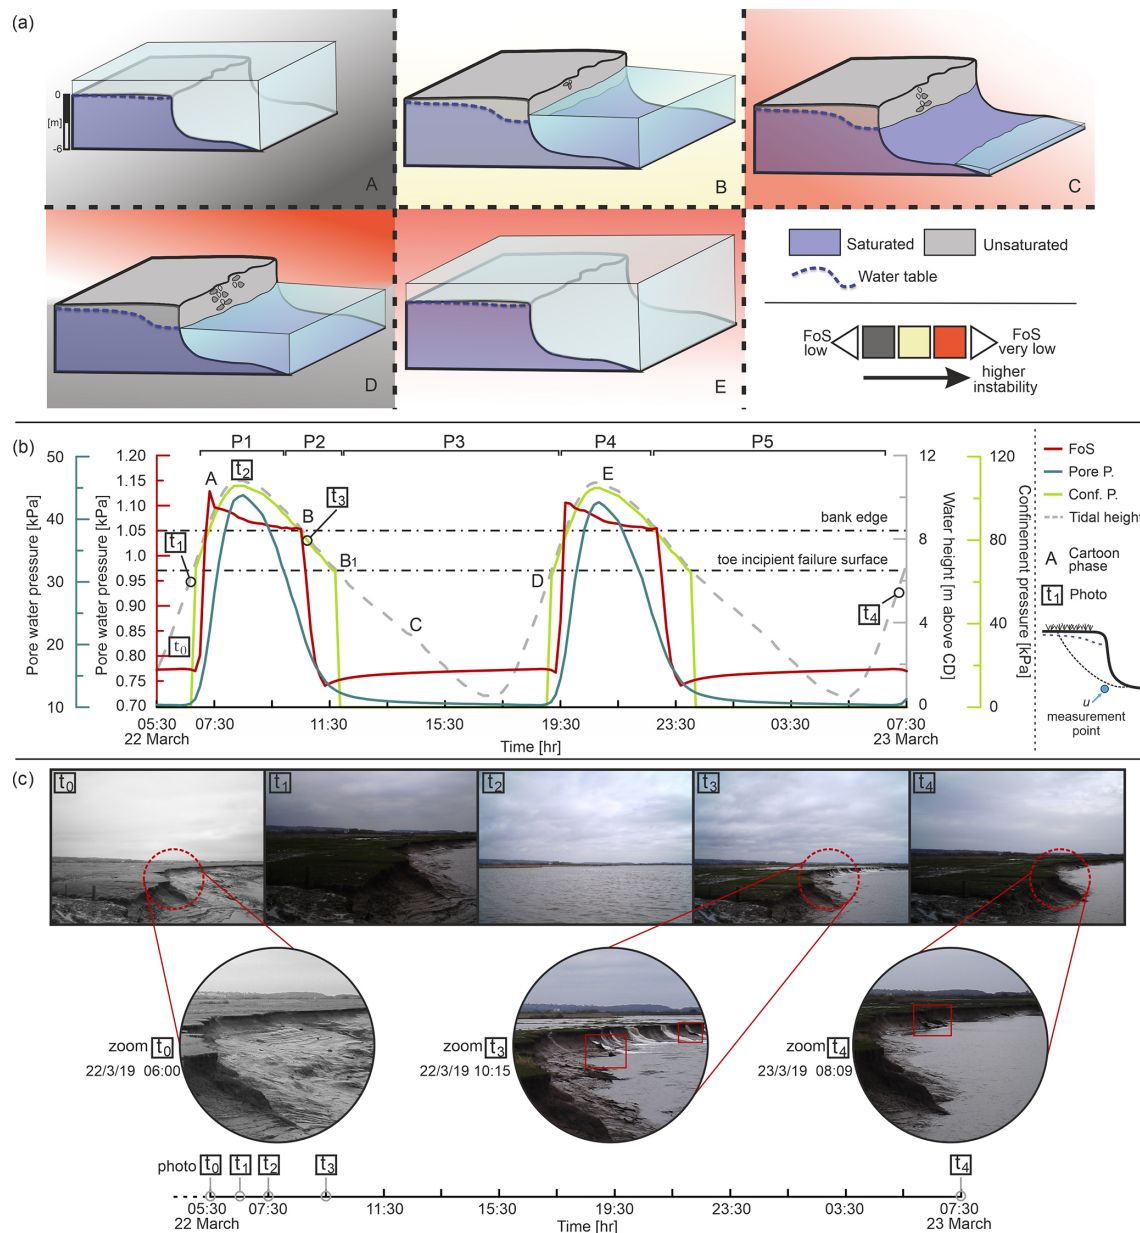
**Figure 9.** Simulated and observed (from fixed-camera images) bank stability conditions at the Plusterwine study area during a 26 h time lapse (22–23 March 2019). **(a)** Cartoon of the studied bank and related conditions; **(b)** physical conditions of the bank. The letters refer to stages of evolution indicated in panel (a) and markers to photographs in panel (c).

The Scenario 1 simulation results (Fig. 9) represent a very high-resolution model (10 min time increment) that provides a detailed visualization of the bank failure processes observed in March 2019 during a 1 d monitoring window. In contrast, Scenario 2 focuses predominantly on the semidiurnal nature of the tidal cycle in the middle Severn Estuary, studying variations in stability within a much longer time frame (the calendar year 2020), which allows for the effects of variations associated with the differences between spring

and neap tidal cycles to be taken into consideration. These results were compared and combined with real-world observations (from the fixed-camera photographs) leading to a detailed analysis of the failure mechanics. The evolution of the bank was subdivided into phases (denoted P1, P2, P3, etc.), and some additional specific time points corresponding to specific exemplar photographs were marked. Figure 9a sketches the tidal cycle represented in the model; the different boxes exhibit different colours highlighting the relative factor of safety (FoS) of the bank. In Fig. 9c, some images linked to specific moments in the simulation have been further analysed with three supplementary zooms related to the pre-failure ( $t_0$ ), failure ( $t_3$ ), and a secondary failure phase (additional minor collapses) ( $t_4$ ).

In the first part of phase P1 (Fig. 9b point A, corresponding to photograph  $t_2$  in Fig. 9c), the tide is at peak level and the entire tidal flat is inundated (22 March 2019, 07:30–08:00). The groundwater table is therefore almost at ground level. Under these conditions, even though the elevated positive pore pressure ( $\sim 43$  kPa at 08:10) promotes bank instability, the simulation results indicate a rising FoS (i.e. increasing stability) (from a value of 0.77 at  $t_0$  to a value of 1.14 at 07:20) due to the high hydrostatic confining pressure ( $\sim 100$  kPa). After the peak in the tidal level is surpassed (mid-phase P1 at 08:40), the pore water pressure also begins to decline. Thus, even as the hydrostatic confining pressure is reducing with the retreat of the tidal waters (106 kPa at the peak at 08:30, 100 kPa at 08:50), the soil saturation remains high ( $\sim 40$  kPa at 08:50) favouring the decrease in the FoS

( $FoS = 1.07$ ). Toward the end of phase P1 (ca. 09:40), the retreat of the tidal waters generates a considerable and fast reduction in the hydrostatic confining pressure (from  $\sim 100$  to  $\sim 88$  kPa at the end of P1). This rapidity, together with the elevated pore water pressure associated with the earlier rising tide that led to a saturation of the bank deposits (the peak in the saturation corresponds to the peak in tidal level), creates a condition in which the bank begins to experience a decline in the  $FoS$  (although the bank is not yet unstable).

The decrease in the  $FoS$  continues also in phase P2. From point B onwards, the stabilizing effect of the hydrostatic confining pressure exerted by the flow in the tidal channel is rapidly reduced as the tidal level starts to fall below the elevation of the bank top (i.e. once it falls below the 8.4 m elevation of the bank top) and the  $FoS$  drops rapidly, changing the bank from stable to unstable state (from a  $FoS$  of 1.05 at 09:45 to 0.9 at ca. 10:00; photograph  $t_3$ ). During this phase the pore water pressure remains positive (falling from 33 kPa at 11:40 to 13 kPa at 11:55), but the condition of instability is further exacerbated by the elevation of the ebbing tide falling below the 6.4 m incipient failure toe elevation threshold (point B1), causing the hydrostatic confining pressure to fall to a value of 0. Therefore, conditions during this phase (P3) are key for promoting bank instability because destabilizing forces remain high and diminish only gradually, whereas the stabilizing forces are removed. In phase P3 (from 11:50 to 19:20), the elevation of the water in the channel remains below the 6.4 m threshold that maintains the stabilizing confining pressure at 0 until the elevation of the water surface exceeds 6.4 m on the next rising tide (starting at point D at 19:20). With zero confining pressure, phase P3 has the lowest simulated  $FoS$  of the entire simulation. During this phase, the bank internal pore pressure evolves only gradually as slow seepage outflow (typical velocities  $3.5 \times 10^{-10} \text{ m s}^{-1}$ ) gradually drains the bank, declining from a value of  $\sim 13$  to  $\sim 10$  kPa between 11:50 and 19:20, respectively. The bank  $FoS$  is, therefore, unable to drop significantly further during this period because the new rising tide terminates phase P3 and induces a new stage of rising bank stability.

Between points D (19:20) and E (21:00), with a swiftly rising tide, the pore pressure again increases due to the inward-directed seepage flow (typical seepage velocities of  $3 \times 10^{-8} \text{ m s}^{-1}$ ), but the hydrostatic confining pressure rises more rapidly from  $\sim 62$  kPa at the start of P4 to  $\sim 100$  kPa at 21:00 giving a rate of change of  $\sim 4 \text{ kPa h}^{-1}$  (compared with the pore pressure curve gradient of ca.  $1 \text{ kPa h}^{-1}$ ). The very low  $FoS$  value persists until the tide again approaches the 6.4 m threshold (point D in Fig. 9b). After point D (19:20), the increase in hydrostatic confining pressure dominates over the slowly increasing positive pore water pressures induced by the new phase of seepage inflow, causing the bank stability to increase to a  $FoS$  value of 1.1 at the start of phase P4 (19:35). A second collapse event is predicted in the last phase (P5, which lasts from 23:20 to the end of the simula-

tion), which corresponds to the next ebb tide. In this second ebb tide phase, the simulated  $FoS$  drops below 1 a few minutes after the water level falls below the bank top threshold (22:50); the confinement pressure is no longer present along the top portion of the bank, while the pore pressure is decreasing following the recession of the tide but is still high ( $\sim 34$  kPa). Similar to phase P2, the most unstable condition is reached when the hydrostatic confining pressure is lost but the positive pore water pressure within the soil remains relatively high (the hydrostatic confining pressure starts dropping from  $\sim 62$  kPa at 23:40 to 0 at 23:50 when the pore pressure is still  $\sim 8$  kPa and the  $FoS$  is 0.75). Note that phases 4 and 5 both occurred during hours of darkness, and the fixed camera was therefore unable to yield images that could constrain precisely the observed timing of the predicted failure. Nevertheless, it is noteworthy that a new mass wasting event was apparent in the first image captured in daylight after the simulated collapse (photograph  $t_4$ , taken at 08:09 on 23 March 2019, Fig. 9d).

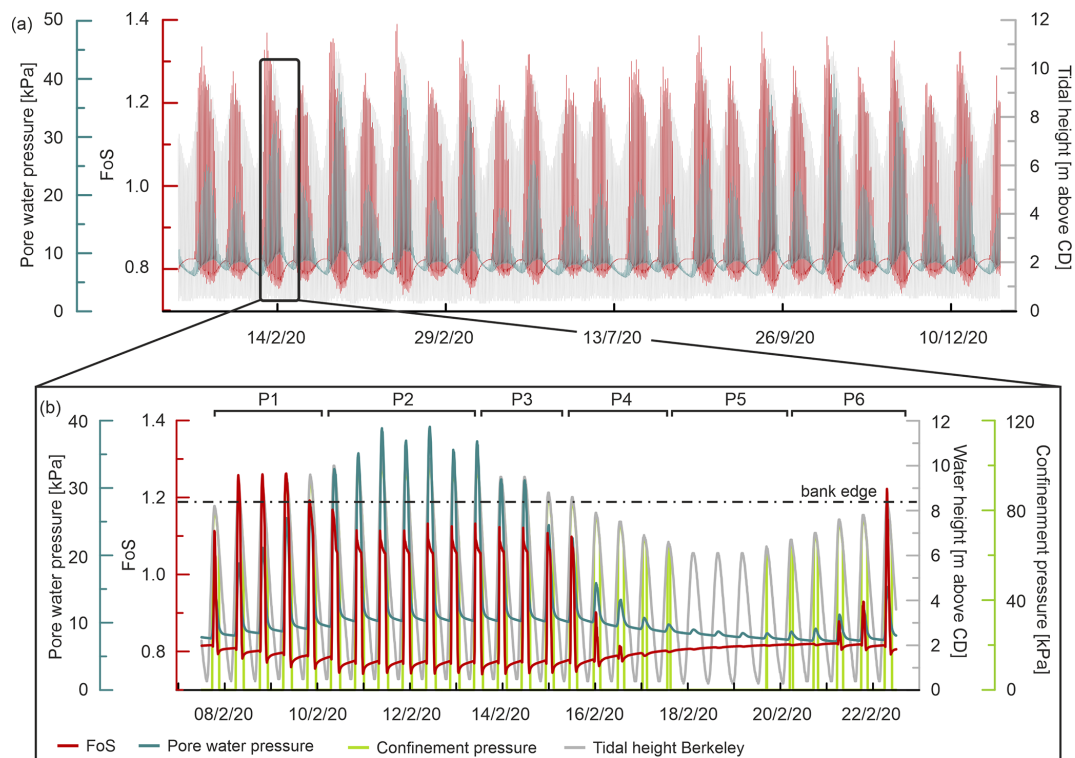
**Figure 10.** (a) Computed bank stability analysis for the year 2020. (b) Zoom into the period covered by the groundwater table monitoring in February 2020. This second plot is subdivided into different Phases (P1, P2, P3, etc.) and pore water pressures are plotted for a representative cell, the location of which is highlighted in Fig. 6.

To better describe the long-term effects of the destabilizing forces and their mutual interactions with the stabilizing forces, the dynamics occurring over a period of 16 d (7 February 2020, 12:00–22 February 2020, 12:00) are represented (Fig. 10b) and discussed. In this longer duration analysis, phase P1 covers a time period in which the tidal conditions are moving from neap to spring tide, therefore from a

period of this phase, the bank eventually becomes stable. In such circumstances (core of phase P1), the hydrostatic confining pressures exerted by the tidal waters ( $\sim 82$  kPa) are relatively high and dominate over the internal pore water pressure of  $\sim 18$  kPa. During P1, the bank line is subject to a regular alternation of stable conditions during high-water stages and unstable phases during low-water stages when the FoS drops below 0.8. As with the results of simulation Scenario 1, this pattern of simulated bank stability is explained by the increasing hydrostatic confining pressure exerted by the tidal water tending to dominate over the slow (destabilizing) and damped variations in the pore water pressure.

In phase P2, the FoS remains above a value of 1 during high-water stages but experiences a gradual decline. This behaviour occurs because of the superimposition of the pore water pressure oscillations at the scale of a (non-semidiurnal) spring–neap tidal cycle onto the semidiurnal oscillations. This superimposition leads to a condition in which the destabilizing pore water pressure attains higher values than in the previous phases ( $\sim 27$  kPa at the end of phase P1;  $\sim 40$  kPa at the mid-point of P2). In such circumstances, the slow response of the pore water pressure (due to the low hydraulic transmissivity of the alluvium) causes the high pore pressures to overlap with the apical part of the spring tide conditions (core of phase P2), such that the stabilizing effects of the

hydrostatic confining pressure no longer dominate the now very high ( $\sim 40$  kPa) pore water pressure levels, diminishing the stability of the bank (with FoS values approaching 1.1 during high-water stages).

Moving toward neap tide conditions (end of phase P2 and during phase P3) the bank is no longer experiencing bank-full stages, and therefore no more full saturation conditions are present. Neap tides water levels decrease the bank saturation but are still sufficient high to stabilize the bank materials (confinement pressure) leading to a condition where the confinement pressure is more efficient than the pore pressure destabilization. Therefore, the bank is still experiencing a degree of stability.

In phase P4, the bank is influenced by the neap stage with an important reduction in the tidal heights. The poorly conductive sediments are still experiencing high pore water pressures ( $\sim 10$  kPa in the central part of P4) even if the tidal level is lower. In this phase, the hydrostatic confining pressure regularly falls to 0 during low-water stages (largely reducing the stabilization effect of this component), favouring factor-of-safety values below 1. At the onset of phase P5, the bank is still experiencing a condition of instability because of the slow process of dissipation of the pore water pressure (residual positive pore pressure  $\sim 8$  kPa) and the absence of hydrostatic confining pressure (tidal waters still regularly re-

main below the 6.4 m threshold). Notwithstanding this, in P5 the overall trend is one of a slowly rising FoS before the onset of a new spring tide condition because of the gradual dissipation of the pore pressures ( $\sim 6$  kPa in the last part of P5). During the initial part of P6, the tidal waters shift back toward a spring condition causing a rise in the hydrostatic confining pressure while the pore water pressure curve is still declining. Once the new spring tide condition is fully set (at the end of phase P6), the pore water pressure is again dominated by the hydrostatic confining pressure, so that the bank returns to more stable conditions ( $\text{FoS} > 1.2$ ).

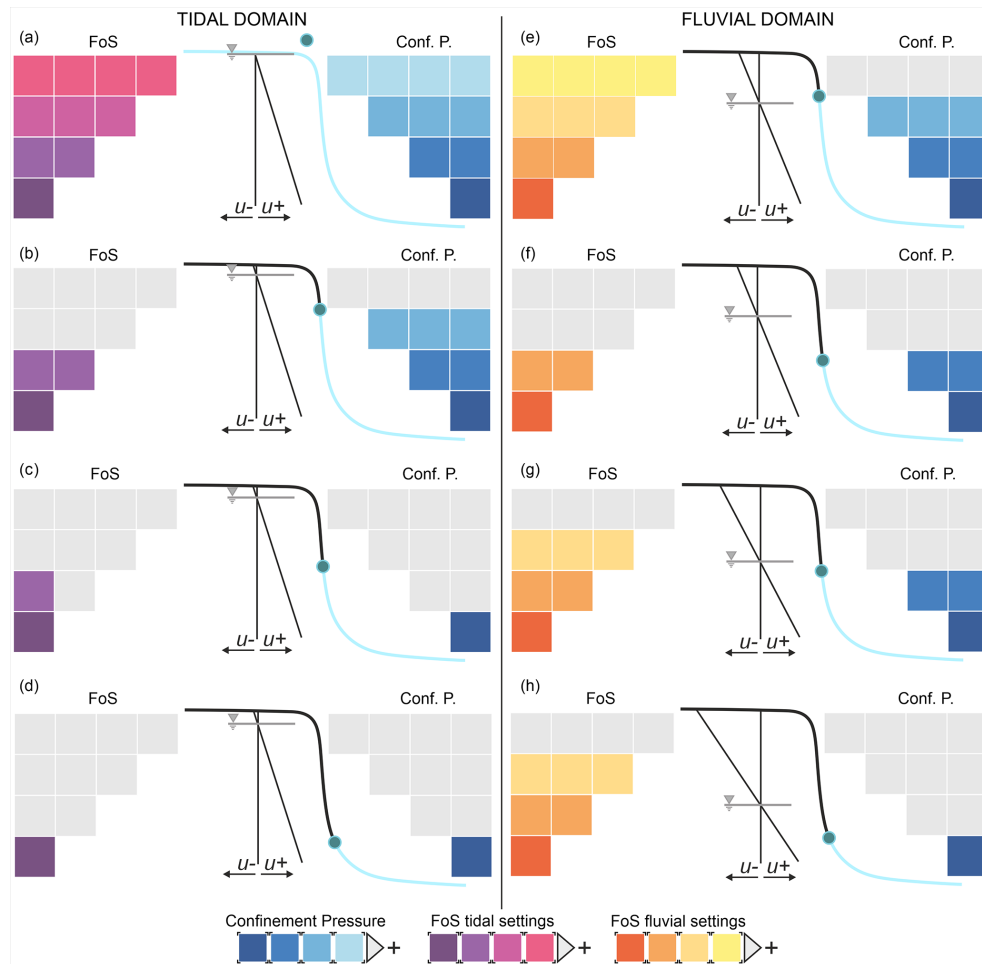
**Figure 11.** Conceptual model of the factors controlling the onset of bank instability in fine-grained tide-dominated hypertidal settings (such as the Severn Estuary) versus fluvially dominated environments.

A synthesis of the dominant factors influencing bank stability in tidal and fluvial settings is presented in Fig. 11, which is subdivided into tidal (left-hand panels) and fluvial (right-hand panels) domains. For the tidal domain, the water level (indicated by the blue dot in the diagrams) follows a path that is identical to that for Scenario 1, starting from a high water level (similar to phase P1 in Fig. 9b and c), while

for the fluvial domain the water level is based on typical hydrographs published in prior studies of rivers (e.g. Casagli et al., 1999; Luppi et al., 2009; Rinaldi et al., 2004) and also commences at a high flow stage.
