Localised geomorphic response to channel-spanning leaky wooden dams

Joshua M. Wolstenholme^{1,2}, Christopher J. Skinner^{3,2}, David Milan⁴, Robert E. Thomas², and Daniel R. Parsons¹

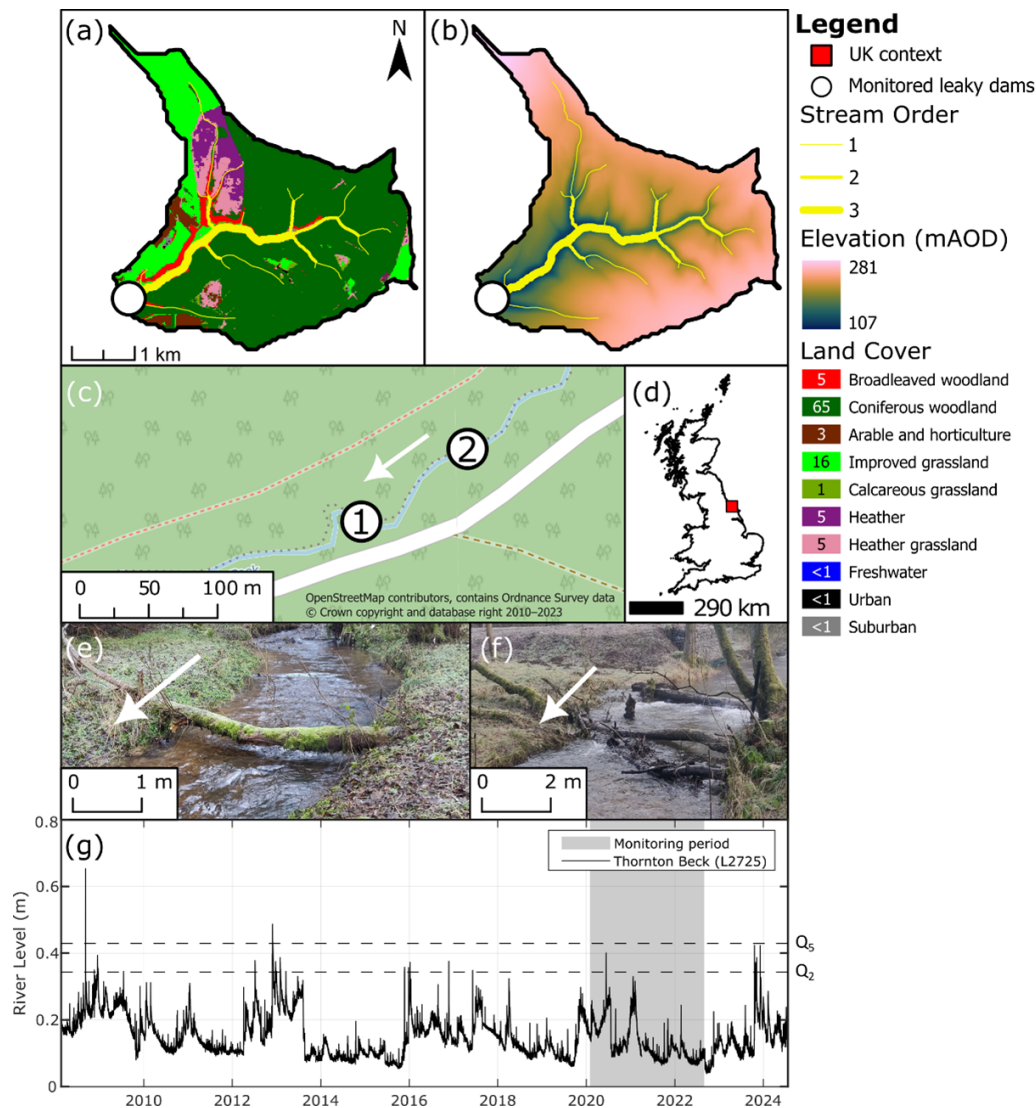
Figure 1. Location of the studied LDs in relation to the Dalby Forest catchment. (a) 2021 land cover map with percentage cover shown in the legend (Marston et al., 2022). (b) Stream network generated from terrain data showing Strahler stream order and elevation (Ordnance Survey, 2020). Note the same scale as panel (a). (c) Location of LD1 and LD2, with the flow direction denoted by a white arrow. (d) UK context for the site location. (e, f) LD1 and LD2, respectively, with the flow direction denoted by a white arrow. (g) River-level record 2008–2024 for Thornton Beck, Thornton Le Dale (Grid Reference: SE 83681 83418; Station ID: L2725), approximately 7 km downstream of the study area (from the Environment Agency) including the estimated return period (Q_n), as described in the Supplement.

LD1 (Fig. 1e) is a channel-spanning LD anchored in situ with a wooden stake on the true right bank to reduce the likelihood of displacement during high flows; it was embedded into the surface on the true left bank. The channel was 2.7 m wide where the LD was installed. The structure was comprised of a single log which was fully separated from a tree trunk, with some thin branches attached facing upwards. Since this LD is fully channel spanning and thus does not interact with baseflow, it is a “Type 1” LD (fully channel spanning, not interacting with baseflows) following the classification of Lo et al. (2021).

LD2 (Fig. 1f) was felled and left in situ, remaining attached to its stump to enable growth (a “living” LD). The LD itself was composed of two sub-sections, with the furthest downstream (LD2a) spanning a 3.85 m wide channel. The structure was partially submerged at the time of installation. LD2a was classified as a “Type 2” LD (fully channel spanning, interacting with baseflows but not touching the stream bed; Lo et al., 2021). LD2 was more complex than LD1 due to the presence of a pre-existing walkway that formed a secondary sub-structure LD2b that was fixed with wooden anchors. LD2b was a “Type 1” LD (fully channel spanning, not interacting with baseflows at all; Lo et al. (2021)). LD2b was installed above the average water depth and spanned a 3.25 m wide channel.

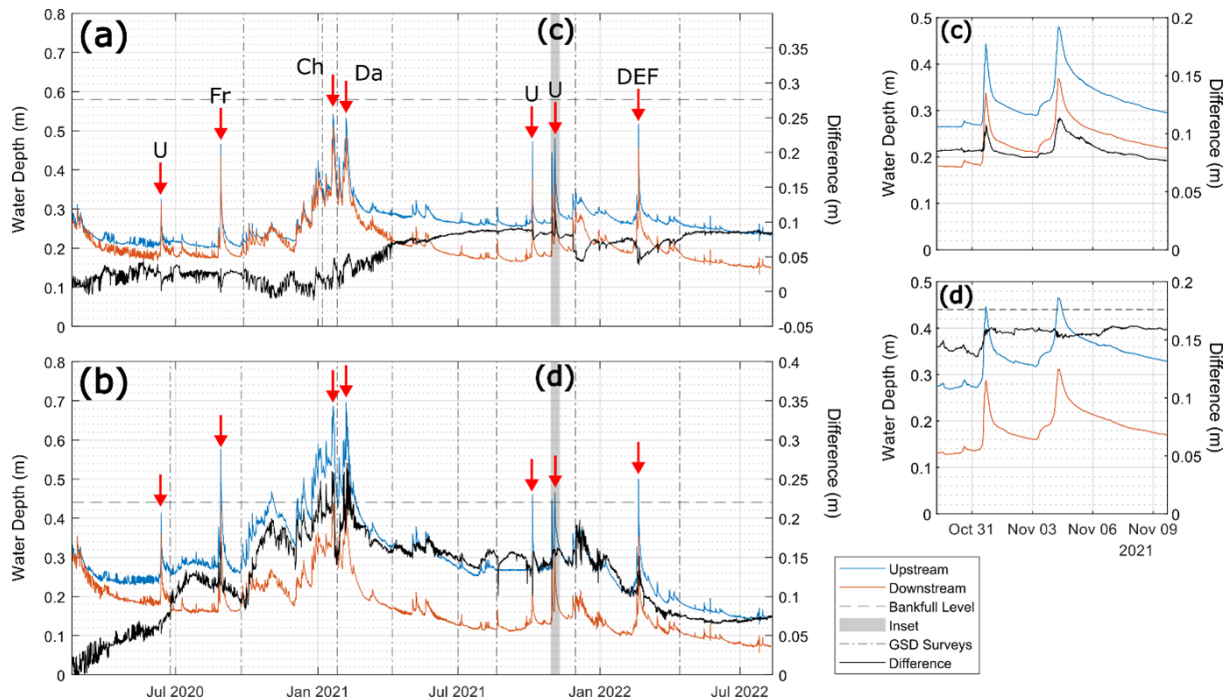
Figure 2. Temporal variations of water depth for LD1 (a) and LD2 (b) with differences between upstream and downstream recordings shown, as well as key peaks and storms (U = unnamed, Fr = Francis, Ch = Christoph, Da = Darcy, DEF = Dudley, Eunice, and Franklin). Also shown are the dates of the GSD surveys and bankfull level. Note the different secondary y-axis scale. Panels (c) and (d) show variations in the water depth throughout time between the two sites.

Initially, water depths at LD1 covaried, averaging 0.21 m downstream and 0.22 m upstream between February 2020 and November 2020, increasing to 0.31 and 0.32 m, respectively, until February 2021, when the upstream depth diverged from the downstream. Throughout the monitoring period, there was an average difference of 0.05 m and a maximum difference of 0.11 m between the two depths, with the upstream depth ranging from 0.20 to 0.54 m, and the downstream depth ranging from 0.13 to 0.51 m.

In contrast, the upstream and downstream water depths quickly diverged at LD2, with an average difference of 0.12 m between the upstream and downstream depths. The downstream peaks were generally shorter in duration than the upstream (Fig. 2b) due to water being stored upstream and slowly released, extending the peak. Additionally, once the LD was fully engaged with the river, there was a near constant difference between the downstream and upstream depths of up to 0.27 m. This difference decreased to less than 0.10 m following the last notable storms of the monitoring record in February 2022 (Dudley, Eunice, and Franklin). The upstream and downstream depths ranged from 0.13 to 0.70 m and from 0.06 to 0.44 m, respectively.

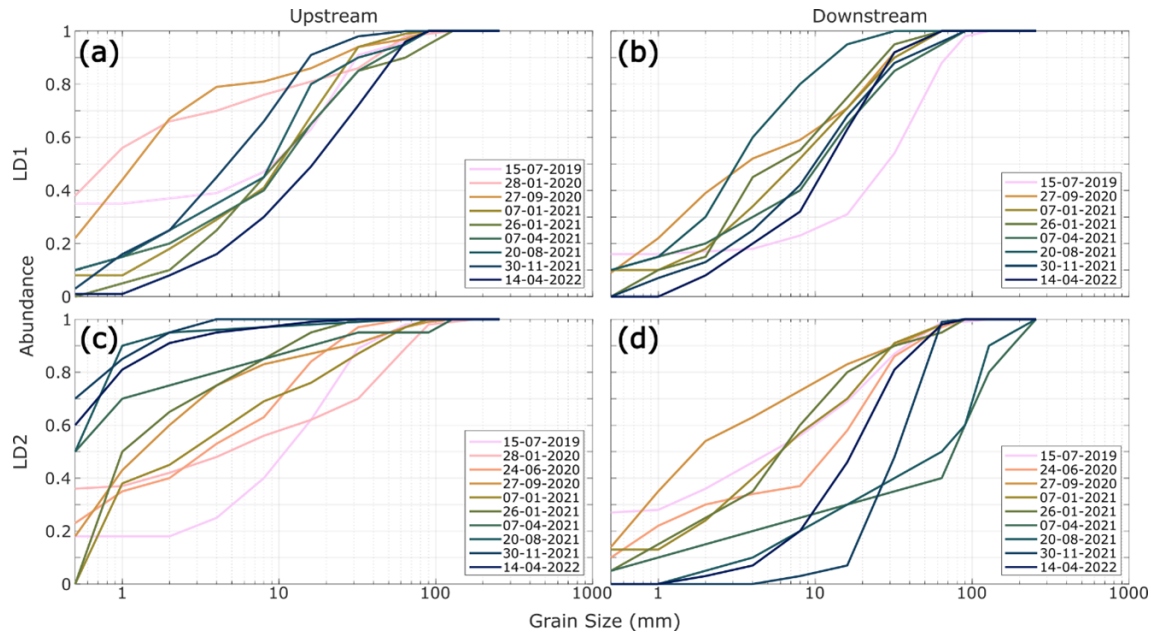
Figure 3. Cumulative density functions of the Wolman pebble count data at LD1 (a, b) and LD2 (c, d). The sites are separated into upstream (a, c) and downstream (b, d) observations.

tions upstream of the structure immediately following installation and until September 2020, the between-event variability was greater than any consistent change to the GSD at LD1 during the monitoring period, although there is some evidence of slight coarsening over the longer record (Fig. 3a, b). In contrast, fine sediment was deposited upstream and scoured downstream at LD2. This was reflected in a consistent fining trend upstream of the structure post-installation, resulting in a decrease of D_{50} from 10 to < 1 mm (Fig. 3c) and a consistent coarsening trend downstream of the structure, resulting in an increase of D_{50} from 5 to 30 mm (Fig. 3d).

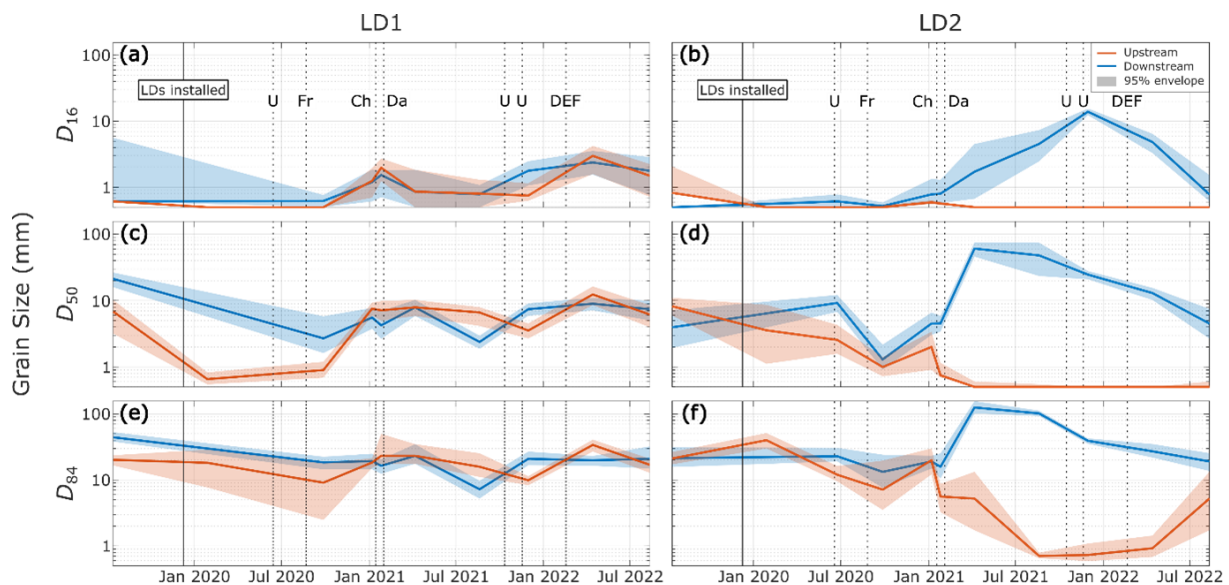
Figure 4. GSD metrics for upstream (orange) and downstream (blue) of the LD structures, with the 95 % error envelope shown. Key storms are indicated by dashed vertical lines.

D_{50} and D_{84} highlight the variability between the two sites as well as upstream and downstream of the LD structures, as shown in Fig. 4. LD1 showed little difference for all metrics, with upstream and downstream matching closely throughout the monitoring period, often within the calculated 95 % confidence interval of the measurements themselves. As such, this aligns with the more detailed GSD overview presented in Fig. 3. In contrast, the metrics for LD2 diverge notably from January 2021 onwards following the wet 2020/21 winter and storms Christoph (RI = 2.3 years) and Darcy (RI = 1.6 years), with downstream coarsening and upstream fining. There was a maximum range of 59 mm for D_{50} in April 2021, 98 mm for D_{84} in August 2021, and 10 mm for D_{16} in November 2021. At the end of the monitoring pe-

riod, all the grain-size metrics converged, most notably upstream of LD2, where D_{84} coarsened to 5.5 mm following winter 2021/22, while D_{16} and D_{50} downstream of the LD both fined to < 1 and 5 mm, respectively, from peaks of 10.5 and 60 mm.

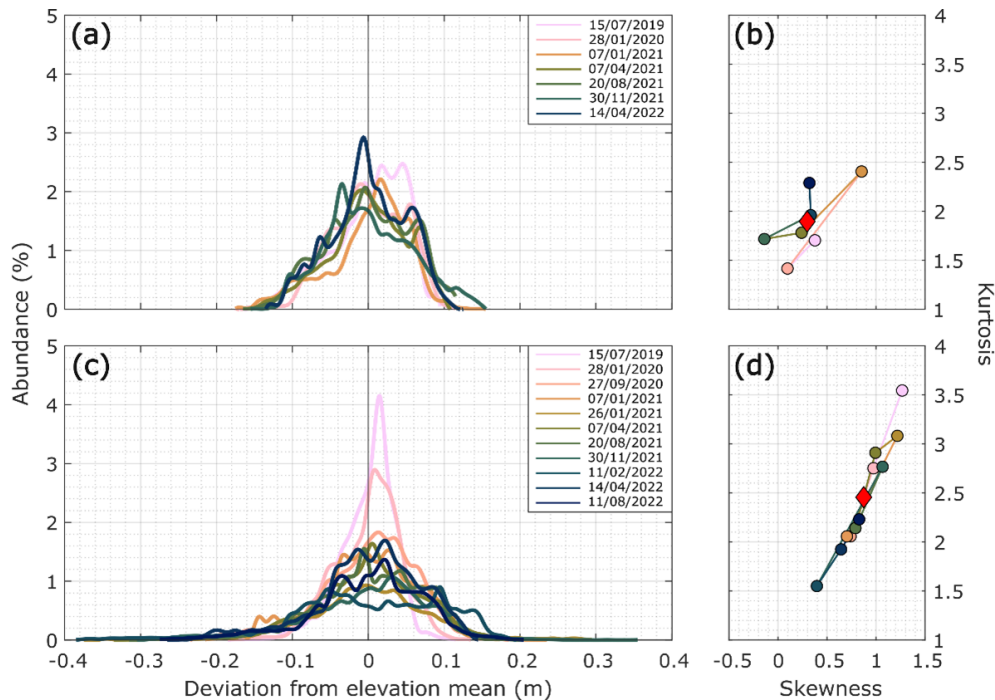
Figure 5. Detrended surface elevations relative to the mean for each bathymetric survey for LD1 (a) and LD2 (c). The associated skewness and kurtosis for each date are also shown with the mean shown as a red diamond (b, d).

In contrast, LD2 (Fig. 5c) exhibited increased topographic variability throughout time, with a minimum bed elevation range of 0.3 m in July 2019 and a maximum of 0.58 m in February 2022 following storms Dudley, Eunice, and

Franklin. The distribution evolved temporally from one that was predominately above the elevation mean with little variability (i.e. skewness > 1, kurtosis > 3.5; Fig. 5d) to a flatter, wider distribution with up to 0.38 m of deviation from the mean (February 2022), highlighting the development of plunge and underflow pools beneath LD2 (Fig. 7c, d). There was a clear progression throughout time from the pre-LD survey in July 2019, stabilising following the wet winter in Jan-

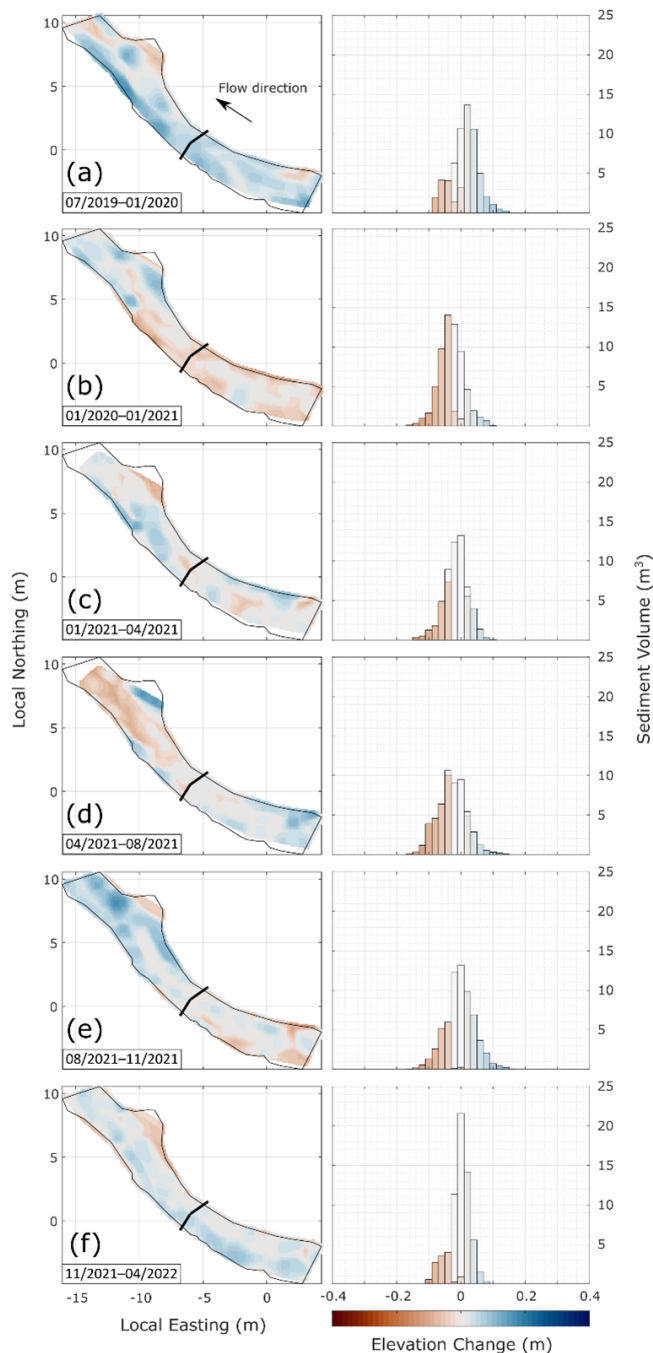
Figure 6. DoDs for LD1 (left column) and histograms of elevation change (right column). Significant elevation change ($\alpha < 0.05$) is denoted by colour (red is erosion, blue is deposition), with insignificant change shown in grey. The channel boundary is shown as a black outline, with the planar view of the LD represented as a thick black line.

LD1 exhibited a maximum scour depth of 0.16 m between January 2020 and November 2021 (Fig. 6b–e) which was distributed throughout the reach, both upstream and down-

stream of the LD. There was a maximum deposition depth of 0.14 m between April and November 2021 (Fig. 6d, e), situated approximately 5 m downstream of the LD. The range of elevation change did not fluctuate greater than ± 0.04 m throughout time. Spatially, most of the change was situated greater than 5 m from the LD, with the change around the LD being below the LoD threshold.

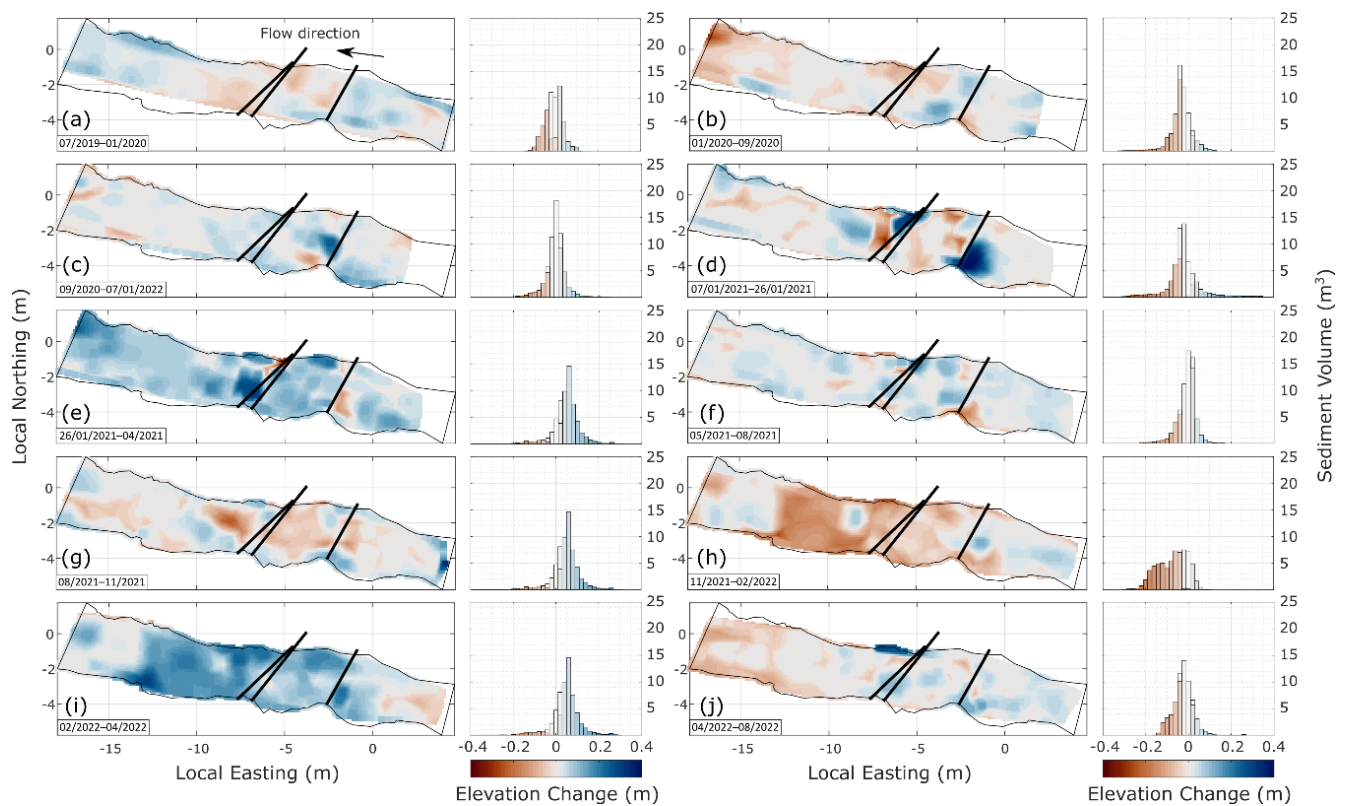
Figure 7. DoDs for LD2 (left column) and histograms of elevation change (right column). Significant elevation change ($\alpha < 0.05$) denoted by colour (red is erosion, blue is deposition), with insignificant change shown in grey. The channel boundary is shown as a black outline, with the planar view of the LD represented as a thick black line. The flow direction is denoted by a black arrow in panel (a).

LD2, which was formed by two linked structures, had a maximum scour depth of 0.38 m between 26 January 2021 and April 2021 (Fig. 7e) and a maximum deposition depth of 0.4 m (7–26 January 2021; Fig. 7d). The range of elevation change fluctuated throughout time from -0.14 – 0.12 m immediately after LD installation (July 2019–January 2020; Fig. 7a) to reported maximum values. Additionally, the DoDs were highly spatially variable, with evidence of pool formation downstream of the lower LD (Fig. 7a, b), which experienced periodic infilling (Fig. 7c, d) and scour (Fig. 7e, h) throughout the monitoring period. Immediately downstream of the upstream LD2a, a secondary pool formed that exhibited similar scour and fill cycles. The upstream LD2a stored sediment during the monitoring period, most clearly illustrated by Fig. 7d (7–26 January 2021 following Storm Christoph), where a substantial area of the DoD exhibited change greater than the LoD. The depositional zone also fluctuated over time, infilling and scouring on the true left bank of LD2a.

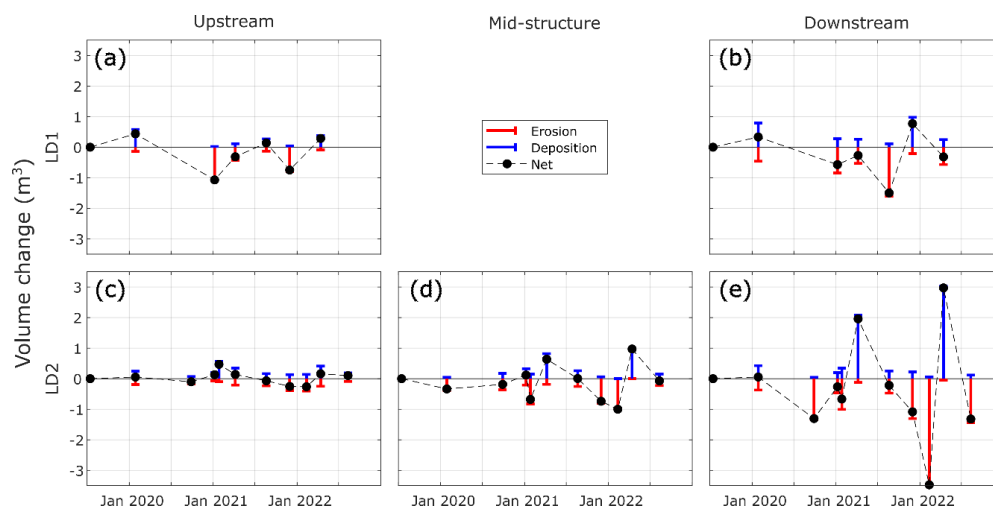
Figure 8. The volumetric change split into erosion and deposition for LD1 upstream (a) and downstream (b), and LD2 (c–e), separated into upstream of LD2b (c), mid-structure (i.e. between LD2a and LD2b; (d)) and downstream of LD2a (e).

Upstream of LD1, the volumetric change was highly variable (Fig. 8a), with no greater than 0.6 m^3 of deposition im-

mediately after the LD installation and 1.1 m^3 of erosion in January 2020. The upstream net change fluctuated throughout the monitoring period, with increased scour following higher flows in winter and increased deposition across sum-

mer period lower flows. Downstream of LD1 exhibited a similar pattern (Fig. 8b) but there was increased erosion (a maximum of 1.6 m^3 in August 2021) and deposition (up to 1 m^3 in November 2021).

Upstream of LD2 there was a clearer temporal trend (Fig. 8c). There was a maximum deposition of 0.6 m^3 on 26 January 2021 and increased erosion (0.4 m^3) following higher flows in February, with a clear progression as less sediment was being stored throughout the year. The LD impounded sediment upstream (Fig. 7d) and scoured over the following year prior to infilling again. Although the range of volume change was smaller than upstream of LD1, there was clearly a progression linked to the presence of the LD. There was more variability mid-structure at LD2, ranging from a maximum of 1 m^3 of erosion between January and February 2022 and 1 m^3 of deposition between February and April 2022 (Fig. 8d), reflecting pool formation and cyclic scour and infilling between the two LDs (see also Fig. 7a–d). Downstream of the LDs also exhibited similar variability (Fig. 8e), where plunge pools developed immediately downstream of the structure near the true right bank, followed by deposition further downstream. This section had the greatest range of volume change, with up to 3.4 m^3 of erosion between February and April 2022 and 3.0 m^3 of deposition between January and February 2022. Spatially, these periods were less variable as there was reach-wide erosion and deposition. However, there were localised areas 1 m downstream of the LD that exhibited little elevation change.

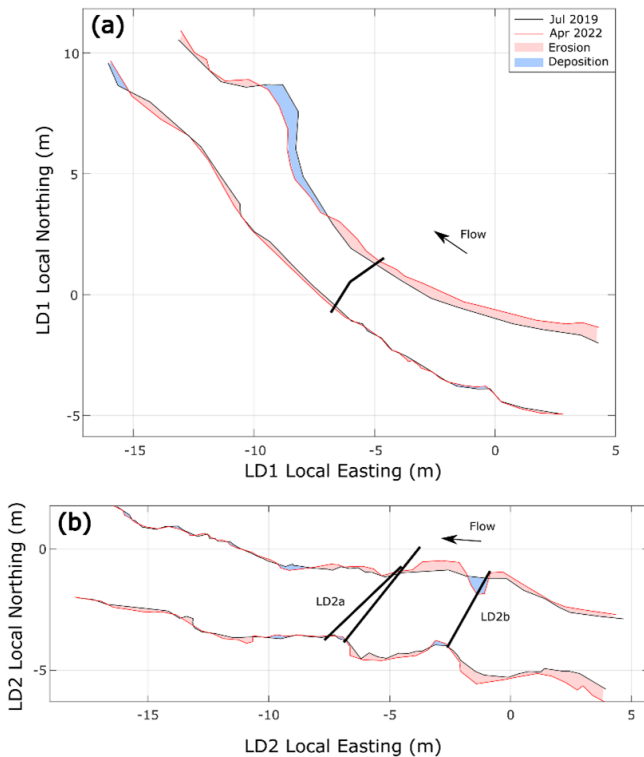
Figure 9. Bank erosion and deposition for LD1 (a) and LD2 (b). LDs are represented as thick black lines.

The banks at LD1 (Fig. 9a) predominantly exhibited erosion upstream of the LD and deposition downstream. The true right bank experienced 2.4 m^2 of bank erosion and 4.8 m^2 of deposition, with a net areal change of 2.4 m^2 (Table 3). In contrast, the true left bank at LD1 predominantly exhibited erosion, experiencing -1.9 m^2 of bank loss, 0.41 m^2 of deposition, and -1.5 m^2 of net areal change. The overall net planform area change at LD1 was 0.90 m^2 . The channel at the site is relatively straight, and there was no clear influence from LD1 on bank erosion since the true right bank had a similar magnitude of planform change both above and below the LD.

LD2 (Fig. 9b) predominantly exhibited erosion, with a net planform area change of -1.10 m^2 but with greater spatial variability near the LD sequence. Immediately downstream of LD2b on the true right bank was an area of deposition, followed by approximately 0.50 m^2 of bank erosion, flanking LD2b. A similar pattern was observed on the true left bank, with an area of erosion upstream of LD2b, and a small area of deposition downstream. Often during high flows, the river would exceed the riverbanks – as highlighted above – and flank the true right bank of LD2b. This clearly resulted in localised scour downstream of LD2b on the true right bank. LD2a appeared to have had little impact on the banks, de-

spite retaining water. Deposition mainly occurred in the mid-structure, preceded and succeeded by bank erosion. There was less apparent impact from LD2a downstream (Fig. 9b) as, despite having increased structural complexity, the structure engaged with deeper flows less frequently than LD2b.
