# Experimental study on granite-weathered crust landslides with different residual layer thicknesses under heavy rainfall

Jingye Chen<sup>1,2</sup>, Qinghua Gong<sup>2</sup>, Jun Wang<sup>2</sup>, and Shaoxiong Yuan<sup>2</sup>

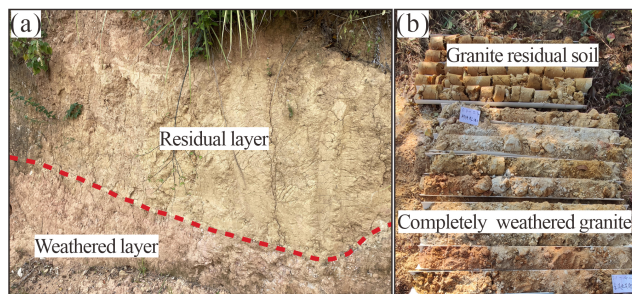
**Figure 2.** Geological condition of the study area. (a) Stratigraphic structure. (b) Drill core samples.

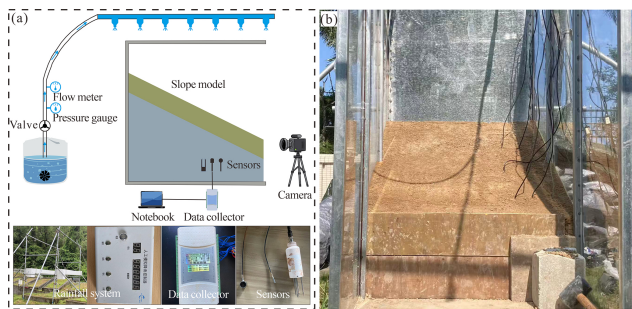
The slope physical model test platform is comprised of a model box, a rainfall system, and a data acquisition system (Fig. 3a). The dimension of the model box is  $2\text{ m} \times 1\text{ m} \times 1.8\text{ m}$  (length  $\times$  width  $\times$  height), and it is constructed with Plexiglas and steel columns. Grid lines have been drawn on the Plexiglas sidewalls to provide coordinate reference and datum control. The EL-RS3/5 mobile artificial rainfall simulation system produced by the Beijing ECO-LEADER company consists of a rainfall machine, a water

**Figure 3.** (a) Slope model test platform. (b) Constructed slope model.

supply system, and a control system. Its effective rainfall area is  $5\text{ m} \times 3\text{ m}$  (length  $\times$  width), with the rainfall uniformity coefficient greater than 0.9. The data acquisition system mainly consists of water content sensors, pore water pressure sensors, soil pressure sensors, and a data collector, which are produced by Xi'an Weizheng Electronic Technology Company. Two layers of sensors were buried at the foot, middle, and top of the slope, respectively, and the specific location is shown in Fig. 4. The sensor data are transferred to the notebook at a frequency of 3 min via the data collector. The deformation damage characteristics of slopes are recorded using the camera.

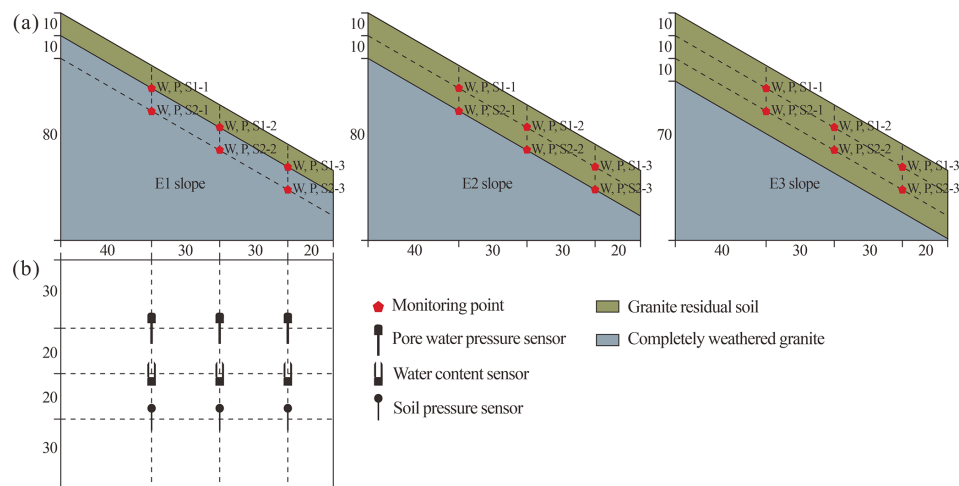
The objective of this test is to explore the rainfall infiltration law and the process of deformation damage in granite-weathered crust slopes with varying residual layer thicknesses during heavy rainfall. A slope model geometric similarity ratio of 1 : 20 was determined based on the field investigation and test conditions. The model measures 120 cm in length and 100 cm in width and has a slope angle of  $30^\circ$ . The depth of the sliding surface and the thickness of the corresponding residual layer were measured for 21 landslides (the positions are plotted in Fig. 1b, and the data are listed in Table 2). The thickness of the residual layer is primarily concentrated at 1.83–2.14, 3.66–4.20, and 5.72–6.42 m, respectively. Consequently, the midpoint values of these three intervals, 2, 4, and 6 m, were selected for the study. According to the geometric similarity ratio, three sets of test models, designated E1, E2, and E3, were designed with residual layer thicknesses of 10, 20, and 30 cm, respectively. The generalized geological model is shown in Fig. 4. According to

**Figure 4.** Schematic diagram of slope dimension and sensor buried position (unit: cm). **(a)** Side view. **(b)** Top view.

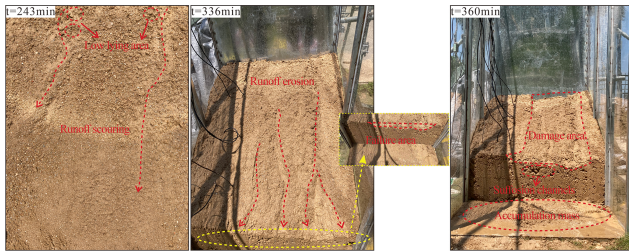
Figure 5 shows the failure process of the E1 slope. As illustrated in the figure, at test 243 min, a small range of low-lying areas was observed on the slope. As rainfall persisted, the residual layer gradually became saturated, and runoff was generated on the slope. The low-lying areas on the slope surface gradually developed into fine gullies as a result of runoff scouring. At test 336 min, the phenomenon of slip collapse

was observed at the foot of the slope. The initial fine gullies, subjected to the continuous action of seepage and erosion, ultimately evolved into erosion trenches of a certain depth and width. At test 360 min, extensive damage occurred at the top of the slope, with soil moving with the water flow and eventually accumulating at the foot of the slope. The accumulation mass exhibited looseness, high water content, and mobility. The slope showed an overall flow-slip damage with no obvious sliding surface. The suffusion channels were observed at the foot of the slope.

**Figure 5.** Deformation and failure process of the E1 slope.

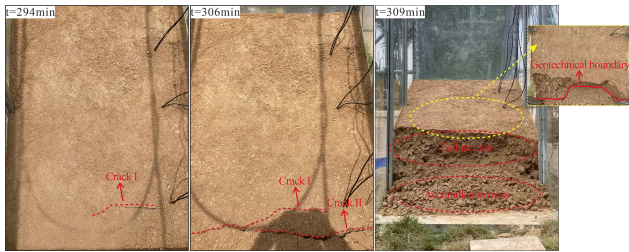
Figure 6 shows the failure process of the E2 slope. As illustrated in the figure, at test 294 min, transverse crack I was observed at the foot of the slope. The formation of the crack is attributed to the continuous flow of rainwater towards the foot of the slope, thereby weakening the soil's resistance to deformation. At test 306 min, the soil body at the foot of the slope exhibited horizontal movement, resulting in uneven settlement of approximately 3 cm of downward misalignment and transverse crack II. Crack II ran almost from the middle to the right border, and crack I had extended to the left border. These two cracks almost traversed the whole slope. At test 309 min, the slope slid along crack I and crack II. The trailing edge of the landslide was located at the foot of the

slope, and the sliding surface was positioned at the soil–rock interface. It took only 15 min for the landslide to happen after the appearance of the crack at the foot of the slope. This landslide exhibited sudden sliding characteristics.

**Figure 6.** Deformation and failure process of the E2 slope.

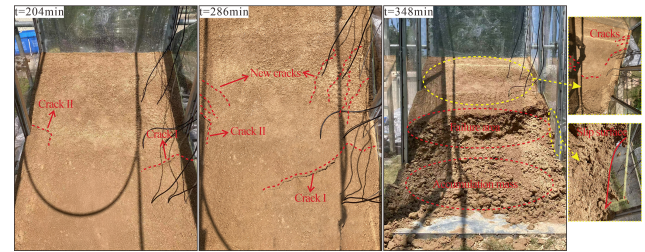
Figure 7 shows the failure process of the E3 slope. As illustrated in the figure, at test 204 min, crack I and crack II were observed at the middle of the slope. These are the tensile cracks caused by uneven settlement of the slope caused by rainfall infiltration. With the infiltration of rainfall, the overall downward deformation of the slope increased, and the slope underwent a shear and tension effect. At test 286 min, crack I was extended and expanded in the lower left direction. New cracks appeared at the top of the slope, arranged in a feathery pattern. At test 348 min, the slope slid along the crack I. The sliding surface exhibited a circular arc shape, and the depth of the landslide was about 23 cm. There were multiple cracks appearing on the slope during the process.

**Figure 7.** Deformation and failure process of the E3 slope.

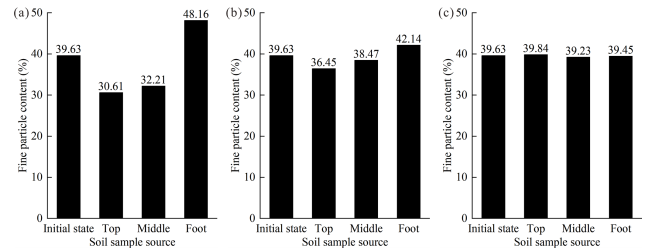
foot of the slope. The phenomenon is essentially particle migration (Lu et al., 2011; Cui et al., 2014). The residual soil lacks intermediate particle size. The coarse particles form the skeleton of the soil, and the fine particles are attached to the skeleton particles as a cement-like substance (Liu et al., 2021). This makes the fine particles able to be carried by water flow and move through the skeleton pore. It is difficult to make direct observations inside the slope without the aid of specialized equipment. In this study, samples were obtained from the top, middle, and foot of the slope of the three groups using a cutting ring. The locations of the samples correspond with the depth of the sliding surface. The fine particles (particle size less than 0.075 mm) in the soil were measured by the particle gradation test, which was then compared with the initial fine particle content. The fine particle content at each location of the slopes at the end of the tests is shown in Fig. 8. It can be seen that there is a large difference in the fine particle content at each location of the E1 slope. The loss of fine particles was most severe at the top of the slope, with a reduction from an initial 39.63 % to 30.61 %. The loss of fine particle content in the middle of the slope was then 7.42 %. Concurrently, the fine particle content at the foot of the slope increased by 8.53 % (Fig. 8a). This indicates that the interior of the slope was undergoing a process of fine particle loss, with the lost portion undergoing longitudinal migration and eventual accumulation at the foot of the slope. The fine particle content of the E2 slope exhibited a 3.18 % decrease at the top of the slope, a 1.16 % decrease at the middle of the slope, and a 2.51 % increase at the foot of the slope (Fig. 8b). The E2 slope has been observed to exhibit a substantial reduction in fine particle loss in comparison to the E1 slope. The fine particle content is nearly identical at all locations in the E3

**Figure 8.** Fine particle content at different positions of slopes with different tests. (a) E1 slope. (b) E2 slope. (c) E3 slope.

slope (Fig. 8c). The movement of fine particles in soils of the same type is primarily influenced by in-slope seepage (Wang et al., 2024). It can be seen that seepage is most pronounced on the E1 slope, with no observable seepage on the E3 slope. The loss of fine particles destroys the soil structure, which has a greater impact on slope stability. The gradual increase in pore size between coarse particles within the slope will in turn exacerbate the loss of fine particles, leading to a reduction in the strength of slopes and their susceptibility to damage.

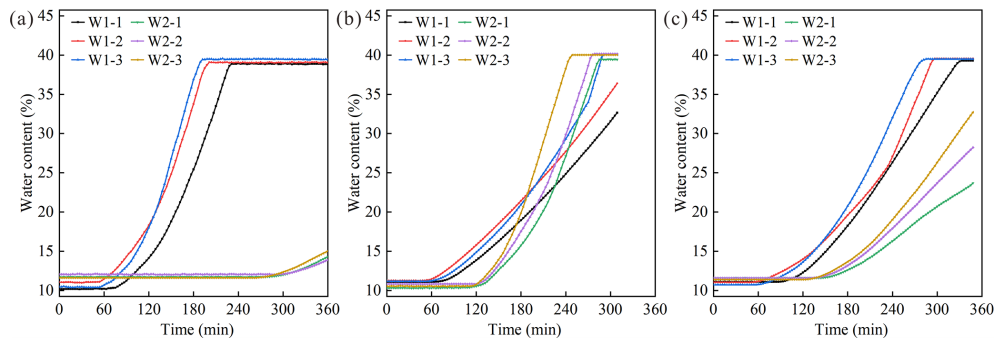
The water content–time curves are presented in Fig. 10. (1) For the E1 slope, at test 57 min, the values of W1-2 and W1-3 increased first, followed by W1-1, indicating that the rainfall had infiltrated to the soil–rock interface and that the water content of the soil near the interface began to increase. Subsequently, the growth rate of W1-1, W1-2, and W1-3 values continued to increase. The values increased sharply and peaked within 135–159 min. This indicates that the soil water content at the soil–rock interface rises rapidly, and the soil becomes saturated in a short period of time. The sensors within the weathered layer did not begin to respond until test 267 min, and the rate of increase in W2-1, W2-2, and W2-3 values was consistently low. At the end of the test, the largest increase in sensor value was only 3.38 %. This suggests that rainfall has a minimal impact on the weathered layer. (2) For the E2 slope, at test 54 min, the values of W1-3, W1-2, and W1-1 commenced an incremental ascent in turn, signifying that the rainfall infiltration had reached 10 cm depth at that moment. At test 111 min, the W2-3 value began to increase,

**Figure 9.** Water content–time curves. (a) E1 slope. (b) E2 slope. (c) E3 slope.

followed by W2-2 and W2-1. This indicates that the rainfall had infiltrated at the soil–rock interface. The values of W2-1, W2-2, and W2-3 increased sharply, and their growth rate was much higher than that of the sensors buried at the 10 cm depth within the slope. The values of W1-1, W1-2, and W1-3 remained stable after 285, 279, and 249 min, respectively. This indicates that the soil at 20 cm depth had reached saturation. At test 273 min, the W1-3 value showed a pronounced increase, suggesting that the rate of soil water content increase at the 10 cm depth at the foot of the slope was considerably more rapid. This is due to the fact that rainwater continues to collect at the slope toe under the influence of seepage within the slope. As the rainfall continued, the soil water content at the foot of the slope eventually became significantly higher than that at the top and middle of the slope, reaching saturation at test 291 min. (3) For the E3 slope, at test 60 min, the infiltration of rainwater into the 10 cm depth resulted in a sequential increase in the values of W1-1, W1-3, and W1-2. At test 138 min, the W2-3 value began to increase, indicating that rainwater infiltrated to the 20 cm depth at the foot of the slope. This was followed by a sequential increase in the values of W2-1 and W2-2. At test 258 min, the W1-2 value showed a significant increasing trend, indicating a swift rise in soil water content at 10 cm depth at the middle of the slope. The reason for this phenomenon is that the crack at the middle of the slope provides easy access for rainfall infiltration, and rainwater infiltrates rapidly in the form of crack-

preferential flow. The peak values of W1-3, W1-1, and W1-2 were observed at 288, 303, and 321 min of the test, respectively, indicating that the soil was nearly saturated at 10 cm depth.

The response time of the water content at 10 cm depth was similar for three slopes. This is due to the fact that at the early stage of rainfall, rainwater mainly infiltrated vertically into the shallow surface layer of the slope in the form of homogenous flow. The rate of increase in water content at 10 cm depth was significantly greater on the E1 slope than on the E2 and E3 slopes. The phenomenon is attributed to the infiltration of rainwater into the weathered layer, which has a low permeability. Moisture is prevented from entering the weathered layer due to the effect of capillary force (Wu and Wang, 2025). Besides, the permeability coefficient of the residual soil is an order of magnitude higher than that of the completely weathered granite. It is very easy for violent horizontal seepage to occur at the geotechnical interface with large permeability differences (Wang et al., 2019). Consequently, the rainwater infiltration rate at the soil–rock interface is greatly reduced, resulting in the stagnant water phenomenon. Rainwater tends to flow along the interface. The above phenomenon has also been observed when the rainfall infiltrates to the 20 cm depth within the E2 slope. Notably, the rate of increase in water content was greater at 20 cm depth than at 10 cm depth, which is related to the nature of the residual soil. The residual soil in the study area is

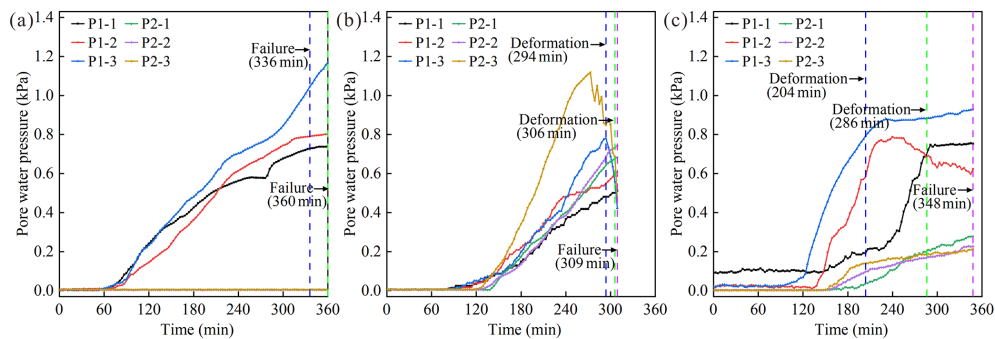
**Figure 10.** Pore water pressure–time curves. (a) E1 slope. (b) E2 slope. (c) E3 slope.

The pore water pressure–time curves are presented in Fig. 10. In general, the pore water pressure change curves exhibit a similar overall trend to the water content change curves. This is due to the fact that the change in pore water pressure is primarily influenced by the soil water content. Furthermore, a partial asynchrony stage has been observed in the changes in pore water pressure and water content, and this has been attributed to the influence of soil deformation on the change in pore water pressure (Iverson et al., 1997). (1) For the E1 slope, the P1-1 value exhibited a slight decline at test 261 min, followed by a rapid increase at test 273 min. This phenomenon may be attributed to the loss of fine particles in soil at the top of the slope, which results in the hollowing out of the soil skeleton, composed of coarse particles. The reclosure of the pore subsequent to the collapse of the skeleton resulted in a sudden increase in pore water pressure. The P1-3 value continued to rise. This is due to the fact that

the accumulation of fine particles at the foot of the slope results in pore obstruction, thereby impeding drainage at this location. Consequently, the pore water pressure continues to increase, resulting in damage failure at the foot of the slope. (2) For the E2 slope, the P2-3 value decreased significantly at test 273 min, preceding the deformation observed, indicating that significant deformation damage occurred at 20 cm depth of the foot of the slope first. At test 294 min, the P1-3 decreased significantly, indicating that the crack has developed upwards to 10 cm depth of the foot of the slope. Subsequently, there is a sharp decrease in values of E1-3 and E2-3, indicating that the foot of the slope is approaching instability. (3) For the E3 slope, the P1-2 value continued to increase at test 204 min, when the slope had deformed. This may be due to the fact that granite residual soil in the area exhibits negative dilatancy (Chen et al., 2024). When shear damage occurred on the slope, the pores within the soil became smaller in size; therefore the pore water pressure continued to in-

crease. At test 255 min, the P1-2 value began to decrease, indicating deformation at 10 cm depth at the middle of the slope. The P1-2 curve exhibited frequent fluctuations, with the value first increasing and subsequently decreasing. This is a sign of slow deformation. The creation of cracks within the slope leads to a decrease in pore water pressure, which is then restored by rainfall infiltration, a cycle that is repeated repeatedly.

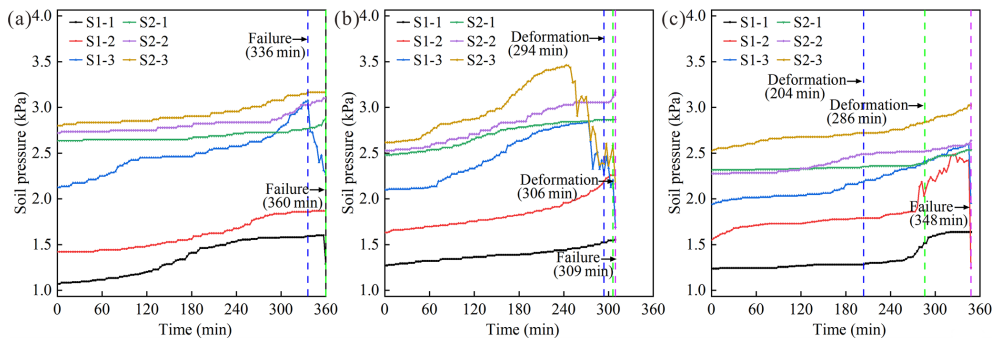
**Figure 11.** Soil pressure–time curves. (a) E1 slope. (b) E2 slope. (c) E3 slope.

In this test, the soil pressure sensor probe was placed perpendicular to the soil surface upward. This embedding method can monitor the change in the sliding thrust of the upper rock and soil mass (Nian et al., 2023). Rainfall infiltration increases the slope's self-weight, leading to an increase in the sliding thrust. Therefore, the soil pressure–time curves show an overall increasing trend. (1) For the E1 slope, the largest increase in the S1-3 value indicates that the landslide thrust increases the most at 10 cm depth at the foot of the slope and that the slope is most vulnerable to damage at that location. The S1-3 value continued to decrease after the damage occurred, indicating that the deformation damage at 10 cm depth at the foot of the slope still continued. (2) For the E2 slope, the trend of the soil pressure curve responds to the slope deformation and damage characteristics consistent with the pore water pressure, which will not be repeated here. Notably, the decrease in S2-3 value is greater than that of S1-3, indicating that the sliding thrust at a depth of 20 cm at the foot of the slope decreases more. This suggests that the degree of deformation of the deeper soils at the foot of the slope is greater than that of the shallower soils. (3) For the E3 slope, the S1-2 value increased significantly at test 273 min. This is due to the fact that water starts to fill in the crack, thereby exerting a hydrostatic pressure on the slope that significantly increases the sliding thrust. When the sliding thrust reaches a certain magnitude, a landslide will occur.

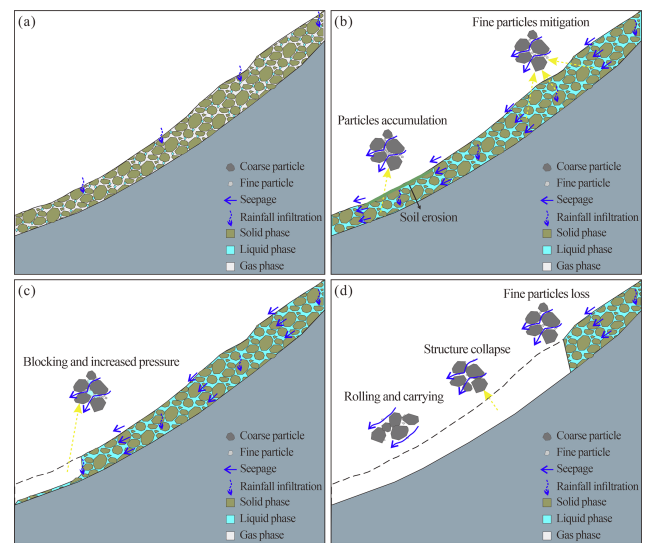
**Figure 12.** Schematic diagram of E1 slope instability. (a) Rainfall infiltration. (b) Runoff and seepage. (c) Local failure. (d) Overall failure.

Based on the test results and analyses, the instability process of these three types of slopes can be divided into several stages, and these are shown in Figs. 12, 13, and 14.

**Rainfall infiltration.** At the beginning of rainfall, rainfall infiltration into the slope increases the soil water content. There is no evident deformation damage, and surface runoff occurs on the slope.

**Runoff and seepage.** As rainfall continues, the soil water content of the residual layer gradually increases and reaches saturation. Concurrently, the weathered layer impedes the rainwater infiltration. At this point the rainfall infiltration capacity is reduced, and a proportion of the rainfall is converted into surface runoff. Low-lying areas and gullies are generated

by the erosion of surface runoff and splash erosion of rainfall. Erosion damage is most severe at the foot and middle of the slope. Seepage occurs within the residual layer, with the water flow creating seepage force within the soil. Granite residual soil is poorly graded and susceptible to suffusion under seepage. Fine particles in the soil are transported with the water flow and accumulate at the foot of the slope.

**Localized failure.** As fine particles continue to collect at the foot of the slope, the pores in the soil are blocked. This will make drainage at the foot of the slope difficult, and excess pore water pressure occurs at this location. The effective

stress in the soil is lost, leading to a reduction in its resistance to deformation and localized damage at the foot of the slope.

**Overall failure.** As the soil continues to be subjected to suffusion, the fine particles in the soil are continuously lost. It is difficult for the soil to maintain its structure, and in turn the soil skeleton collapses. Soils with lost structure are prone to disintegration under seepage. At this time, the support at the foot of the slope has been lost, and the soil of the disintegration moves downslope under water flow, showing a wide range of flow-slip failure without an obvious sliding surface.

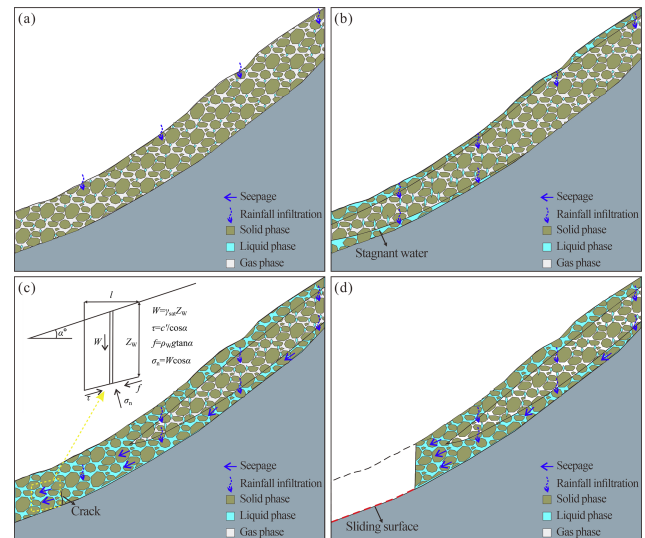
**Figure 13.** Schematic diagram of E2 slope instability. (a) Rainfall infiltration. (b) Stagnant water. (c) Critical sliding. (d) Landslide occurrence.

**Rainfall infiltration.** At the beginning of rainfall, rainfall infiltration into the slope increases the soil water content. There

is no evident deformation damage, and surface runoff occurs on the slope.

**Stagnant water.** As rainfall continues, shallow soil water content gradually increases and becomes saturated, and a saturated zone occurs. When rainfall infiltrates into the soil–rock interface, the underlying weathered layer has weak water permeability, and a relatively impermeable layer is easily formed. Rainwater accumulates at the soil–rock interface, forming a saturated zone. The diffusion rate of this saturated zone is greater than that of the shallow surface layer. The soil is softened at this location, thus forming a plane of weakness.

**Critical sliding.** Rainwater always flows towards the foot of the slope under gravity, saturating the residual layer at this location. Due to the large difference in permeability between the residual layer and the weathered layer, strong seepage is easily generated along the soil–rock interface. At this time, the sliding mode of the slope is traction and drag, and deformation tends to occur first at the soil–rock interface. Considering the role of hydrodynamic pressure, the calculation formula for the slope stability factor can be expressed as follows:

**Landslide occurrence.** When the driving force is greater than the resisting force, the slope generally occurs in a translational slide at the soil–rock interface.

$$FS = \frac{\tau + \sigma n \tan \varphi'}{W \sin \alpha + f} \\ = \frac{c' / \cos \alpha + \gamma_{\text{sat}} Z_w \cos \alpha \tan \varphi'}{\gamma_{\text{sat}} Z_w \sin \alpha + \rho_w g \tan \alpha},$$

where  $\alpha$  represents slope angle ( $^{\circ}$ ),  $Z_w$  represents saturation zone depth (m),  $\rho_w$  represents water density ( $\text{kg m}^{-3}$ ),  $\gamma_{\text{sat}}$  represents the water volumetric weight of saturated soil ( $\text{N m}^{-3}$ ),  $c'$  represents cohesion of saturated soil (kPa),  $\varphi'$  represents the internal friction angle of saturated soil ( $^{\circ}$ ), and  $g$  represents gravitational acceleration ( $\text{m s}^{-2}$ ).

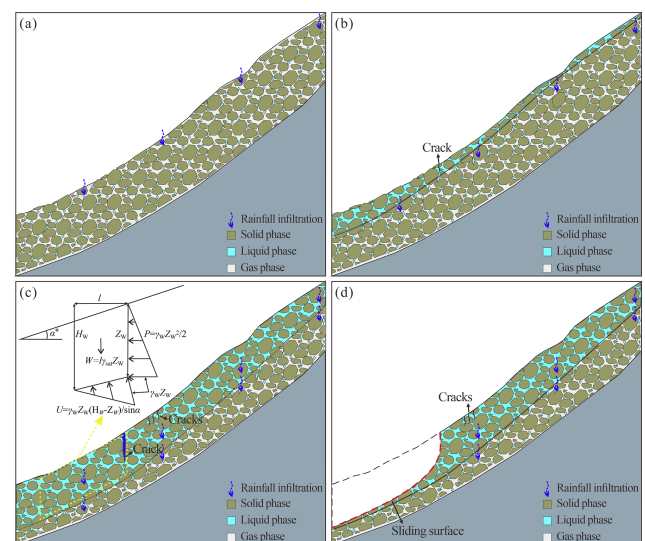
**Figure 14.** Schematic diagram of E3 slope instability. (a) Rainfall infiltration. (b) Crack generation. (c) Critical sliding. (d) Landslide occurrence.

**Rainfall infiltration.** At the beginning of rainfall, rainfall infiltration into the slope increases the soil water content. There is no evident deformation damage, and surface runoff occurs on the slope.

**Crack generation.** As rainfall continues, shallow soil water content gradually increases and becomes saturated, and a saturated zone occurs. The increase in water content results in a softening of the soil, thereby reducing its strength. Meanwhile, rainfall infiltration increases the driving force on the slope, causing downward creep. Uneven distribution of soil strength leads to crack generation.

**Critical sliding.** The crack provides easy access for rainfall infiltration. The accumulation of rainwater within the crack exerts a pressure on the slope, which contributes to the expansion of the cracks. When rainfall is sufficiently adequate, the crack fills with water, creating hydrostatic pressure. At

this time, the sliding mode of the slope is characterized by the coexistence of traction and thrust. The source of force that prompts the deformation and damage of the slope mainly comes from the slope's self-weight and hydrostatic pressure. The calculation formula for the slope stability factor can be expressed as follows:

**Landslide occurrence.** When the driving force is greater than the resisting force, the slope occurs generally in a rotational slide within the residual layer.

where  $\alpha$  represents slope angle ( $^\circ$ ),  $l$  represents horizontal projection of slope length (m),  $Z_w$  represents height of water level in the crack (m),  $\gamma_w$  represents water volumetric weight ( $\text{N m}^{-3}$ ),  $\gamma_{\text{sat}}$  represents water volumetric weight of saturated soil ( $\text{N m}^{-3}$ ),  $c'$  represents cohesion of saturated soil (kPa), and  $\varphi'$  represents internal friction angle of saturated soil ( $^\circ$ ).

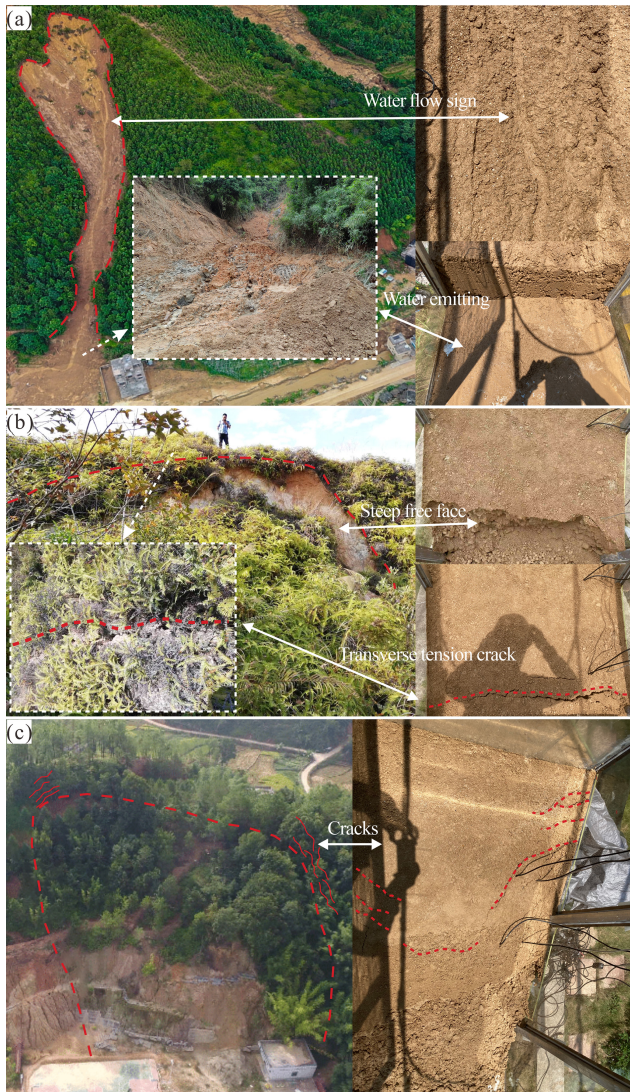
**Figure 15.** Comparison of Mibei landslide deformation with model tests. (a) E1 slope. (b) E2 slope. (c) E3 slope.

This study was conducted based on model tests, and the model materials utilized were collected in the field and are considered to be remodeled samples. It should be noted that the constructed slope model may differ somewhat from the actual situation, which may result in limited practical usability of the results of this research. Consequently, this study investigated the correspondence between the actual residual layer thickness and landslides, as well as analyzing the consistency between the findings and the model test results. (1) For the E1 slope, the slopes show clear water flow signs. The water content of the landslide accumulation mass is very high, essentially saturated with water-emitting phenomena. (2) For the E2 slope, the trailing edge of landslides has no cracks other than the transverse tension cracks, which is because the slope deformation starts from a deeper layer. The landslides generate steep free faces due to traction-stagger deformation. (3) For the E3 slope, the number and distribution of tensile cracks at the trailing edge of the landslides are large, which are formed during the downward deformation of the slopes. It is evident that this test accurately replicates the destabilization of granite-weathered crust slopes with different residual layer thicknesses.
