Response to Review 1 (I. Fuller)

Response to general comments:

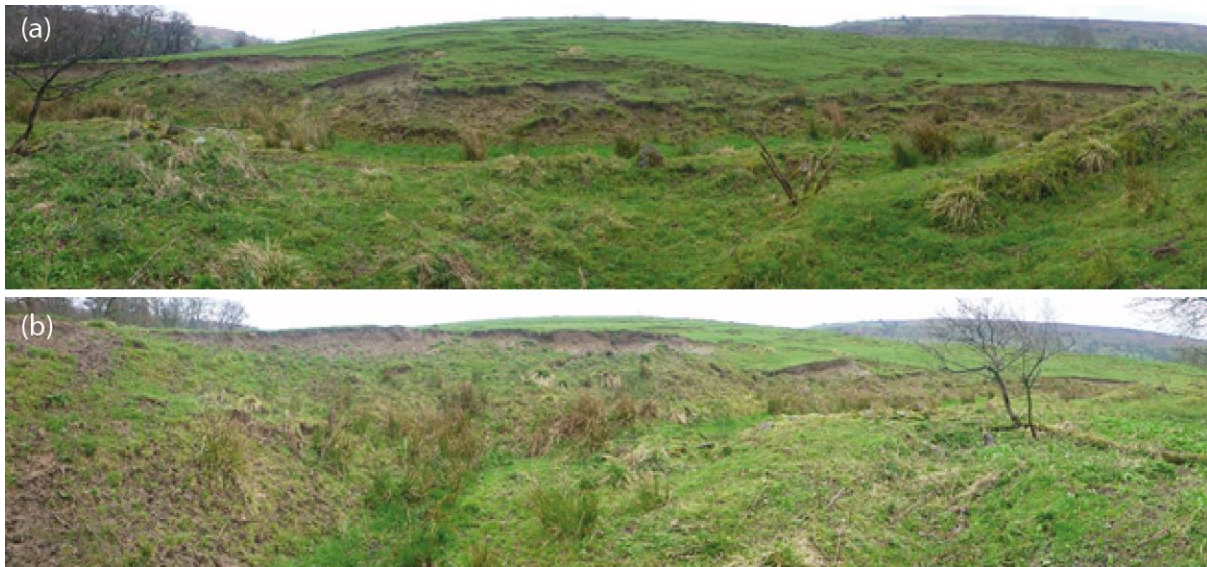
Reply 6. The landslide itself was not subject to direct monitoring. However the activity of the mass-movement was informally evaluated as a result of routine site visits. Evidence of the relative stability is shown through repeat photographs of the area. Images collected in 2014 (Figure R1) clearly demonstrate several key features including: i) revegetation of the erosional surface; and ii) progressive reduction in bank angle due to the lack of fluvial activity at the landslide toe and storage of hillslope material in the former channel. The storage of this material at the base of the slope is buttressing the landslide and arresting further progression. Based on observations during the active monitoring period, it is unlikely the landslide will re-activate given current site conditions.

Figure R1. Images of the landslide 07/04/2014 looking (a) NE towards the slip-face and (b) upstream in a SE direction.
