# ~~A low-cost technique to measure bank erosion processes along middle-size river reaches~~ Bank erosion processes measured with UAV-SfM along complex banklines of a straight mid-sized river reach

Gonzalo Duró<sup>1</sup>, Alessandra Crosato<sup>1,2</sup>, Maarten G. Kleinhans<sup>3</sup>, Wim S. J. Uijttewaal<sup>1</sup>

Keywords: Riverbank erosion monitoring, erosion cycle, restoration, Unmanned Aerial Vehicles (UAV), Structure from Motion (SfM).

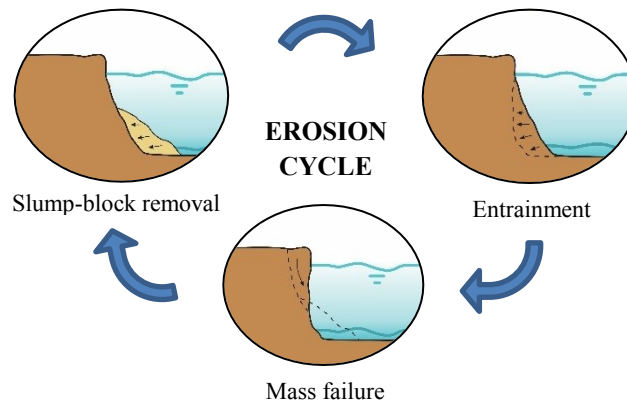
5 **Figure 1:** Schematic bank erosion phases: Slump-block removal (left), entrainment of bare bank (right) and incipient mass failure (centre)

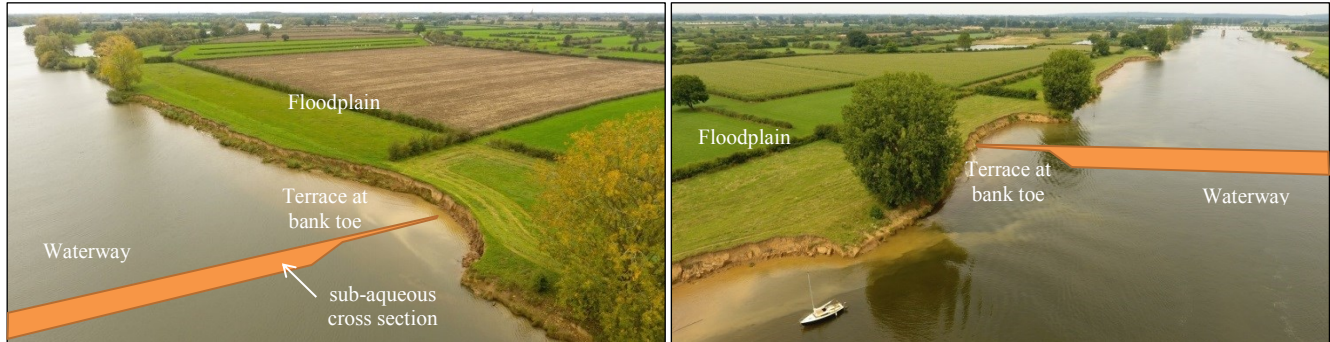
**Figure 2:** Restored bank in the Meuse River, upstream view of first 300 m (left) and downstream view of middle 500 m (right). Bank  
20 erosion has caused a series of bays in the 1,200 meter restored reach. Note eroded bank sediment in suspension.

The study site is the left bank of a 1200 m long straight reach (Fig. 2) located between the Sambeek and Grave weirs in southeast Netherlands. Seven years after restoration, this reach presents different bank retreat patterns, with sub-reaches of rather uniform erosion and others with embayments of different lengths. Grassy fields used for grazing cover the riparian zone, followed by crop fields across the floodplain. In the near-bank area there are poplar trees every 100 m, some  
15 of which have been dislodged during the erosion progression, which is possible to appreciate in Fig. 2 (left) considering the ~200 m embayment between the foreground tree and the next in the background.

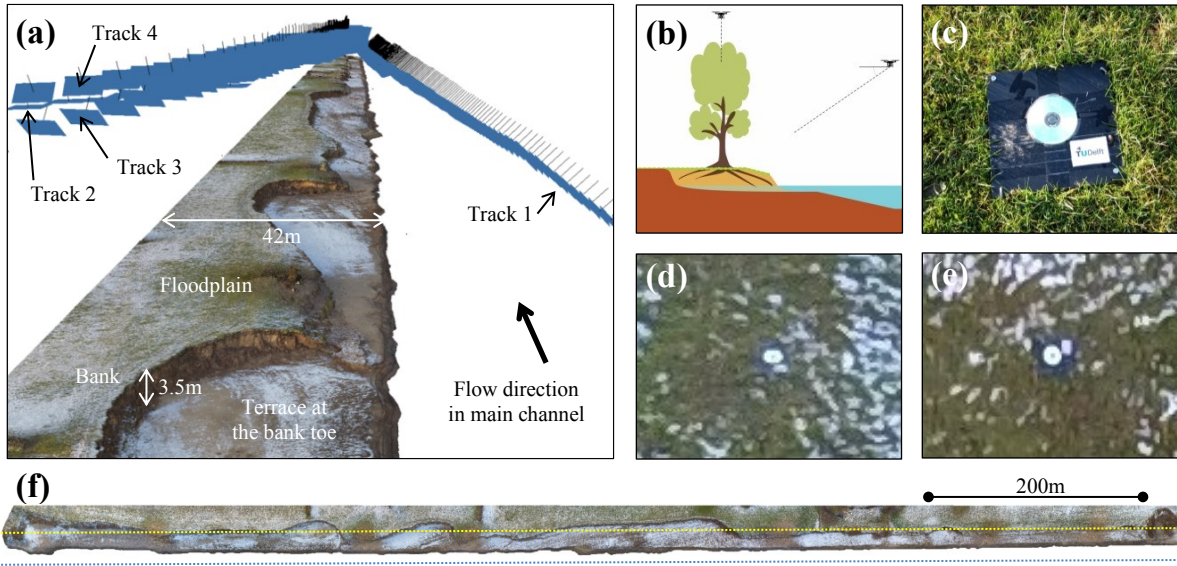
**Figure 3:** a) Camera positions and orientations in perspective view. The digital surface model shows the low-water condition during January 2017, which exposed a terrace at the bank toe. b) Cross-sectional scheme of UAV paths. c) Ceramic plaque with CD as ground-control point on the floodplain. d) GCP in photograph from track 1. e) Same GCP from track 2. f) Top view of DSM with UAV track 1 in blue and tracks 2-4 in yellow.

We used Agisoft PhotoScan software to process the imagery. ~~For a successful photo alignment from different UAV tracks (Table 1),~~ the camera yaw, pitch and roll recorded during the UAV flight ~~from different perspectives (Table 1)~~ were ~~necessary inputs to ensure that the image matching assigned all photos into a single model (Stöcker et al., 2015).~~ For this step we used three GCPs along the reach, two at the extremes and one at the middle, all close to the bank and easily visible from tracks 1 and 2. These approximate orientations and a priori known ground points helped obtaining a consistent sparse point cloud of the bank along the entire reach. The resulting camera positions and orientations of the photo alignment are visible in Fig. 3a, evidencing the UAV tracks. This figure also shows the DSM textured with colours from the photographs, in which the green area on the left side with white patches corresponds to the floodplain partially covered with snow (see also Fig. 3d-f) and the right brownish area is the terrace at the bank toe, with snow remains as well.

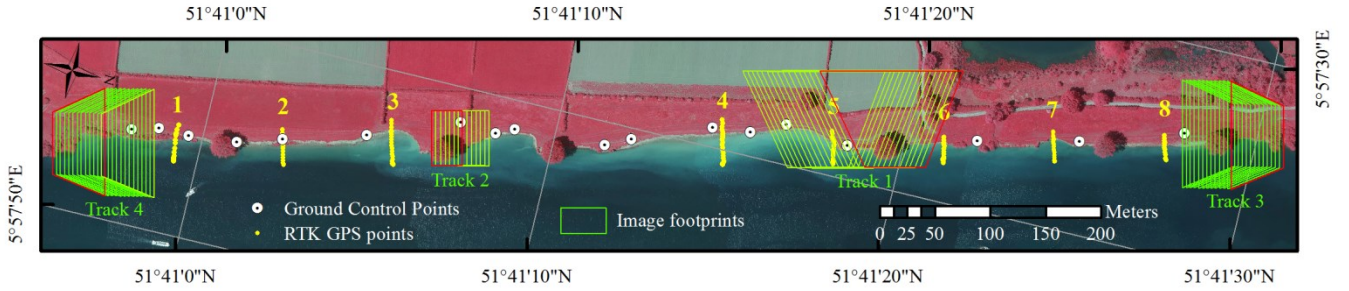
**Figure 4:** Study reach of the Meuse River with GCPs, RTK GPS measurements with cross-section locations and numbers, and some image footprints for all UAV tracks.

After obtaining the sparse point cloud, we ~~marked-identified~~ the remaining 15 GCPs (Fig. 4) ~~in the photographs, helped by their estimated locations in the model.~~ Then, we refined the camera parameters by minimizing the sum of GCP reprojection and misalignment errors, ~~i.e., using the camera optimization option in PhotoScan.~~ This ~~camera optimization~~ adjusts the estimated point cloud by reducing non-linear deformations. Once the dense point cloud was computed, we removed the points outside the area of interest, as well as those points at the water surface, tree canopies and individual bushes at the floodplain. Finally, the point cloud was triangulated and interpolated to generate a ~~triangle-mesh TIN, through the arbitrary surface option and the highest number of mesh faces suggested in PhotoScan.~~ This mesh consisted of a non-monotonic surface that was later processed in MATLAB to plot 2D cross sections.

The rotation potential of the model is evaluated comparing SfM DSM elevations with those of the 129 GPS points (Fig. 4). Fig. 10a presents the locations of the GPS points used for accuracy control projected at the potential rotation plane, showing that they covered the domain across the channel (abscissa axis) and different elevations along of the scarp area (ordinate axis), resulting in a reasonable sample to assess the model georeferentiation stability. Fig. 10b presents the DSM elevation errors distributed across the regression line 1. In this plane, a second regression line was computed with all 129 points, represented with a dashed black line in Fig. 10b. This line is tilted from the horizontal suggesting that the model was rotated with a magnitude equal to the respective slope.

Six bank profiles were selected among those surveyed with GPS on January 2017 (Fig. 4) to compare the bank representation with the different survey techniques. Fig. 11 shows the bank profiles at sections 1, 2, 4, 6, 7 and 8. These sections presented distinct erosion magnitudes and features after seven years of restoration, for example, section 8 (Fig. 4 and 11) appeared close to the original condition, with a mild slope and nearly no erosion, whereas sections 6 and 7 had vertical scarps. The SfM DSM profiles are represented by continuous lines, the ALS profiles with dashed lines, and GPS points with circles. The SfM representation had better proximity to the GPS points than the ALS in almost all cases. What is

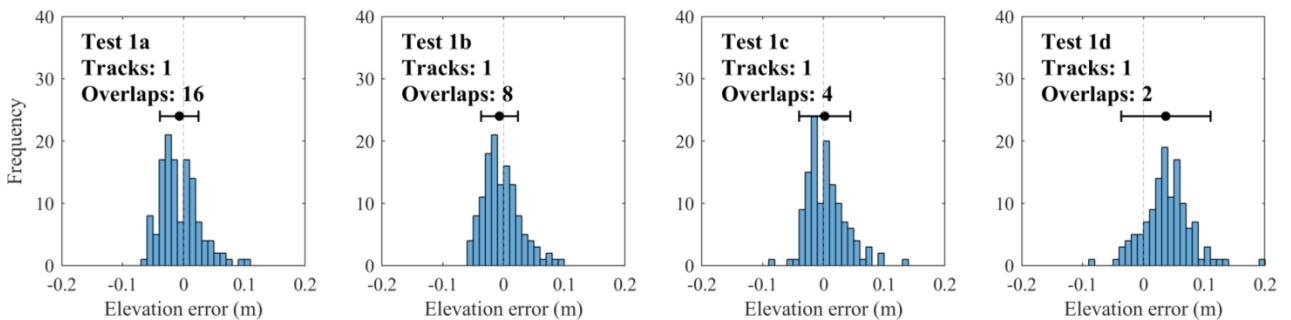
**Figure 5:** Elevation error distributions for SfM tests *1a*, *1b*, *1c*, and *1d*, assuming that the RTK points are correct and without error. Indicated overlaps are the minimum.

The sequentially decreasing photo overlaps of Track 1 (Table 1) produced four DSMs, tests *1a–1d*, whose elevation differences with the 129 RTK GPS points are presented in the histograms of Fig. 5. The elevation errors mostly ranged within 10 cm in all tests, but the mean and standard deviation (SD) presented some differences (Table 2 and dot with bar in Fig. 5). Tests *1a*, *1b* and *1c* presented mean values smaller than 1 cm and SD within 3–4 cm, while for test *1d* these values increased to 4 cm and 7 cm respectively (Table 2, rows 1–2). The mean errors on the bank area alone for test *1a*, *1b* and *1c* were lower than 1 cm (Table 2, row 5), but test *1c* had a higher SD of 7 cm compared to 4 and 3 cm of tests *1a* and *1b* respectively (Table 2, row 6). Then, tests *1a* and *1b* had the highest precisions and showed little error differences between them: less than 1 cm for all values in Table 2. Consequently, test *1b* with eight photo overlaps was as effective as test *1a* with 16 overlaps to achieve the highest DSM accuracy. In addition, test *1b* fully covered the tortuous bank area in contrast to test *1c*, especially at the perpendicular stretches of embayments (Fig. 3–4), which assured the choice of 8 image overlaps over 4, despite the general close performance of the latter in terms of accuracy (Table 2, all rows). Therefore, test *1b* became the reference for tests *1* and was used in combination with test 2 to generate test 3.

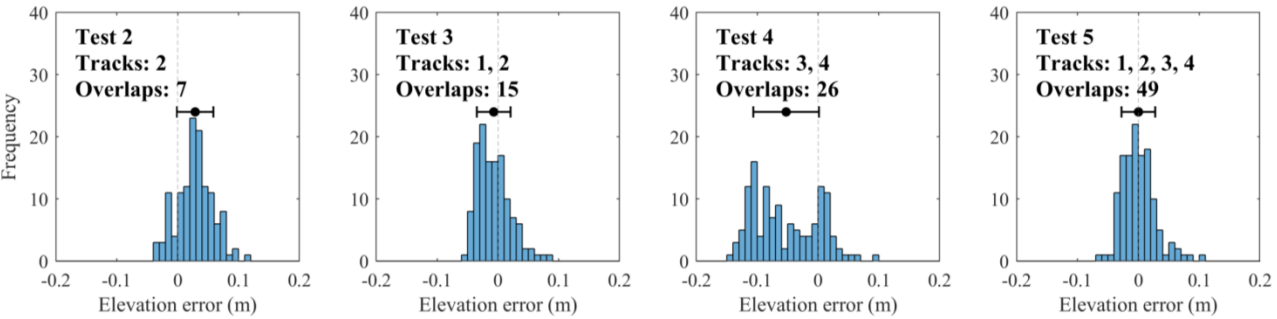
**Figure 6:** Elevation error distribution for tests 2, 3, 4, and 5. Ordinates indicate number of GPS points in each bin.

Figure 6 shows the error distributions of the remaining four DSMs, i.e. tests 2–5, which also were mostly within 10 cm, except for Test 4. This test had evident higher errors than the rest, mostly concentrated at the terrace (Table 2, row 7). Tests 3 and 5 had the lowest mean elevation errors, both lower than 1 cm, with the same SD at all surfaces that were lower than 3 cm. Test 2 presented a similar SD, but the mean was biased 3 cm. This test in combination with test 1*b* slightly reduced the SD errors of the latter (Table 2, rows 7 and 6), but without significant overall improvements. All in all, tests 1*b*, 3 and 5 had the best performances with average errors lower than 1 cm and standard deviations within 3 cm, however with increasing number of photographs (Table 1). The most efficient one was then test 1*b* that used the lowest number of photographs to achieve similar precision, especially on banks.

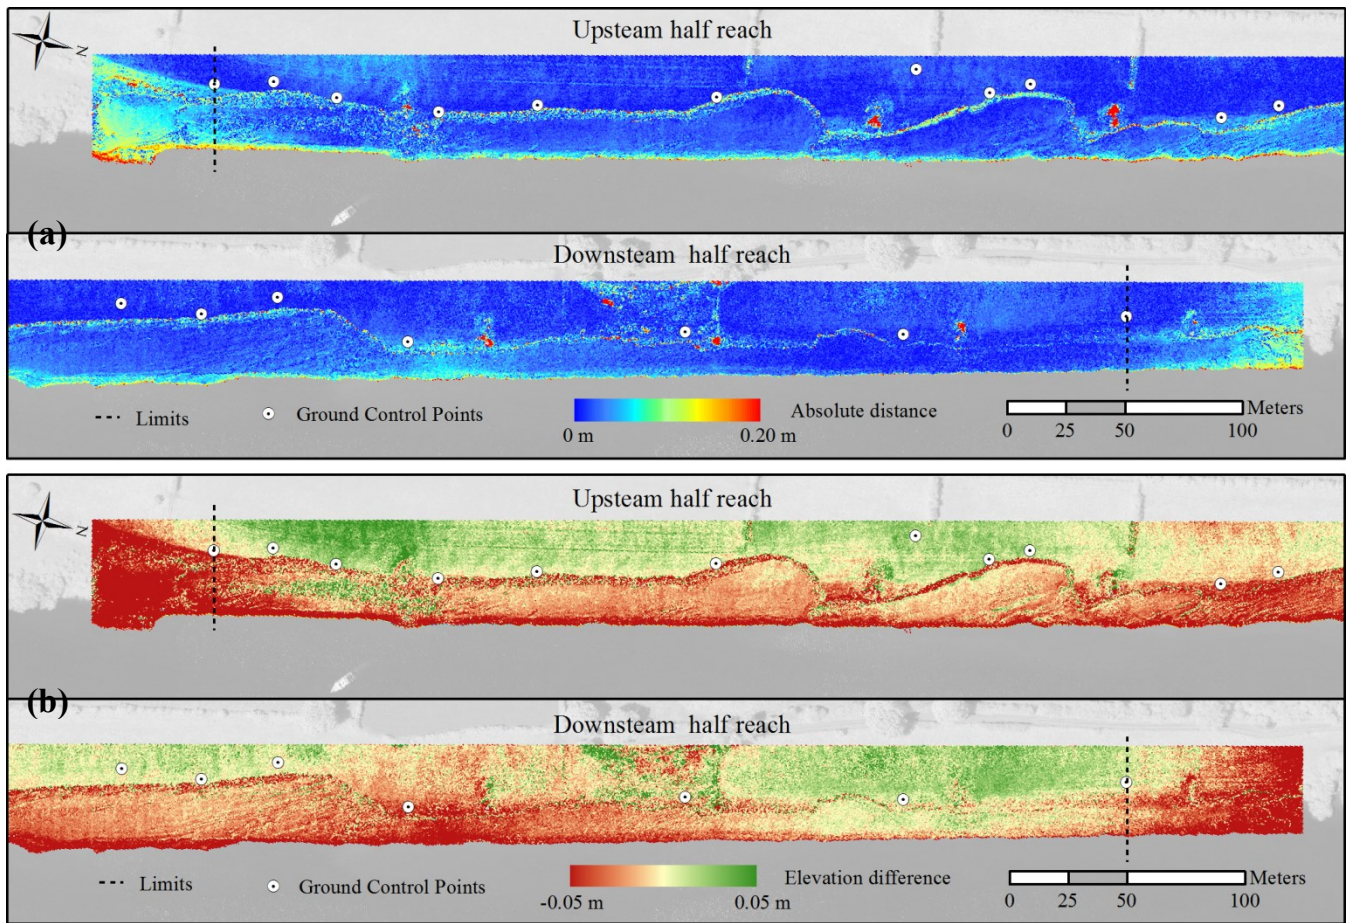
**Figure 7:** a) Absolute elevation differences between SfM and ALS along the reach. b) Signed elevation differences between SfM and ALS with a smaller scale range.

Compared to the ALS grid, test 3 point cloud showed a good agreement over most of the reach. This is observable from Fig. 7a, corresponding to the blue areas that indicate elevation differences lower than 5 cm. ~~Yet~~However, two notable regions surpassed this difference: the bank and the extremes of the reach. The latter were zones beyond the GCPs, where higher errors in the DSM are expected when using parallel image directions due to inaccurate correction of radial lens distortion (James and Robson, 2014; Smith et al., 2014). Consequently, the results outside the GCP limits ~~cannot-were not~~be considered ~~representative-as reliable as those within, where distortion is minimal, and thus of the whole domain and they~~ were discarded for the subsequent statistical comparisons (beyond the dashed lines in Fig. 7). Within the GCP bounds, the bank area presented relatively high elevation differences, which makes the bankline visible in Fig. 7. Moreover, another sloped area at end of the terrace also presented higher differences than surrounding areas, which is visible as a thin light-blue line at bottom of the domain in Fig. 7a (see also Fig. 3a-b for other perspectives of this slope toward the channel bed).

Figure 7b presents signed elevation differences with a smaller scale range to highlight areas with positive and negative deviations between techniques. Green zones indicate higher ground elevations on the SfM DSM than in the ALS grid, red indicate the opposite, and yellow elevation matches. The upstream half domain presented a general tendency of SfM to overestimate elevations on the floodplain, and in turn underestimate them on the terrace. This trend is also observed in the upper part of the downstream reach. ~~Yet~~ Nevertheless, these zones showed exceptions, such as a green patch at the terrace close to the dashed limit, and a red patch on the floodplain at the end of the upstream half reach. Despite the described general opposed behaviour between floodplain and terrace, the downstream reach evidenced two zones with consistent trends across the domain, covering both the floodplain and terrace. First, lower SfM elevations at the end of the largest embayment (downstream half reach), and second, SfM higher elevations at the end of the reach, before the dashed limit.

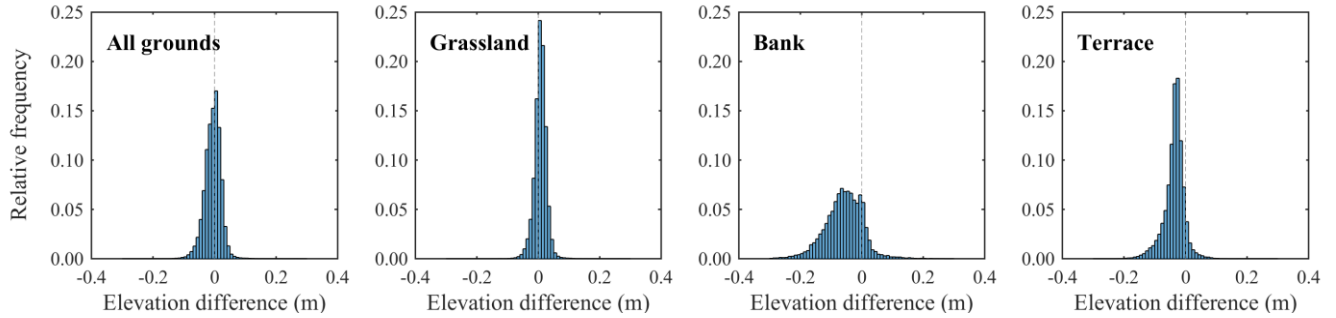
**Figure 8:** Comparison of elevation differences between SfM and ALS for distinct surface types

Figure 8 presents the relative frequency distributions of the elevation differences divided into three regions: the grassy floodplain, the steep bank, and the bare-ground terrace. Over the grassland, both SfM and ALS had rather similar

results (Fig. 8, centre left), with 1 cm mean difference and 2 cm of standard deviation (Table 3). In contrast, the bank had a bias between techniques of 6 cm (Table 3) and a relatively high standard deviation of the same value. Finally, the terrace showed a slightly higher deviation than over the grassland (Fig. 8 and Table 3) but with a bias of -4 cm. The bank area together with the terrace induce an overall small negative bias in the elevation difference distribution (Fig. 8 left and Table 3). The former with a small contribution to the total number of measurements and the latter with a greater number but a lower magnitude.

The elevation bias at the bank between the SfM-based DSM and the ALS grid (Fig. 8) was caused by the topographic overestimation of ALS (Table 3 and Fig. 9). This ubiquitous error is ascribed to a known limitation of ALS systems related to the laser beam divergence angle, which locates the closest feature within the laser footprint at the centre of the footprint.

The elevation differences between the methods observed for grassland (Fig. 8, centre left) were probably caused by dissimilar ground resolutions, because a larger elevation scatter is expected in the SfM-based DSM when capturing grass with 2 cm resolution, compared to the interpolated ALS samples into a 50 cm grid, even when derived from 0.16 m beam  
15 footprints. Nonetheless, the mean difference was zero (Table 3), so that both methods overestimate in the same way the real ground elevation due to grass cover. The effect of this is visible, for instance, in the increasing surface elevations on the floodplain over a year (Fig. 12a), which happens after the mowing period in October. The terrace at the bank toe presented a similar scatter as grassland, but had a small negative bias that could be explained by a DSM rotation or a slight transverse ‘dome’ effect of the SfM DSM.

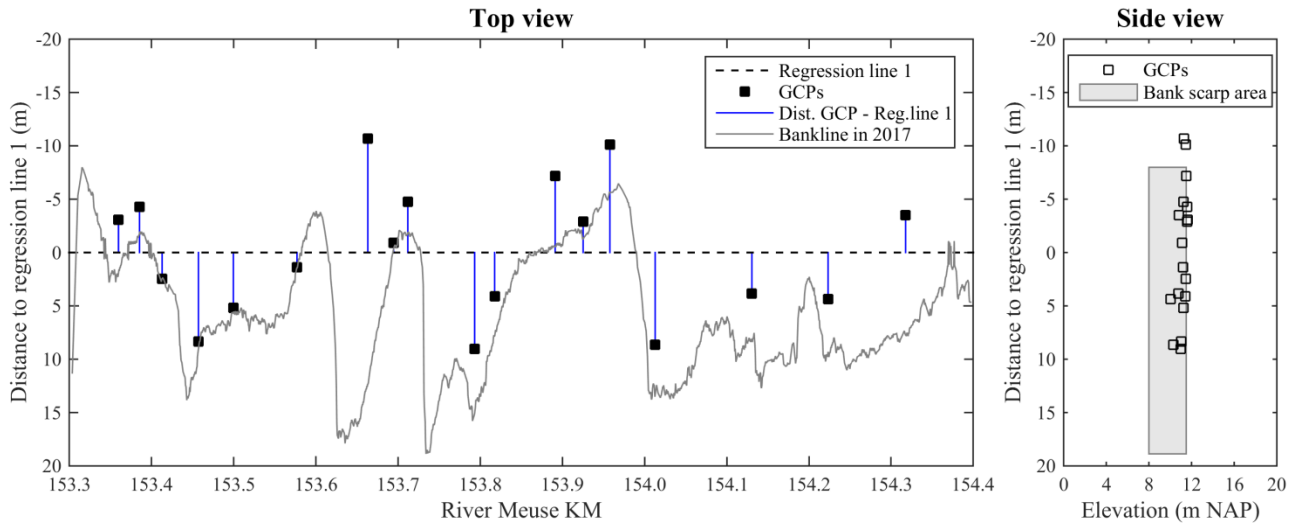
**Figure 9:** GCP horizontal distances to regression line (left) and respective positions in potential rotation plane from the regression line (right)

A regression line was computed with the locations of the GCPs to analyse with respect to this axis the rotational tendency of the model. The GCP distribution around the regression line and the bankline are shown in Fig. 9 (left). The adopted GCPs spanned 19.7 m across the reach and 1.6 m in the vertical direction (Fig. 9, right). The bank scarp along the reach, which is the target survey area, covered 26.9 m in cross-sectional direction due to the wide-ranging erosion magnitudes of the case study, with maximum bank heights of 3.5 m, indicated with a grey area in the right panel of Fig. 9. This side perspective of the domain evidences the potential plane of rotation, whose stability depends on the position of the GCPs.

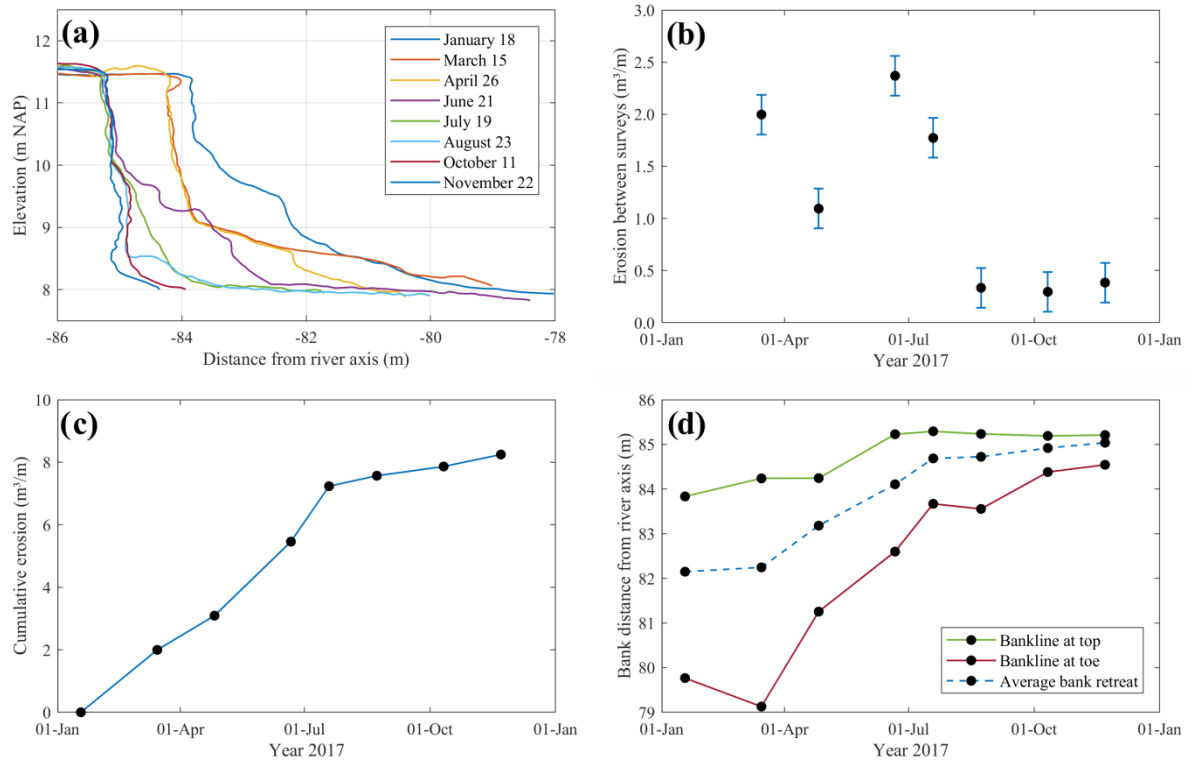
**Figure 12:** Sequential surveys at cross section 4, Meuse River km. 153.9, over 2017. a) Bank profiles from DSMs; b) Eroded volume per unit width between consecutive surveys; c) Cumulative erosion along surveys; d) Bankline locations at the top and toe of the bank.

The temporal development of section 4 (Fig. 4 and 11) is illustrated in Fig. 12a by a sequence of SfM-UAV surveys. The initial stage corresponds to the survey of Fig. 11 on 18 January 2017. The consecutive surveys showed the evolution of the vertical bank profile, through which different processes can be inferred. The bank profile, initially characterized by a top short scarp and slump blocks along the bank face, experienced a mass failure and a further removal of blocks between January 18 and March 15 2017. Between March 15 and April 26, only toe erosion occurred. By June 21, another mass failure happened, which left slump blocks along the lower half of the bank. On July 19, these blocks were removed, leaving a steep bank face. Then, further toe erosion caused a small soil failure at the lower bank whose remains laid at the toe. On October 11, this wasted material was removed. Then, until the last survey on November 22, entrainment occurred at the lower half of the bank profile, further steepening the bank. In light of the results, the methodology resolution and accuracy are high enough to identify different phases of the erosion cycle, enabling the analysis of bank erosion processes in conjunction with data on potential drivers.

In addition to process description, the quantification of eroded volumes is possible computing the net area between sequential bank profiles. For example, Fig. 12b shows eroded volumes per unit width between consecutive surveys plotted at the end of each time interval, with an error bar based on the RMSE of test 3. Evidently, there were different erosion rates during the year and the highest ones happened in the first part of it. Fig. 12c presents the respective cumulative eroded volumes per unit width, where the two trends can be distinguished: a gentle slope towards the end and higher rates of sediment yield during the first half of the year. Given that the topographic measurements are limited to a single year, it is not possible to state whether this behaviour is recurrent on a yearly basis. However, this case exemplifies the possibilities to quantify eroded volumes throughout different phases of the erosion cycle.

The bankline retreat as a measure of bank erosion involves the identification over time of the bank top, but this concept could be extended, for instance, to the bank toe. Fig. 12d shows the temporal progression of the bankline distance from the river axis for both the bank top and the toe, which we arbitrarily defined for this case at 11.1 m and 8.1 m, respectively. The top bankline showed a mayor jump between April and June and a smaller one between the first two surveys, corresponding to mass failure events. The bank toe presented a more gradual retreat, with events of slumping and temporal accretion that were timely captured along the surveys. This alternative bank retreat representation provides

evidence of the development of bank erosion at every survey. The contrast of bankline retreats at the top and toe of the bank illustrates how different processes on their own represent dissimilar erosion evolutions, since they constitute different phases of the erosion cycle, i.e. at the top mass failures and the toe slump block removal and entrainment. Finally, the average bankline between bank toe and top would best represent the real retreat (dashed line in Fig. 12d), despite not necessarily indicating an actual bank location for a specific elevation. This approach logically considers all erosion phases and follows a similar trend as the cumulative erosion of Fig. 12c.

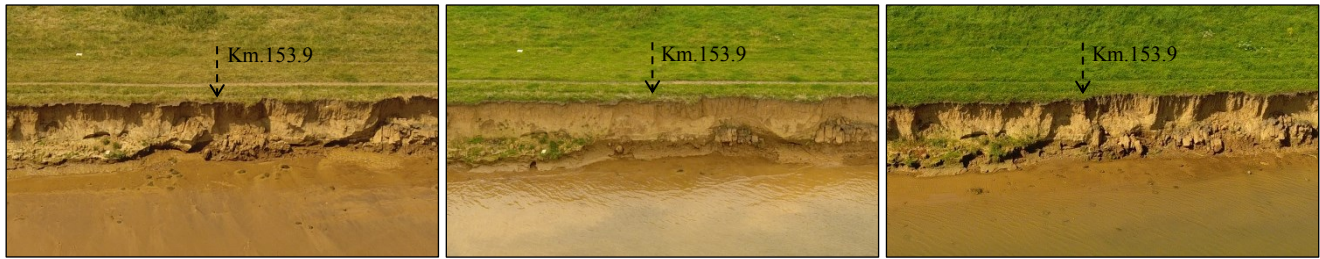
**Figure 13:** Zoomed-in UAV photos from track 1 at section 4, km. 153.9, showing diverse bank erosion stages: slump blocks at bank toe on June 21 (left), clean bank face after block removal on July 19 (centre), and undermining on August 23 (right).

Finally, the availability of the UAV imagery provides additional information to analyse and interpret bank evolution through direct observation. Figure 13 shows photographs from the three consecutive surveys on June 21, July 19 and August 23 at section 4, km. 153.9. At this bank area, the sequence shows on the left side of the panels only entrainment at the bank toe, and from the centre (km. 153.9) to the right, one or more erosion cycles. Cross section 4 presented on June 21 (Fig.13, left panel) slump blocks laying at the bank toe that were removed by July 19. Then on August 23, this cross section had incipient undermining at the lower bank and block deposition at the toe. The bank area at the right of section 4 experienced a second mass failure after June 21, completing one erosion cycle, and further downstream it is more difficult to keep track of the cycles due to faster erosion rates. The UAV photos also evidence the progressive growth of grass over the floodplain, especially observable next to the walking path, which was captured along the surveys (Fig. 12a).
