A low-cost technique to measure bank erosion processes along middle-size river reaches

We investigate the capabilities of Structure from Motion (SfM) photogrammetry applied with imagery from an Unmanned Aerial Vehicle (UAV) to measure bank erosion processes in middle-size rivers. This technique offers a unique set of characteristics compared to previously used methods to monitor banks, such as high resolution, low-cost and relatively fast deployment in the field. We analyse a 1.2 km restored bank of the Meuse River with complex vertical scarps laying on a straight reach, features that present specific challenges to the UAV-SfM application. We surveyed eight times within a year, combining different photograph perspectives and overlaps to identify an effective UAV flight. The accuracy of the Digital Surface Models (DSMs) was evaluated with RTK GPS points and an Airborne Laser Scanning (ALS) of the whole reach. An oblique perspective with eight photo overlaps and 20 m of cross-sectional ground-control point (GCP) distribution were sufficient to achieve the relative precision to observation distance of $\sim 1:1400$ and 3 cm RMSE, complying with the required accuracy. A complementary

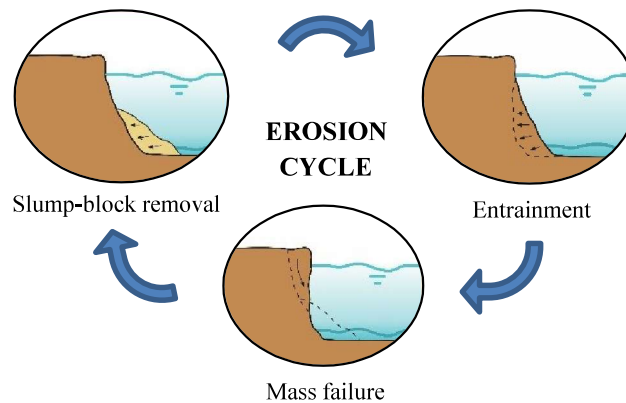
Figure 1: Schematic bank erosion phases: Slump-block removal (left), entrainment of bare bank (right) and incipient mass failure (centre)

Bank erosion may consist of three phases (Thorne and Tovey, 1981): fluvial entrainment of near-bank river-bed and bank material, mass failure, and disintegration and removal of slump blocks. These three phases are particularly important for

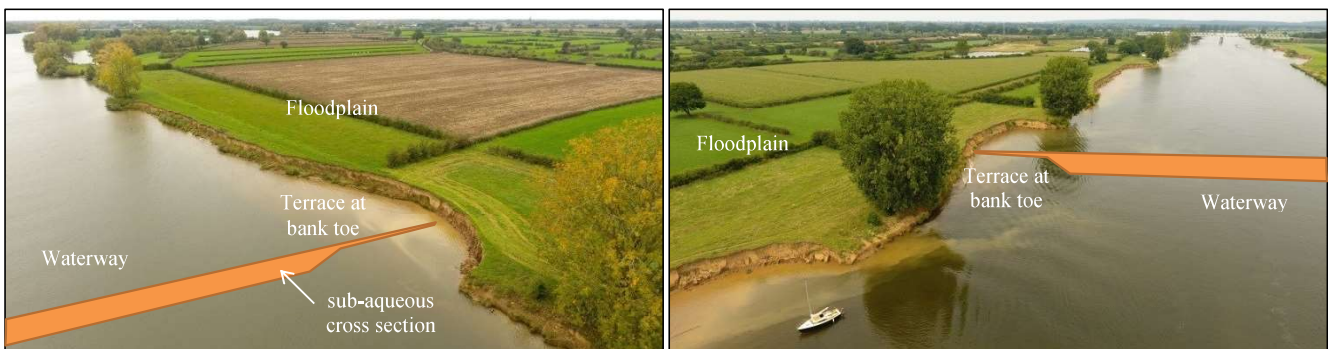
Figure 2: Restored bank in the Meuse River, upstream view of first 300 m (left) and downstream view of middle 500 m (right). Bank erosion has caused a series of bays in the 1,200 meter restored reach. Note eroded bank sediment in suspension.

The study site is the left bank of a 1200 m long straight reach (Fig. 2) located between the Sambeek and Grave weirs in southeast Netherlands. Seven years after restoration, this reach presents different bank retreat patterns, with sub-reaches of rather uniform erosion and others with embayments of different lengths. Grassy fields used for grazing cover the riparian zone, followed by crop fields across the floodplain. In the near-bank area there are poplar trees every 100 m, some of which have been dislodged during the erosion progression, which is possible to appreciate in Fig. 2 (left) considering the ~200 m embayment between the foreground tree and the next in the background.

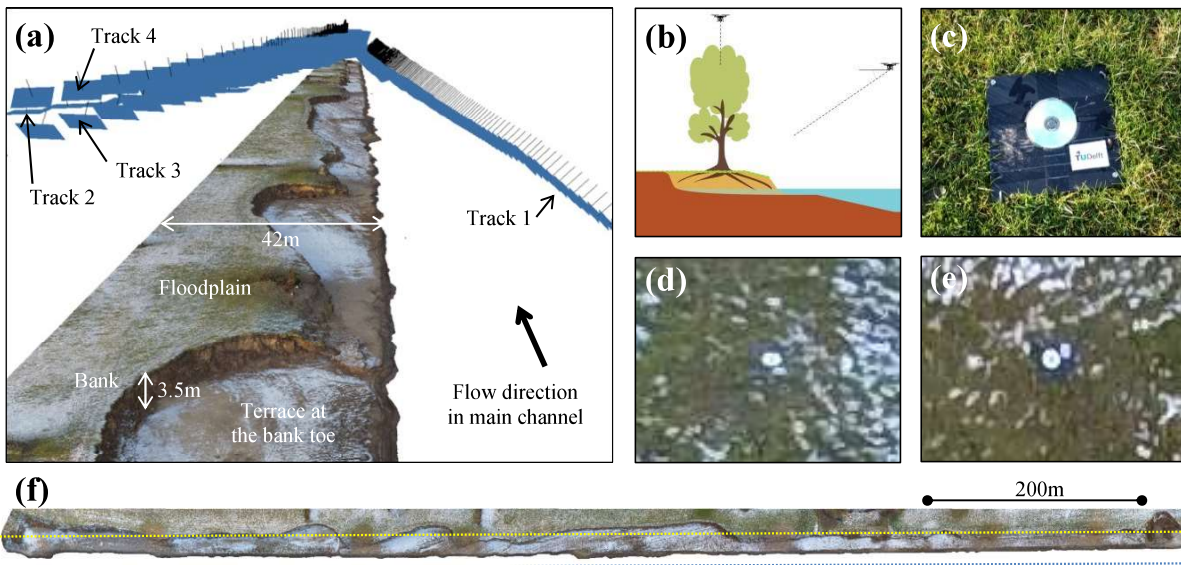
Figure 3: a) Camera positions and orientations in perspective view. The digital surface model shows the low-water condition during January 2017, which exposed a terrace at the bank toe. b) Cross-sectional scheme of UAV paths. c) Ceramic plaque with CD as ground control point on the floodplain. d) GCP in photograph from track 1. e) Same GCP from track 2. f) Top view of DSM with UAV track 1 in blue and tracks 2-4 in yellow.

For instance, if the first GCP line is 40 m from the UAV camera in oblique direction (Fig. 3b), the second line could be placed 51 m inland from the first line to be 80 m from the UAV sensor (twice as far), but with targets four times as big as those next to the bankline to linearly compensate for the decrease in the image resolution (although no linear trend was found between errors and sensor-object distance, Eltner et al., 2016). In this example, the rotational error would decrease 2.5 times compared to the results presented here, given by the increase in the cross-sectional GCP footprint and considering similar elevation errors (from GPS and image identification). Finally, as indicated in the previous section, it is advisable to use

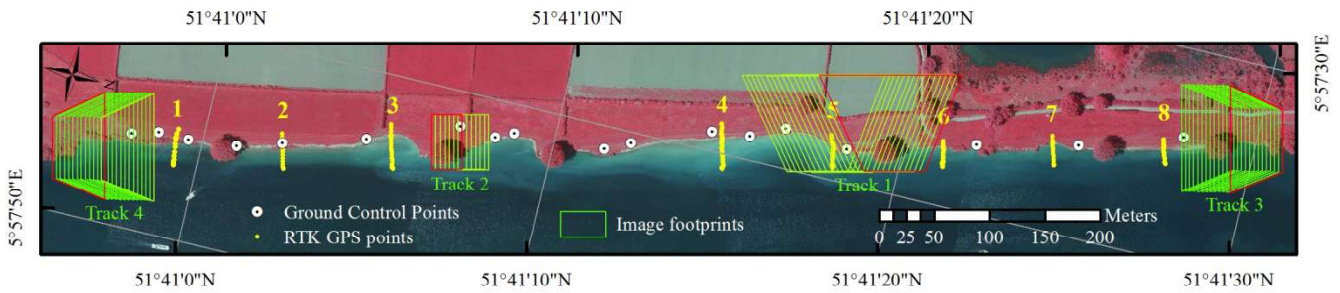
Figure 4: Study reach of the Meuse River with GCPs, RTK GPS measurements with cross-section locations and numbers, and some image footprints for all UAV tracks.

After obtaining the sparse point cloud, we marked the remaining 15 GCPs (Fig. 4). Then, we refined the camera parameters by minimizing the sum of GCP reprojection and misalignment errors. This camera optimization adjusts the estimated point cloud by reducing non-linear deformations. Once the dense point cloud was computed, we removed the points outside the area of interest, as well as those points at the water surface, tree canopies and individual bushes at the floodplain. Finally, the point cloud was triangulated and interpolated to generate a triangle mesh. This mesh consisted of a non-monotonic surface that was later processed in MATLAB to plot 2D cross section.

Six bank profiles were selected among those surveyed with GPS on January 2017 (Fig. 4) to compare the bank representation with the different survey techniques. Fig. 11 shows the bank profiles at sections 1, 2, 4, 6, 7 and 8. These sections presented distinct erosion magnitudes and features after seven years of restoration, for example, section 8 (Fig. 4 and 11) appeared close to the original condition, with a mild slope and nearly no erosion, whereas sections 6 and 7 had vertical scarps. The SfM DSM profiles are represented by continuous lines, the ALS profiles with dashed lines, and GPS points with circles. The SfM representation had better proximity to the GPS points than the ALS in almost all cases. What is

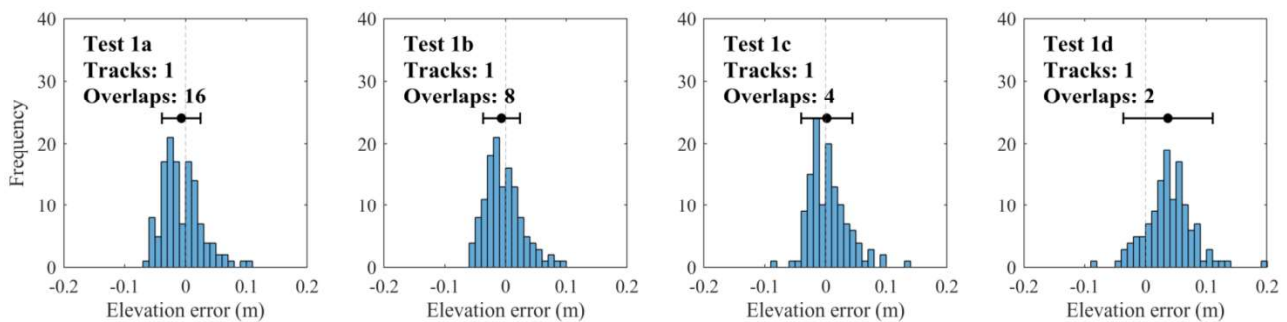
Figure 5: Elevation error distributions for SfM tests *1a*, *1b*, *1c*, and *1d*, assuming that the RTK points are correct and without error. Indicated overlaps are the minimum.

The sequentially decreasing photo overlaps of Track 1 (Table 1) produced four DSMs, tests *1a–1d*, whose elevation differences with the 129 RTK GPS points are presented in the histograms of Fig. 5. The elevation errors mostly ranged within 10 cm in all tests, but the mean and standard deviation (SD) presented some differences (Table 2 and dot with bar in Fig. 5). Tests *1a*, *1b* and *1c* presented mean values smaller than 1 cm and SD within 3–4 cm, while for test *1d* these values increased to 4 cm and 7 cm respectively (Table 2, rows 1–2). The mean errors on the bank area alone for test *1a*, *1b* and *1c* were lower than 1 cm (Table 2, row 5), but test *1c* had a higher SD of 7 cm compared to 4 and 3 cm of tests *1a* and *1b* respectively (Table 2, row 6). Then, tests *1a* and *1b* had the highest precisions and showed little error differences between them: less than 1 cm for all values in Table 2. Consequently, test *1b* with eight photo overlaps was as effective as test *1a* with 16 overlaps to achieve the highest DSM accuracy. In addition, test *1b* fully covered the tortuous bank area in contrast to test *1c*, especially at the perpendicular stretches of embayments (Fig. 3–4), which assured the choice of 8 image overlaps over 4, despite the general close performance of the latter in terms of accuracy (Table 2, all rows). Therefore, test *1b* became the reference for tests *1* and was used in combination with test 2 to generate test 3.

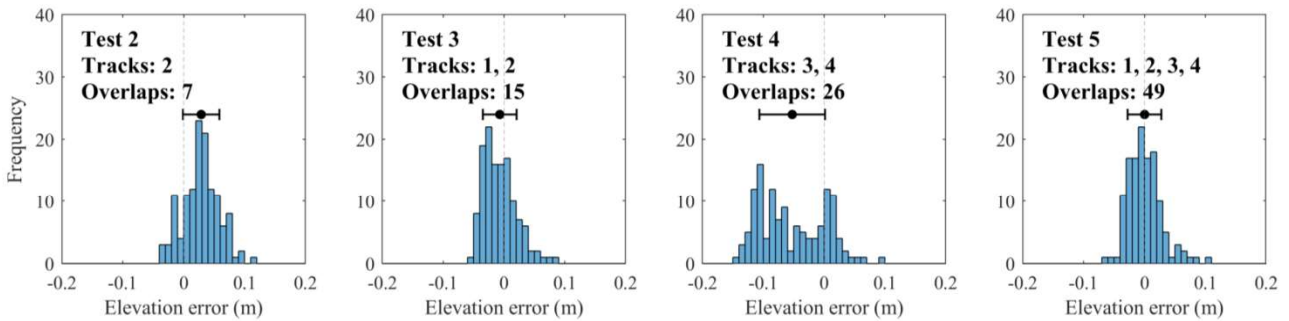
Figure 6: Elevation error distribution for tests 2, 3, 4, and 5. Ordinates indicate number of GPS points in each bin.

5 Figure 6 shows the error distributions of the remaining four DSMs, i.e. tests 2–5, which also were mostly within 10 cm, except for Test 4. This test had evident higher errors than the rest, mostly concentrated at the terrace (Table 2, row 7). Tests 3 and 5 had the lowest mean elevation errors, both lower than 1 cm, with the same SD at all surfaces that were lower than 3 cm. Test 2 presented a similar SD, but the mean was biased 3 cm. This test in combination with test 1b slightly reduced the SD errors of the latter (Table 2, rows 7 and 6), but without significant overall improvements. All in all, tests 1b, 10 3 and 5 had the best performances with average errors lower than 1 cm and standard deviations within 3 cm, however with increasing number of photographs (Table 1). The most efficient one was then test 1b that used the lowest number of photographs to achieve similar precision, especially on banks.

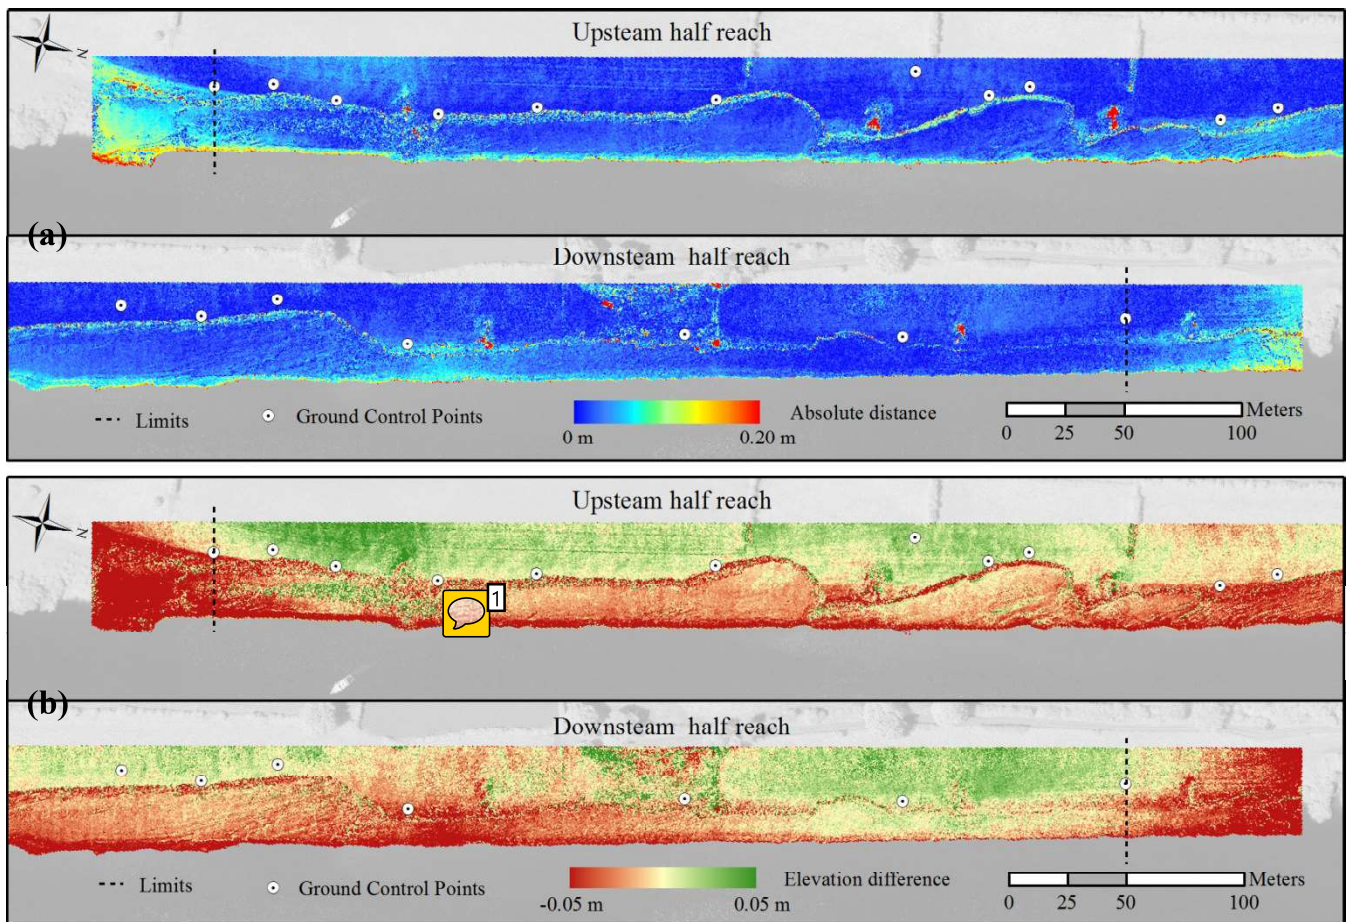
Figure 7: a) Absolute elevation differences between SfM and ALS along the reach. b) Signed elevation differences between SfM and ALS with a smaller scale range.

Figure 7b presents signed elevation differences with a smaller scale range to highlight areas with positive and negative deviations between techniques. Green zones indicate higher ground elevations on the SfM DSM than in the ALS grid, red indicate the opposite, and yellow elevation matches. The upstream half domain presented a general tendency of SfM to overestimate elevations on the floodplain, and in turn underestimate them on the terrace. This trend is also observed in the upper part of the downstream reach. Yet, these zones showed exceptions, such as a green patch at the terrace close to the dashed limit, and a red patch on the floodplain at the end of the upstream half reach. Despite the described general opposed behaviour between floodplain and terrace, the downstream reach evidenced two zones with consistent trends across the domain, covering both the floodplain and terrace. First, lower SfM elevations at the end of the largest embayment (downstream half reach), and second, SfM higher elevations at the end of the reach, before the dashed limit.

You missed a key point here: based on figure 7b, you have a doming deformation in the DOWNSTREAM direction. This effect is added to a mis-calibration of the focal length that results in a slightly incorrect vertical scale.

The lack of elevation diversity in the dah GCP data explains the problems in calibrating the focal length which are clear from figures 7.

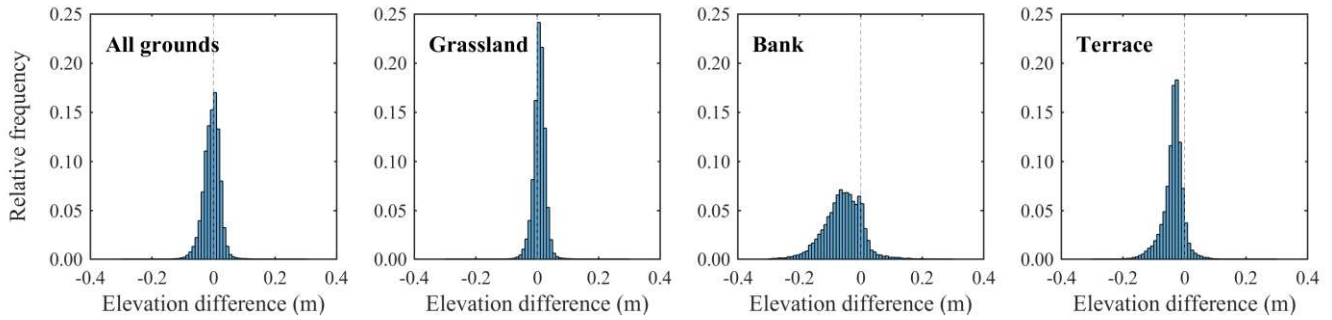
Figure 8: Comparison of elevation differences between SfM and ALS for distinct surface types

bias between techniques of 6 cm (Table 3) and a relatively high standard deviation of the same value. Finally, the terrace showed a slightly higher deviation than over the grassland (Fig. 8 and Table 3) but with a bias of -4 cm. The bank area together with the terrace induce an overall small negative bias in the elevation difference distribution (Fig. 8 left and Table 3). The former with a small contribution to the total number of measurements and the latter with a greater number but a lower magnitude.

The elevation bias at the bank between the SfM-based DSM and the ALS grid (Fig. 8) was caused by the topographic overestimation of ALS (Table 3 and Fig. 9). This ubiquitous error is ascribed to a known limitation of ALS systems related to the laser beam divergence angle, which locates the closest feature within the laser footprint at the centre of the footprint.

The elevation differences between the methods observed for grassland (Fig. 8, centre left) were probably caused by dissimilar ground resolutions, because a larger elevation scatter is expected in the SfM-based DSM when capturing grass with 2 cm resolution, compared to the interpolated ALS samples into a 50 cm grid, even when derived from 0.16 m beam
15 footprints. Nonetheless, the mean difference was zero (Table 3), so that both methods overestimate in the same way the real ground elevation due to grass cover. The effect of this is visible, for instance, in the increasing surface elevations on the floodplain over a year (Fig. 12a), which happens after the mowing period in October. The terrace at the bank toe presented a similar scatter as grassland, but had a small negative bias that could be explained by a DSM rotation or a slight transverse 'dome' effect of the SfM DSM.

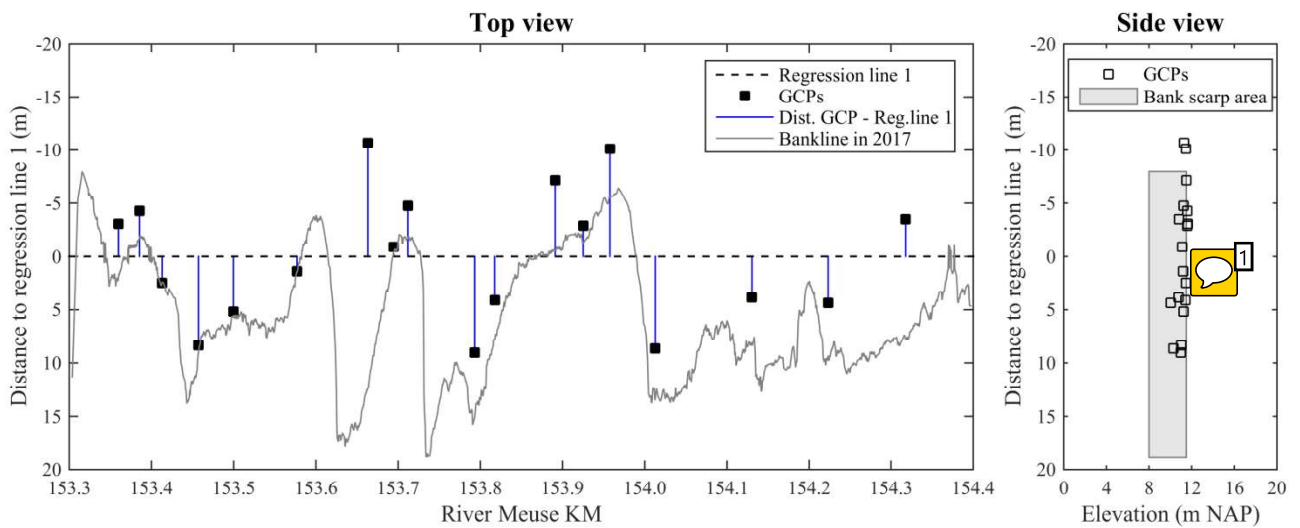
Figure 9: GCP horizontal distances to regression line (left) and respective positions in potential rotation plane from the regression line (right)

A regression line was computed with the locations of the GCPs to analyse with respect to this axis the rotational tendency of the model. The GCP distribution around the regression line and the bankline are shown in Fig. 9 (left). The adopted GCPs spanned 19.7 m across the reach and 1.6 m in the vertical direction (Fig. 9, right). The bank scarp along the reach, which is the target survey area, covered 26.9 m in cross-sectional direction due to the wide-ranging erosion magnitudes of the case study, with maximum bank heights of 3.5 m, indicated with a grey area in the right panel of Fig. 9. This side perspective of the domain evidences the potential plane of rotation, whose stability depends on the position of the GCPs.

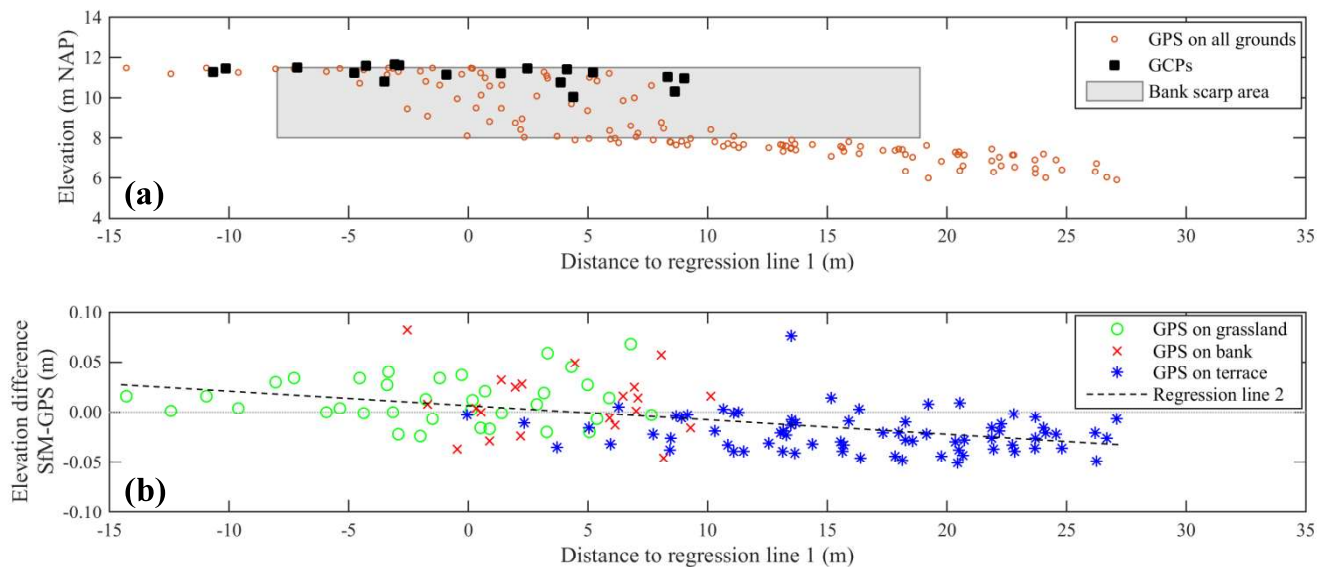
Figure 10: a) Location of GPS measurements in potential rotation plane around regression line 1. b) SfM DSM elevation errors across regression line 1, distinguished among areas of grassland, bank and terrace.

The rotation potential of the model is evaluated comparing SfM DSM elevations with those of the 129 GPS points (Fig. 4). Fig. 10a presents the locations of the GPS points used for accuracy control projected at the potential rotation plane, showing that they covered the domain across the channel (abscissa axis) and different elevations along of the scarp area (ordinate axis), resulting in a reasonable sample to assess the model georeferentiation stability. Fig. 10b presents the DSM elevation errors distributed across the regression line 1. In this plane, a second regression line was computed with all 129 points, represented with a dashed black line in Fig. 10b. This line is tilted from the horizontal suggesting that the model was rotated with a magnitude equal to the respective slope.

The GPS points corresponded to different surface types, shown with different point markers in Fig. 10b. It is clear that on the left side to the regression line 2 down-crossing, errors mostly had a positive bias, whereas on the right they mostly presented a negative bias. At the same time, those errors with positive bias were generally over a ground covered with grass, and those with negative trend were measured on a slightly sloped bare ground (see also Table 2, column for Test 3). Then, these tendencies could also be ascribed to the overestimation of the grass cover in the former case, and a non-linear transverse deformation beyond the GCP bounds, for the latter. Regardless of the causes, the results showed an overall transverse DSM inclination with respect of the GPS points used for accuracy control. The regression line 2 when evaluated at the extremes of the bank scarp area (-7.99 m and +18.87 m) yielded an elevation difference between these points of 3.9 cm.

The analysis made for test 3 on model rotation evidenced a linear trend with increased surface elevations on the floodplain side of the domain and decreased elevations on the main channel side (Fig. 10b). This tendency was probably caused by a rotation of the DSM around somewhat aligned GCPs that may lead to co-linear solutions of the Helmert

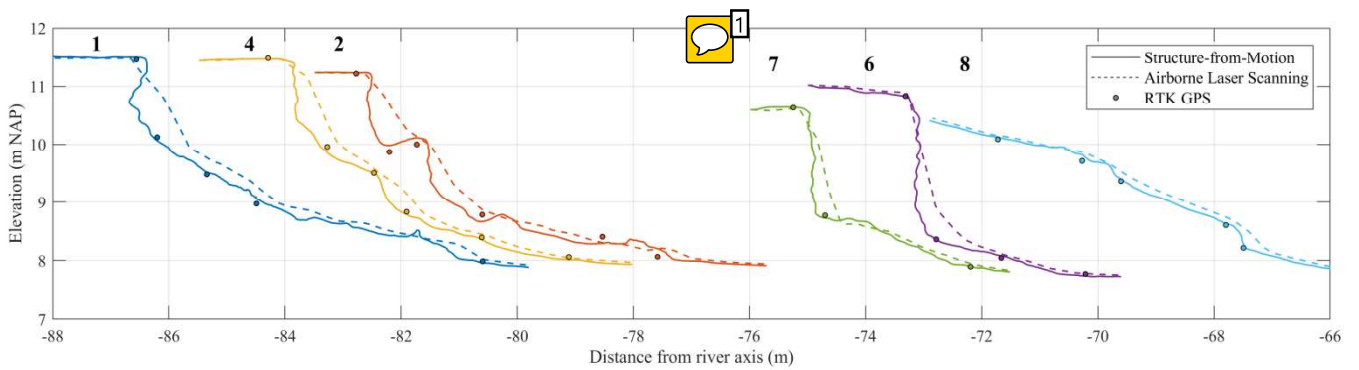
Figure 11: Banks measured with SfM (continuous lines), ALS (dashed lines) and GPS (circles) on 17–18 January 2017. Cross-sections are located from left to right, at river km. 153.4, 153.9, 153.5, 154.2, 154.1, and 154.3 (see Fig. 4 for locations).

more, ALS generally overestimated the elevation corresponding to the GPS points, which confirms the bias observed in the comparison of bank elevations shown in Fig. 7 and 8.

SfM profiles showed detailed bank features, such as a collapsed upper bank laying at the toe (section 2), an overhang at the bank top (section 1), small-scale roughness on scarps (sections 6 and 7), and slump-block deposits (section 4). These features appeared as simple shapes in the profiles but they were confirmed with field observations. The ALS depicted simpler profiles, smoothed by coarser resolution, which made it difficult to identify characteristic features of the erosion cycle in them. Yet, ALS profiles had enough point spacing to capture gentle bank slopes with reasonable precision (section 8), but for steeper ones (sections 1, 2 and 4) and specially at scarps (sections 6 and 7), this technique provides lower accuracies.

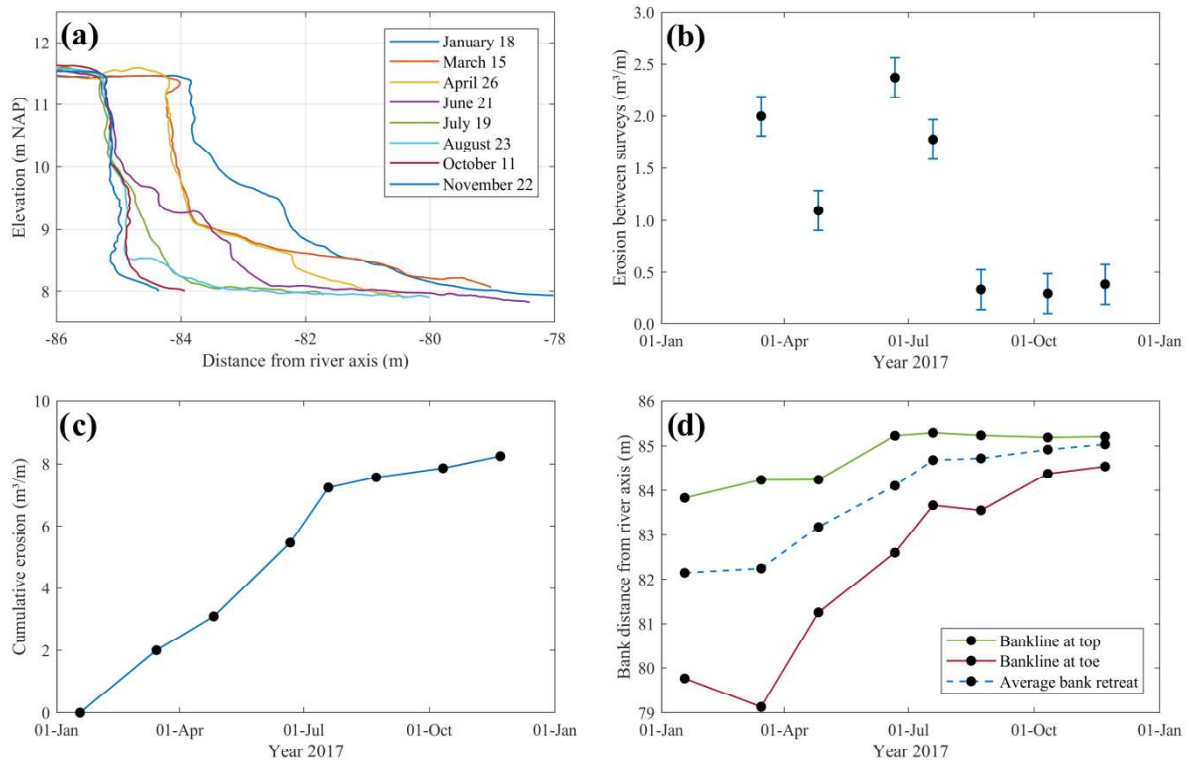
Figure 12: Sequential surveys at cross section 4, Meuse River km. 153.9, over 2017. a) Bank profiles from DSMs; b) Eroded volume per unit width between consecutive surveys; c) Cumulative erosion along surveys; d) Bankline locations at the top and toe of the bank.

The temporal development of section 4 (Fig. 4 and 11) is illustrated in Fig. 12a by a sequence of SfM-UAV surveys. The initial stage corresponds to the survey of Fig. 11 on 18 January 2017. The consecutive surveys showed the evolution of the vertical bank profile, through which different processes can be inferred. The bank profile, initially characterized by a top short scarp and slump blocks along the bank face, experienced a mass failure and a further removal of blocks between January 18 and March 15 2017. Between March 15 and April 26, only toe erosion occurred. By June 21, another mass failure happened, which left slump blocks along the lower half of the bank. On July 19, these blocks were removed, leaving a steep bank face. Then, further toe erosion caused a small soil failure at the lower bank whose remains laid at the toe. On October 11, this wasted material was removed. Then, until the last survey on November 22, entrainment occurred at the lower half of the bank profile, further steepening the bank. In light of the results, the methodology resolution and accuracy are high enough to identify different phases of the erosion cycle, enabling the analysis of bank erosion processes in conjunction with data on potential drivers.

This is not the best way to represent the data. You stated above that you required an accuracy of 14cm, but here you have a 5m vertical scale on a figure that occupies 1/8th of a page. Figure 7 was better at showing the errors on a scale that the reader can compare to your requirements.

In addition to process description, the quantification of eroded volumes is possible computing the net area between sequential bank profiles. For example, Fig. 12b shows eroded volumes per unit width between consecutive surveys plotted at the end of each time interval, with an error bar based on the RMSE of test 3. Evidently, there were different erosion rates during the year and the highest ones happened in the first part of it. Fig. 12c presents the respective cumulative eroded volumes per unit width, where the two trends can be distinguished: a gentle slope towards the end and higher rates of sediment yield during the first half of the year. Given that the topographic measurements are limited to a single year, it is not possible to state whether this behaviour is recurrent on a yearly basis. However, this case exemplifies the possibilities to quantify eroded volumes throughout different phases of the erosion cycle.

The bankline retreat as a measure of bank erosion involves the identification over time of the bank top, but this concept could be extended, for instance, to the bank toe. Fig. 12d shows the temporal progression of the bankline distance from the river axis for both the bank top and the toe, which we arbitrarily defined for this case at 11.1 m and 8.1 m, respectively. The top bankline showed a mayor jump between April and June and a smaller one between the first two surveys, corresponding to mass failure events. The bank toe presented a more gradual retreat, with events of slumping and temporal accretion that were timely captured along the surveys. This alternative bank retreat representation provides

evidence of the development of bank erosion at every survey. The contrast of bankline retreats at the top and toe of the bank illustrates how different processes on their own represent dissimilar erosion evolutions, since they constitute different phases of the erosion cycle, i.e. at the top mass failures and the toe slump block removal and entrainment. Finally, the average bankline between bank toe and top would best represent the real retreat (dashed line in Fig. 12d), despite not necessarily indicating an actual bank location for a specific elevation. This approach logically considers all erosion phases and follows a similar trend as the cumulative erosion of Fig. 12c.

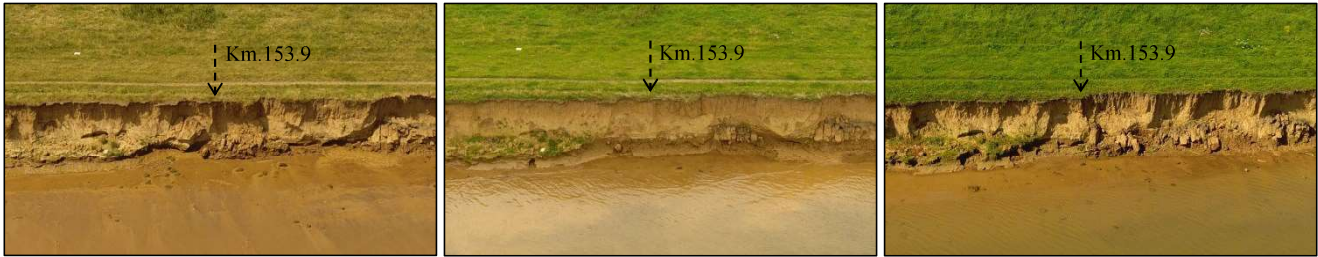
Figure 13: Zoomed-in UAV photos from track 1 at section 4, km. 153.9, showing diverse bank erosion stages: slump blocks at bank toe on June 21 (left), clean bank face after block removal on July 19 (centre), and undermining on August 23 (right).

Finally, the availability of the UAV imagery provides additional information to analyse and interpret bank evolution through direct observation. Figure 13 shows photographs from the three consecutive surveys on June 21, July 19 and August 23 at section 4, km. 153.9. At this bank area, the sequence shows on the left side of the panels only entrainment at the bank toe, and from the centre (km. 153.9) to the right, one or more erosion cycles. Cross section 4 presented on June 21 (Fig.13, left panel) slump blocks laying at the bank toe that were removed by July 19. Then on August 23, this cross section had incipient undermining at the lower bank and block deposition at the toe. The bank area at the right of section 4 experienced a second mass failure after June 21, completing one erosion cycle, and further downstream it is more difficult to keep track of the cycles due to faster erosion rates. The UAV photos also evidence the progressive growth of grass over the floodplain, especially observable next to the walking path, which was captured along the surveys (Fig. 12a).
