A low-cost technique to measure bank erosion processes along middle-size river reaches

Gonzalo Duró¹, Alessandra Crosato^{1,2}, Maarten G. Kleinhans³, Wim S. J. Uijttewaal¹

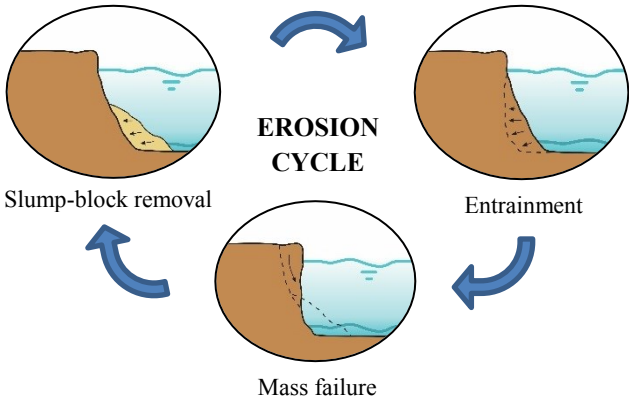
Figure 1: Schematic bank erosion phases: Slump-block removal (left), entrainment of bare bank (right) and incipient mass failure (centre)

Bank erosion may consist of three phases (Thorne and Tovey, 1981): fluvial entrainment of near-bank river-bed and bank material, mass failure, and disintegration and removal of slump blocks. These three phases are particularly important for

cohesive banks since their retreat is typically delayed by the protection offered by slump blocks at their toe (Thorne, 1982; Lawler, 1992; Parker et al., 2011). The waste material settles at the bank toe where it remains for a time depending on its resistance to fluvial erosion and on the flow capacity to transport the blocks. In contrast, loose waste material from non-cohesive banks is generally transported away relatively quicker by the river flow, leaving the bank sooner unprotected.

5 Entrainment of near-bank bed material and the intact bank face occurs once the bank toe is exposed again (e.g., see Clark and Wynn, 2007), which continues until the collapse of the upper bank. Mass failure occurs due to geotechnical instability, which can be triggered by different factors, such as fluvial bank-toe erosion (e.g., Darby et al., 2007) or a rapid drawdown of the river stage (e.g., Thorne and Tovey, 1981; Rinaldi et al., 2004).

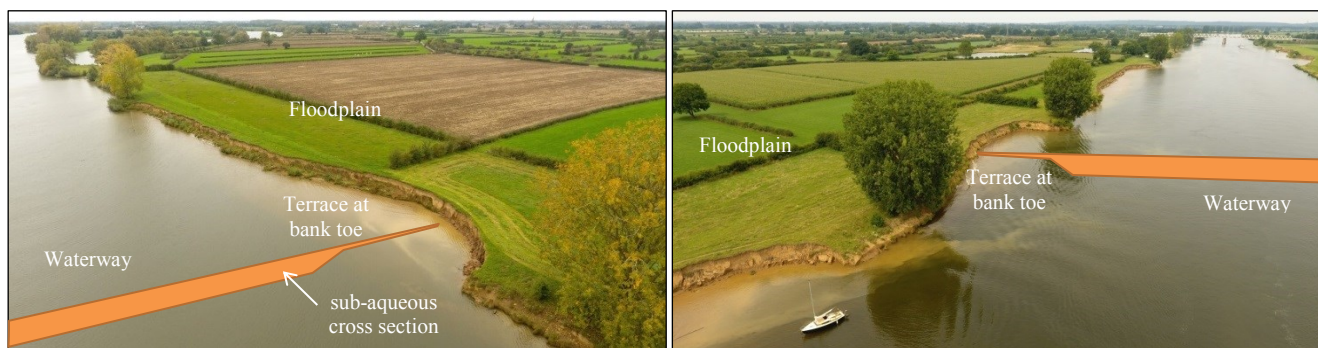
Figure 2: Restored bank in the Meuse River, upstream view of first 300 m (left) and downstream view of middle 500 m (right). Bank erosion has caused a series of bays in the 1,200 meter restored reach. Note eroded bank sediment in suspension.

The study site is the left bank of a 1200 m long straight reach (Fig. 2) located between the Sambeek and Grave weirs in southeast Netherlands. Seven years after restoration, this reach presents different bank retreat patterns, with sub-reaches of rather uniform erosion and others with embayments of different lengths. Grassy fields used for grazing cover the riparian zone, followed by crop fields across the floodplain. In the near-bank area there are poplar trees every 100 m, some of which have been dislodged during the erosion progression, which is possible to appreciate in Fig. 2 (left) considering the ~200 m embayment between the foreground tree and the next in the background.

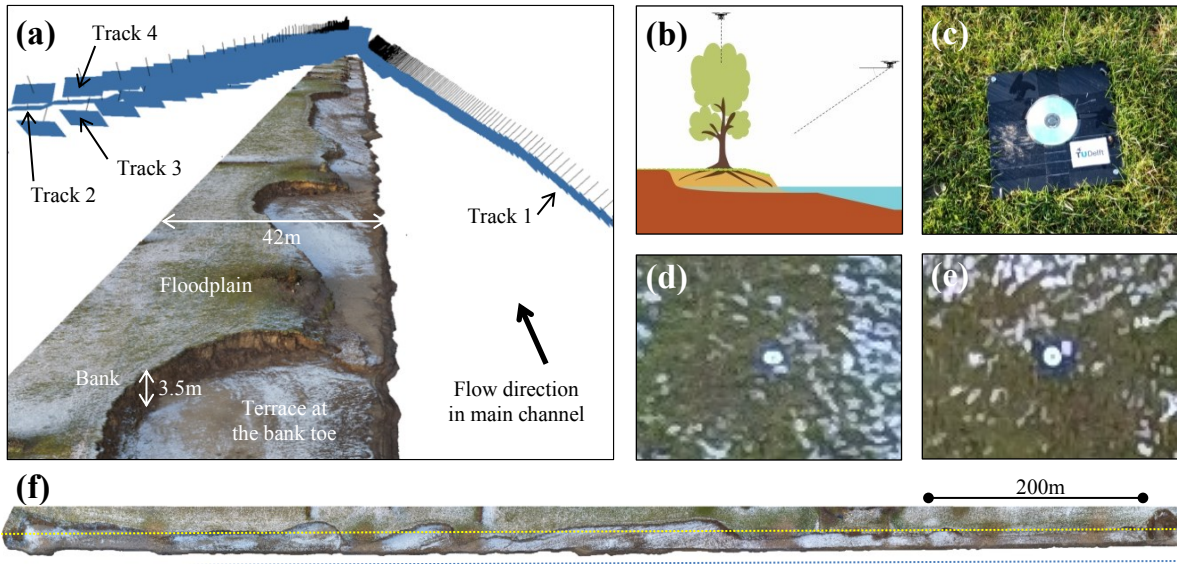
Figure 3: a) Camera positions and orientations in perspective view. The digital surface model shows the low-water condition during January 2017, which exposed a terrace at the bank toe. b) Cross-sectional scheme of UAV paths. c) Ceramic plaque with CD as ground control point on the floodplain. d) GCP in photograph from track 1. e) Same GCP from track 2. f) Top view of DSM with UAV track 1 in blue and tracks 2-4 in yellow.

We used Agisoft PhotoScan software to process the imagery. For a successful photo alignment from different UAV tracks (Table 1), the camera yaw, pitch and roll recorded during the UAV flight were necessary inputs. For this step we used three GCPs along the reach, two at the extremes and one at the middle, all close to the bank and easily visible from tracks 1 and 2. These approximate orientations and a priori known ground points helped obtaining a consistent sparse point cloud of the bank along the entire reach. The resulting camera positions and orientations of the photo alignment are visible in Fig. 3a, evidencing the UAV tracks. This figure also shows the DSM textured with colours from the photographs, in which the green area on the left side with white patches corresponds to the floodplain partially covered with snow (see also Fig. 3d-f) and the right brownish area is the terrace at the bank toe, with snow remains as well.

For instance, if the first GCP line is 40 m from the UAV camera in oblique direction (Fig. 3b), the second line could be placed 51 m inland from the first line to be 80 m from the UAV sensor (twice as far), but with targets four times as big as those next to the bankline to linearly compensate for the decrease in the image resolution (although no linear trend was found between errors and sensor-object distance, Eltner et al., 2016). In this example, the rotational error would decrease 2.5 times compared to the results presented here, given by the increase in the cross-sectional GCP footprint and considering similar elevation errors (from GPS and image identification). Finally, as indicated in the previous section, it is advisable to use

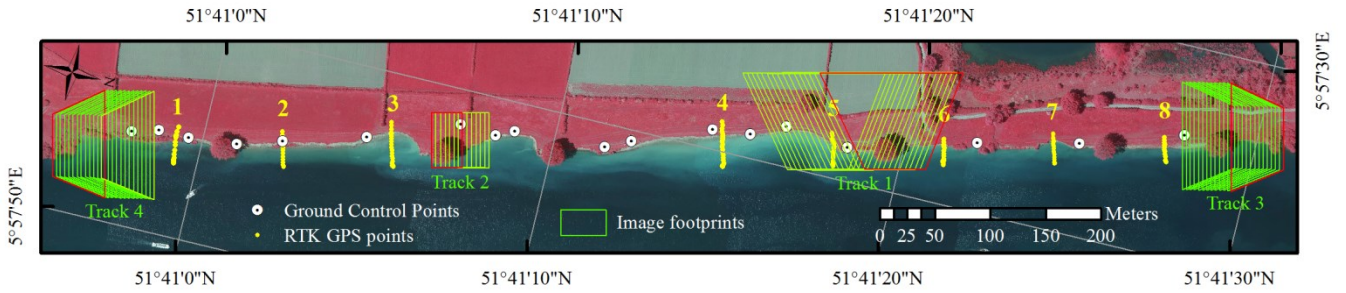
Figure 4: Study reach of the Meuse River with GCPs, RTK GPS measurements with cross-section locations and numbers, and some image footprints for all UAV tracks.

After obtaining the sparse point cloud, we marked the remaining 15 GCPs (Fig. 4). Then, we refined the camera parameters by minimizing the sum of GCP reprojection and misalignment errors. This camera optimization adjusts the estimated point cloud by reducing non-linear deformations. Once the dense point cloud was computed, we removed the points outside the area of interest, as well as those points at the water surface, tree canopies and individual bushes at the floodplain. Finally, the point cloud was triangulated and interpolated to generate a triangle mesh. This mesh consisted of a non-monotonic surface that was later processed in MATLAB to plot 2D cross sections.

The rotation potential of the model is evaluated comparing SfM DSM elevations with those of the 129 GPS points (Fig. 4). Fig. 10a presents the locations of the GPS points used for accuracy control projected at the potential rotation plane, showing that they covered the domain across the channel (abscissa axis) and different elevations along of the scarp area (ordinate axis), resulting in a reasonable sample to assess the model georeferentiation stability. Fig. 10b presents the DSM elevation errors distributed across the regression line 1. In this plane, a second regression line was computed with all 129 points, represented with a dashed black line in Fig. 10b. This line is tilted from the horizontal suggesting that the model was rotated with a magnitude equal to the respective slope.

Six bank profiles were selected among those surveyed with GPS on January 2017 (Fig. 4) to compare the bank representation with the different survey techniques. Fig. 11 shows the bank profiles at sections 1, 2, 4, 6, 7 and 8. These sections presented distinct erosion magnitudes and features after seven years of restoration, for example, section 8 (Fig. 4 and 11) appeared close to the original condition, with a mild slope and nearly no erosion, whereas sections 6 and 7 had vertical scarps. The SfM DSM profiles are represented by continuous lines, the ALS profiles with dashed lines, and GPS points with circles. The SfM representation had better proximity to the GPS points than the ALS in almost all cases. What is

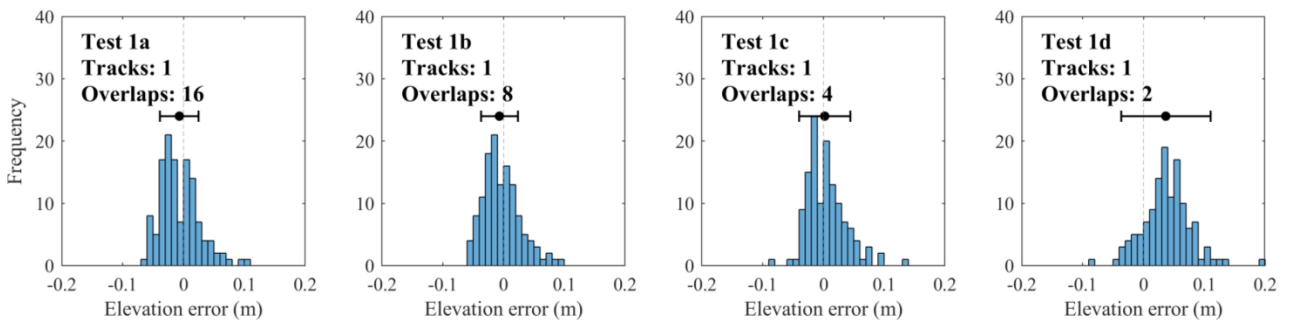
Figure 5: Elevation error distributions for SfM tests *1a*, *1b*, *1c*, and *1d*, assuming that the RTK points are correct and without error. Indicated overlaps are the minimum.

The sequentially decreasing photo overlaps of Track 1 (Table 1) produced four DSMs, tests *1a–1d*, whose elevation differences with the 129 RTK GPS points are presented in the histograms of Fig. 5. The elevation errors mostly ranged within 10 cm in all tests, but the mean and standard deviation (SD) presented some differences (Table 2 and dot with bar in Fig. 5). Tests *1a*, *1b* and *1c* presented mean values smaller than 1 cm and SD within 3–4 cm, while for test *1d* these values increased to 4 cm and 7 cm respectively (Table 2, rows 1–2). The mean errors on the bank area alone for test *1a*, *1b* and *1c* were lower than 1 cm (Table 2, row 5), but test *1c* had a higher SD of 7 cm compared to 4 and 3 cm of tests *1a* and *1b* respectively (Table 2, row 6). Then, tests *1a* and *1b* had the highest precisions and showed little error differences between them: less than 1 cm for all values in Table 2. Consequently, test *1b* with eight photo overlaps was as effective as test *1a* with 16 overlaps to achieve the highest DSM accuracy. In addition, test *1b* fully covered the tortuous bank area in contrast to test *1c*, especially at the perpendicular stretches of embayments (Fig. 3–4), which assured the choice of 8 image overlaps over 4, despite the general close performance of the latter in terms of accuracy (Table 2, all rows). Therefore, test *1b* became the reference for tests *1* and was used in combination with test 2 to generate test 3.

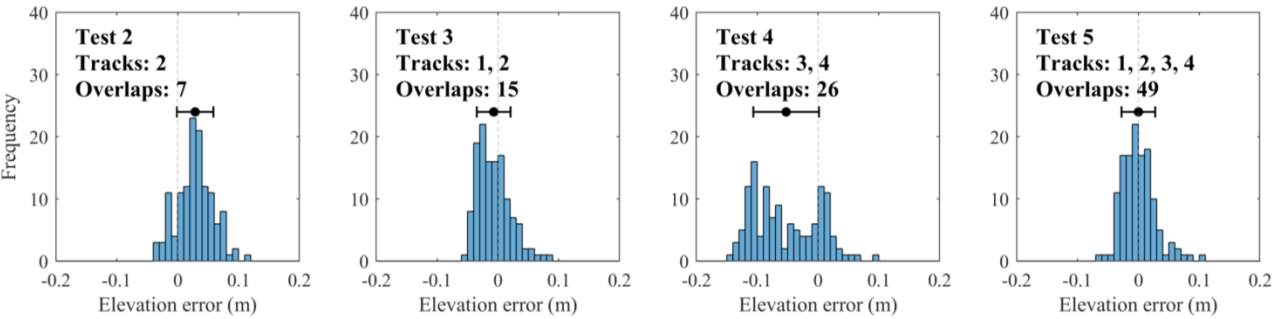
Figure 6: Elevation error distribution for tests 2, 3, 4, and 5. Ordinates indicate number of GPS points in each bin.

5 Figure 6 shows the error distributions of the remaining four DSMs, i.e. tests 2–5, which also were mostly within 10 cm, except for Test 4. This test had evident higher errors than the rest, mostly concentrated at the terrace (Table 2, row 7). Tests 3 and 5 had the lowest mean elevation errors, both lower than 1 cm, with the same SD at all surfaces that were lower than 3 cm. Test 2 presented a similar SD, but the mean was biased 3 cm. This test in combination with test 1*b* slightly reduced the SD errors of the latter (Table 2, rows 7 and 6), but without significant overall improvements. All in all, tests 1*b*, 10 3 and 5 had the best performances with average errors lower than 1 cm and standard deviations within 3 cm, however with increasing number of photographs (Table 1). The most efficient one was then test 1*b* that used the lowest number of photographs to achieve similar precision, especially on banks.

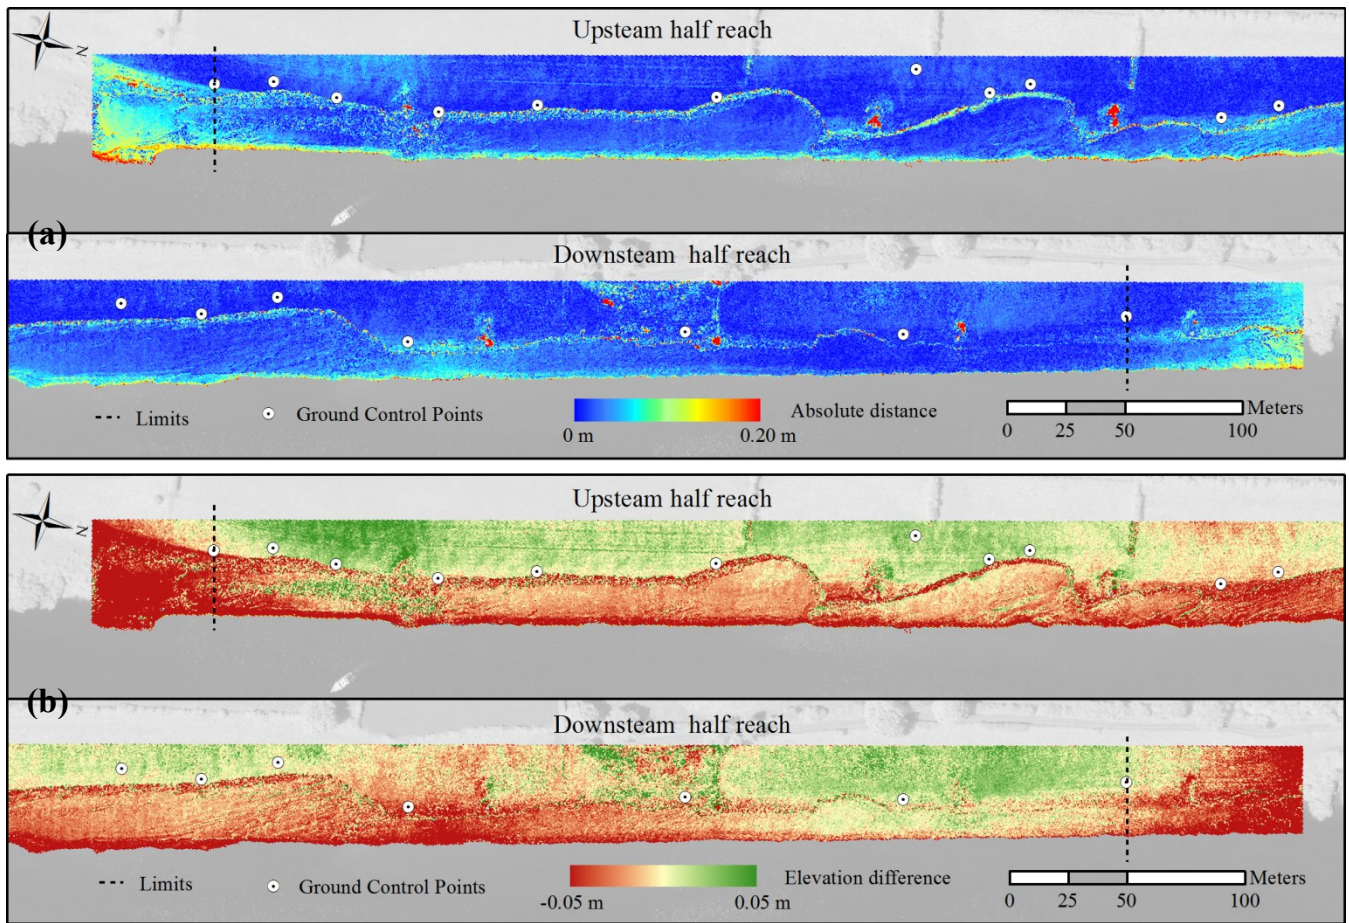
Figure 7: a) Absolute elevation differences between SfM and ALS along the reach. b) Signed elevation differences between SfM and ALS with a smaller scale range.

Compared to the ALS grid, test 3 point cloud showed a good agreement over most of the reach. This is observable from Fig. 7a, corresponding to the blue areas that indicate elevation differences lower than 5 cm. Yet, two notable regions surpassed this difference: the bank and the extremes of the reach. The latter were zones beyond the GCPs, where higher errors in the DSM are expected when using parallel image directions due to inaccurate correction of radial lens distortion (James and Robson, 2014; Smith et al., 2014). Consequently, the results outside the GCP limits cannot be considered representative of the whole domain and they were discarded for the subsequent statistical comparisons (beyond the dashed lines in Fig. 7). Within the GCP bounds, the bank area presented relatively high elevation differences, which makes the bankline visible in Fig. 7. Moreover, another sloped area at end of the terrace also presented higher differences than surrounding areas, which is visible as a thin light-blue line at bottom of the domain in Fig. 7a (see also Fig. 3a-b for other perspectives of this slope toward the channel bed).

Figure 7b presents signed elevation differences with a smaller scale range to highlight areas with positive and negative deviations between techniques. Green zones indicate higher ground elevations on the SfM DSM than in the ALS grid, red indicate the opposite, and yellow elevation matches. The upstream half domain presented a general tendency of SfM to overestimate elevations on the floodplain, and in turn underestimate them on the terrace. This trend is also observed in the upper part of the downstream reach. Yet, these zones showed exceptions, such as a green patch at the terrace close to the dashed limit, and a red patch on the floodplain at the end of the upstream half reach. Despite the described general opposed behaviour between floodplain and terrace, the downstream reach evidenced two zones with consistent trends across the domain, covering both the floodplain and terrace. First, lower SfM elevations at the end of the largest embayment (downstream half reach), and second, SfM higher elevations at the end of the reach, before the dashed limit.

more, ALS generally overestimated the elevation corresponding to the GPS points, which confirms the bias observed in the comparison of bank elevations shown in Fig. 7 and 8.

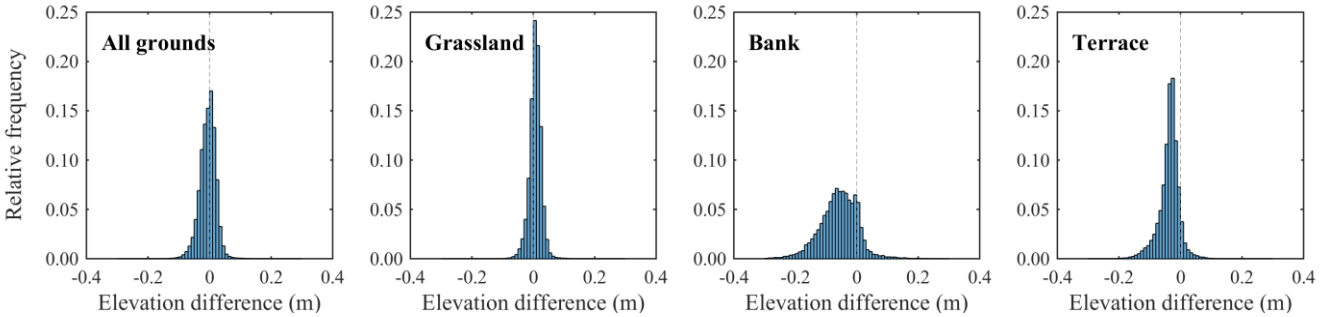
Figure 8: Comparison of elevation differences between SfM and ALS for distinct surface types

Figure 8 presents the relative frequency distributions of the elevation differences divided into three regions: the grassy floodplain, the steep bank, and the bare-ground terrace. Over the grassland, both SfM and ALS had rather similar results (Fig. 8, centre left), with 1 cm mean difference and 2 cm of standard deviation (Table 3). In contrast, the bank had a

bias between techniques of 6 cm (Table 3) and a relatively high standard deviation of the same value. Finally, the terrace showed a slightly higher deviation than over the grassland (Fig. 8 and Table 3) but with a bias of -4 cm. The bank area together with the terrace induce an overall small negative bias in the elevation difference distribution (Fig. 8 left and Table 3). The former with a small contribution to the total number of measurements and the latter with a greater number but a lower magnitude.

The elevation bias at the bank between the SfM-based DSM and the ALS grid (Fig. 8) was caused by the topographic overestimation of ALS (Table 3 and Fig. 9). This ubiquitous error is ascribed to a known limitation of ALS systems related to the laser beam divergence angle, which locates the closest feature within the laser footprint at the centre of the footprint.

The elevation differences between the methods observed for grassland (Fig. 8, centre left) were probably caused by dissimilar ground resolutions, because a larger elevation scatter is expected in the SfM-based DSM when capturing grass with 2 cm resolution, compared to the interpolated ALS samples into a 50 cm grid, even when derived from 0.16 m beam
15 footprints. Nonetheless, the mean difference was zero (Table 3), so that both methods overestimate in the same way the real ground elevation due to grass cover. The effect of this is visible, for instance, in the increasing surface elevations on the floodplain over a year (Fig. 12a), which happens after the mowing period in October. The terrace at the bank toe presented a similar scatter as grassland, but had a small negative bias that could be explained by a DSM rotation or a slight transverse ‘dome’ effect of the SfM DSM.

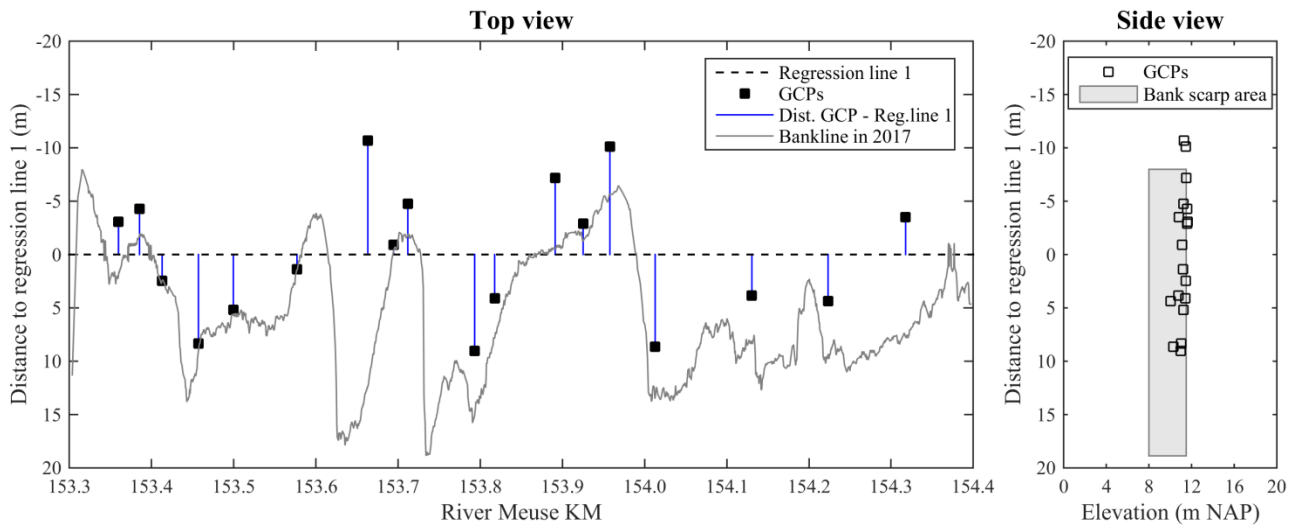
Figure 9: GCP horizontal distances to regression line (left) and respective positions in potential rotation plane from the regression line (right)

A regression line was computed with the locations of the GCPs to analyse with respect to this axis the rotational tendency of the model. The GCP distribution around the regression line and the bankline are shown in Fig. 9 (left). The adopted GCPs spanned 19.7 m across the reach and 1.6 m in the vertical direction (Fig. 9, right). The bank scarp along the reach, which is the target survey area, covered 26.9 m in cross-sectional direction due to the wide-ranging erosion magnitudes of the case study, with maximum bank heights of 3.5 m, indicated with a grey area in the right panel of Fig. 9. This side perspective of the domain evidences the potential plane of rotation, whose stability depends on the position of the GCPs.

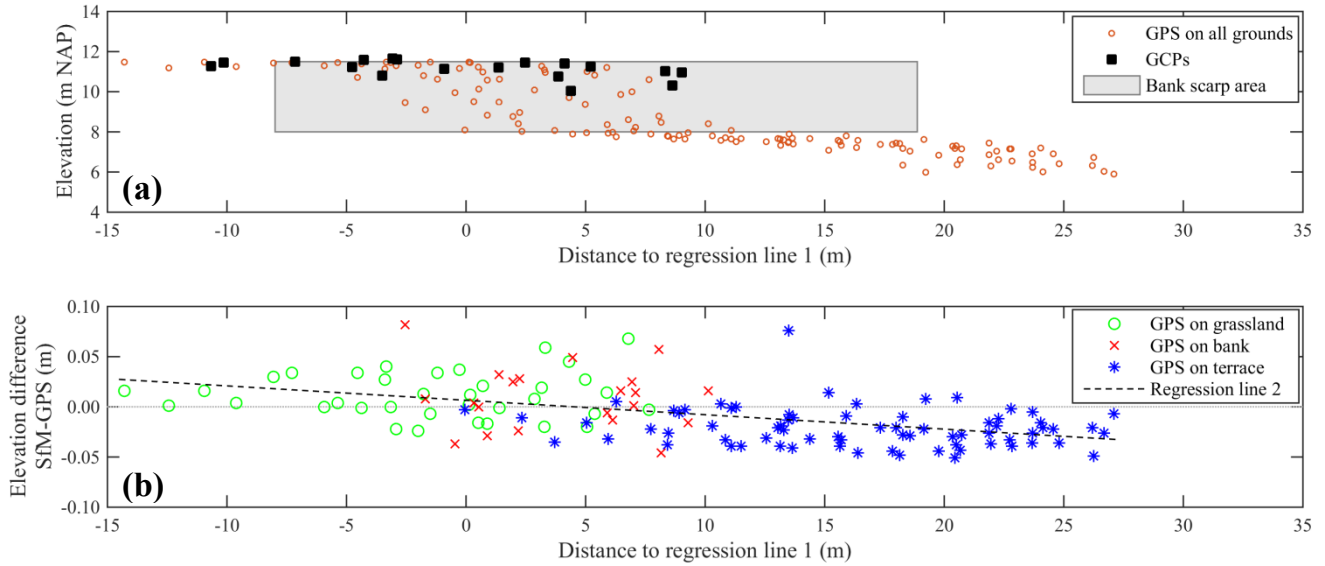
Figure 10: a) Location of GPS measurements in potential rotation plane around regression line 1. b) SfM DSM elevation errors across regression line 1, distinguished among areas of grassland, bank and terrace.

The GPS points corresponded to difference surface types, shown with different point markers in Fig. 10b. It is clear that on the left side to the regression line 2 down-crossing, errors mostly had a positive bias, whereas on the right they mostly presented a negative bias. At the same time, those errors with positive bias were generally over a ground covered with grass, and those with negative trend were measured on a slightly sloped bare ground (see also Table 2, column for Test 3). Then, this tendencies could also be ascribed to the overestimation of the grass cover in the former case, and a non-linear transverse deformation beyond the GCP bounds, for the latter. Regardless of the causes, the results showed an overall transverse DSM inclination with respect of the GPS points used for accuracy control. The regression line 2 when evaluated at the extremes of the bank scarp area (-7.99 m and +18.87 m) yielded an elevation difference between these points of 3.9 cm.

The analysis made for test 3 on model rotation evidenced a linear trend with increased surface elevations on the floodplain side of the domain and decreased elevations on the main channel side (Fig. 10b). This tendency was probably caused by a rotation of the DSM around somewhat aligned GCPs that may lead to co-linear solutions of the Helmert

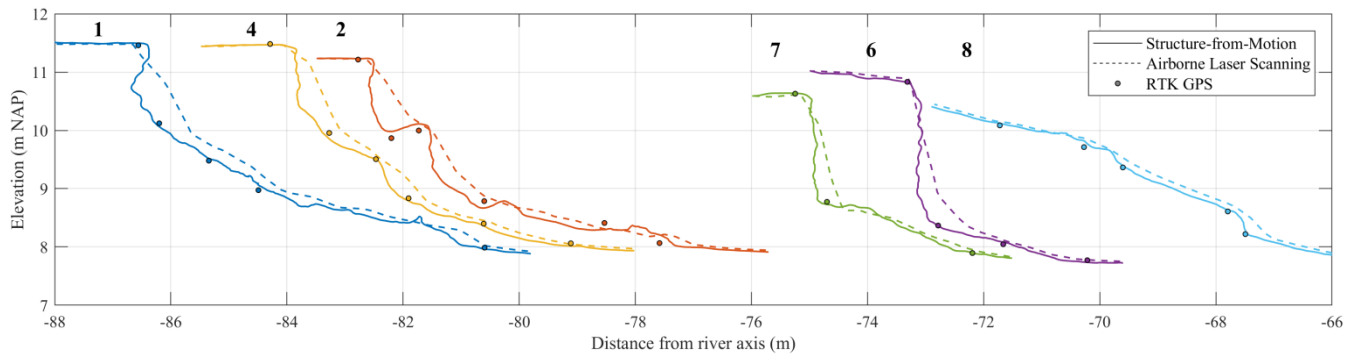
Figure 11: Banks measured with SfM (continuous lines), ALS (dashed lines) and GPS (circles) on 17–18 January 2017. Cross-sections are located from left to right, at river km. 153.4, 153.9, 153.5, 154.2, 154.1, and 154.3 (see Fig. 4 for locations).

SfM profiles showed detailed bank features, such as a collapsed upper bank laying at the toe (section 2), an overhang at the bank top (section 1), small-scale roughness on scarps (sections 6 and 7), and slump-block deposits (section 4). These features appeared as simple shapes in the profiles but they were confirmed with field observations. The ALS depicted simpler profiles, smoothed by coarser resolution, which made it difficult to identify characteristic features of the erosion cycle in them. Yet, ALS profiles had enough point spacing to capture gentle bank slopes with reasonable precision (section 8), but for steeper ones (sections 1, 2 and 4) and specially at scarps (sections 6 and 7), this technique provides lower accuracies.

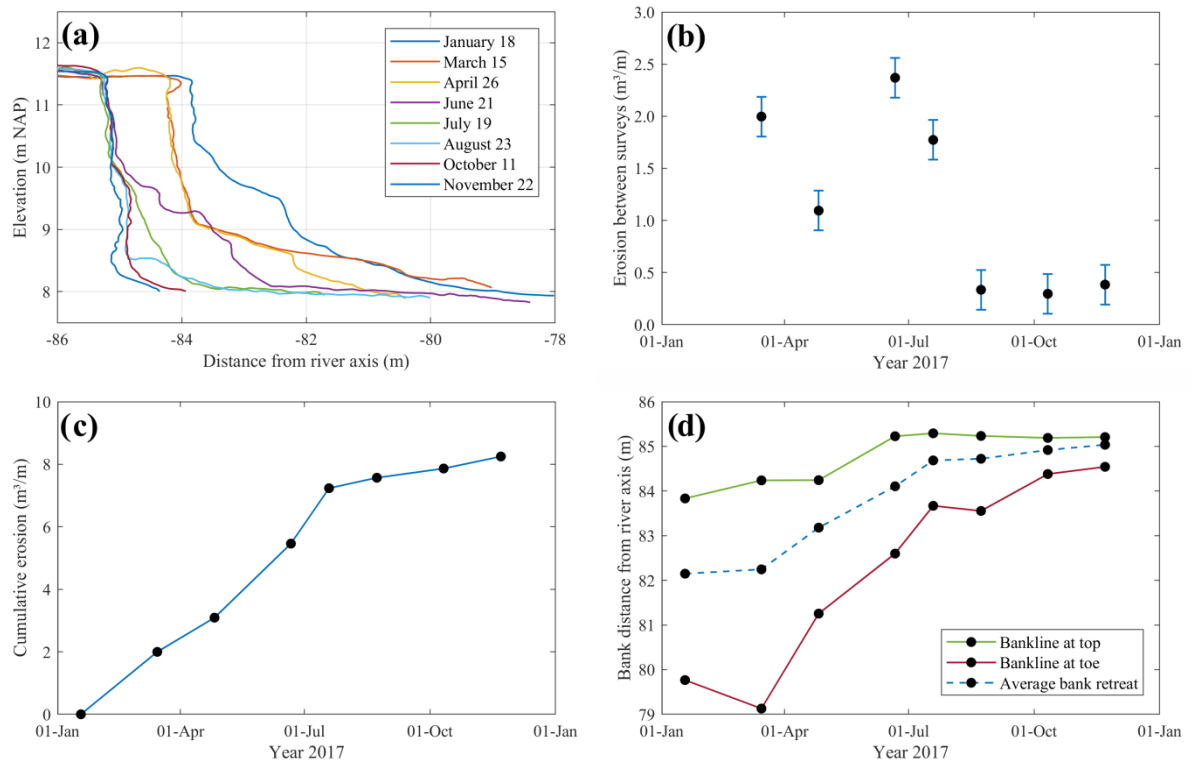
Figure 12: Sequential surveys at cross section 4, Meuse River km. 153.9, over 2017. a) Bank profiles from DSMs; b) Eroded volume per unit width between consecutive surveys; c) Cumulative erosion along surveys; d) Bankline locations at the top and toe of the bank.

The temporal development of section 4 (Fig. 4 and 11) is illustrated in Fig. 12a by a sequence of SfM-UAV surveys. The initial stage corresponds to the survey of Fig. 11 on 18 January 2017. The consecutive surveys showed the evolution of the vertical bank profile, through which different processes can be inferred. The bank profile, initially characterized by a top short scarp and slump blocks along the bank face, experienced a mass failure and a further removal of blocks between January 18 and March 15 2017. Between March 15 and April 26, only toe erosion occurred. By June 21, another mass failure happened, which left slump blocks along the lower half of the bank. On July 19, these blocks were removed, leaving a steep bank face. Then, further toe erosion caused a small soil failure at the lower bank whose remains laid at the toe. On October 11, this wasted material was removed. Then, until the last survey on November 22, entrainment occurred at the lower half of the bank profile, further steepening the bank. In light of the results, the methodology resolution and accuracy are high enough to identify different phases of the erosion cycle, enabling the analysis of bank erosion processes in conjunction with data on potential drivers.

In addition to process description, the quantification of eroded volumes is possible computing the net area between sequential bank profiles. For example, Fig. 12b shows eroded volumes per unit width between consecutive surveys plotted at the end of each time interval, with an error bar based on the RMSE of test 3. Evidently, there were different erosion rates during the year and the highest ones happened in the first part of it. Fig. 12c presents the respective cumulative eroded volumes per unit width, where the two trends can be distinguished: a gentle slope towards the end and higher rates of sediment yield during the first half of the year. Given that the topographic measurements are limited to a single year, it is not possible to state whether this behaviour is recurrent on a yearly basis. However, this case exemplifies the possibilities to quantify eroded volumes throughout different phases of the erosion cycle.

The bankline retreat as a measure of bank erosion involves the identification over time of the bank top, but this concept could be extended, for instance, to the bank toe. Fig. 12d shows the temporal progression of the bankline distance from the river axis for both the bank top and the toe, which we arbitrarily defined for this case at 11.1 m and 8.1 m, respectively. The top bankline showed a mayor jump between April and June and a smaller one between the first two surveys, corresponding to mass failure events. The bank toe presented a more gradual retreat, with events of slumping and temporal accretion that were timely captured along the surveys. This alternative bank retreat representation provides

evidence of the development of bank erosion at every survey. The contrast of bankline retreats at the top and toe of the bank illustrates how different processes on their own represent dissimilar erosion evolutions, since they constitute different phases of the erosion cycle, i.e. at the top mass failures and the toe slump block removal and entrainment. Finally, the average bankline between bank toe and top would best represent the real retreat (dashed line in Fig. 12d), despite not necessarily indicating an actual bank location for a specific elevation. This approach logically considers all erosion phases and follows a similar trend as the cumulative erosion of Fig. 12c.

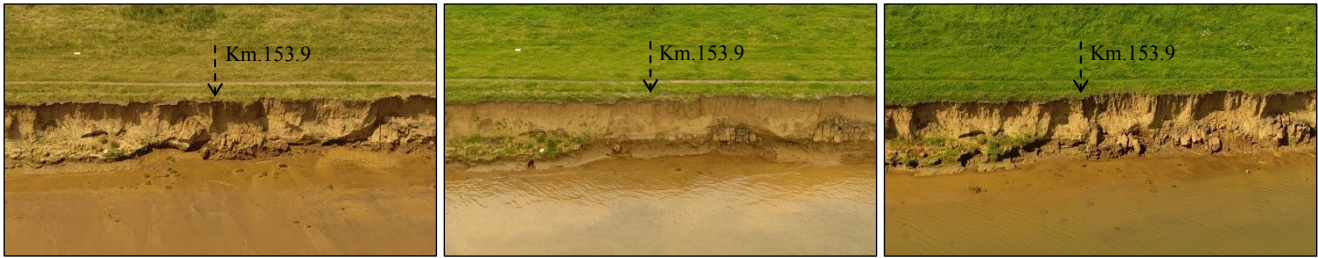
Figure 13: Zoomed-in UAV photos from track 1 at section 4, km. 153.9, showing diverse bank erosion stages: slump blocks at bank toe on June 21 (left), clean bank face after block removal on July 19 (centre), and undermining on August 23 (right).

Finally, the availability of the UAV imagery provides additional information to analyse and interpret bank evolution through direct observation. Figure 13 shows photographs from the three consecutive surveys on June 21, July 19 and August 23 at section 4, km. 153.9. At this bank area, the sequence shows on the left side of the panels only entrainment at the bank toe, and from the centre (km. 153.9) to the right, one or more erosion cycles. Cross section 4 presented on June 21 (Fig.13, left panel) slump blocks laying at the bank toe that were removed by July 19. Then on August 23, this cross section had incipient undermining at the lower bank and block deposition at the toe. The bank area at the right of section 4 experienced a second mass failure after June 21, completing one erosion cycle, and further downstream it is more difficult to keep track of the cycles due to faster erosion rates. The UAV photos also evidence the progressive growth of grass over the floodplain, especially observable next to the walking path, which was captured along the surveys (Fig. 12a).
