# Evolution of events before and after the 17 June 2017 rock avalanche at Karrat Fjord, West Greenland – a multidisciplinary approach to detect and locate unstable rock slopes in a remote Arctic area

Kristian Svennevig<sup>1</sup>, Trine Dahl-Jensen<sup>1</sup>, Marie Keiding<sup>1</sup>, John Peter Merryman Boncori<sup>2</sup>, Tine B. Larsen<sup>1</sup>, Sara Salehi<sup>1</sup>, Anne Munck Solgaard<sup>1</sup> and Peter H. Voss<sup>1</sup>

<sup>1</sup>Geological Survey of Denmark and Greenland (GEUS), Copenhagen, 1350, Denmark.

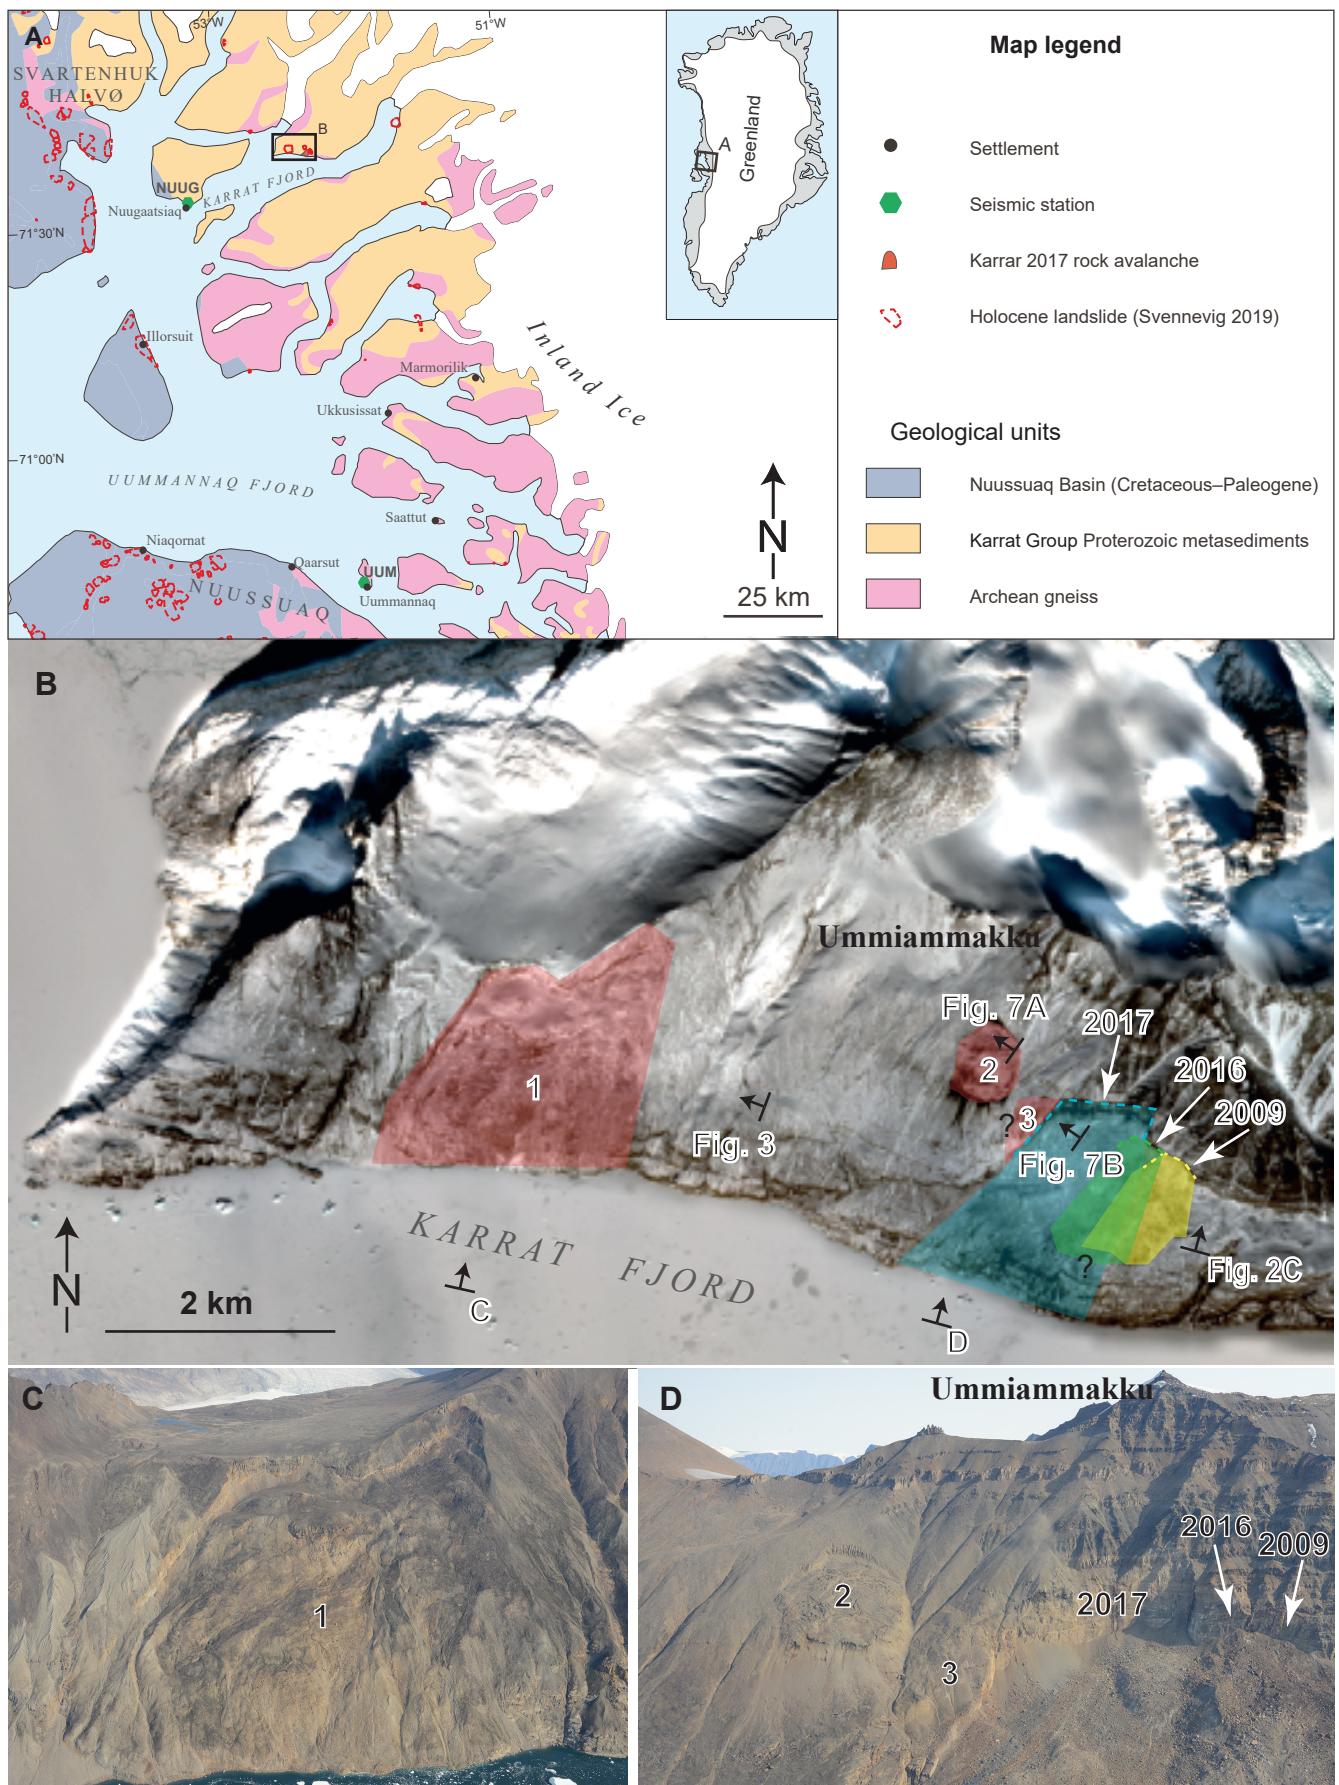
**Fig 1**

On 17 June 2017 the village of Nuugaatsiaq in West Greenland was hit by a tsunami generated by a 35-58 million m<sup>3</sup> rock avalanche on the south facing slope of the Ummiammakku mountain in Karrat Fjord, located 32 km to the east of the village (Besette-Kirton et al., 2017; Clinton et al., 2017; Gauthier et al., 2018; Paris et al., 2019). A large part of the village was destroyed, and four people lost their lives. The tsunami was also observed in other settlements more than 100 km away. Following this, the Greenlandic authorities evacuated 170 residents from Nuugaatsiaq and the neighbouring settlement of Illorsuit due to the threat of further rock slope failures in the area and the villages are still under evacuation orders at the time of this writing due to fear of additional induced tsunamis (Fig. 1).

The study area is located on the south facing slope of the Ummiammakku mountain in Karrat Fjord, central West Greenland (Fig. 1A). The topography is influenced by quaternary glaciations with up to 2000 m high oversteepened slopes and long fjords up to 1100 m deep. The climate is arctic with a mean annual air temperature of -3.9 at sea level in the town of Uummannaq 110 km to the south and the slopes in the region are permanently frozen (Westergaard-Nielsen et al., 2018). At present West Greenland represent an area of tectonic stability and only few minor tectonic earthquakes are known (Voss et al., 2007).

The scar of the 2009 rock avalanche shows that it released along a near-vertical back scarp (Fig. 1B,D). The basal sliding plane is covered by boulders but is interpreted to follow the bedding dipping 10-30° towards the fjord (Fig. 2C). Based on this, we suggest that the 2009 rock avalanche initiated as a dipslope failure. The timing of the avalanche was initially confined to a five-year interval by the two oldest ArcticDEM strips (3 June 2008 – 12 October 2013). Google Earth Images from 1 May 2009 shows no larger recent activity and thus further constrain the event (Fig. 4A). It was then further

The 2016 Karrat rock avalanche occurred immediately west of the 2009 scarp (Figs. 1B,D, 4C), and had the same east-west oriented vertical back scarp and dipslope weakness as surface of rupture. Due to the constant winter darkness the timing of the rock avalanche, based on Sentinel-2 data alone, could only be loosely constrained to some time during the winter of 2016-2017. However, a DInSAR interferogram formed from Sentinel-1 images acquired on 11 and 17 November 2016 show a localized loss of coherence, compatible with a rock avalanche in this area (Fig. 5). Analysis of

315 Area 3 is an 800 by 500 m unstable rock slope located between the scarp of the Karrat 2017 rock avalanche and Area 2 (Fig 1B,D). A clear backscarp is not visible but the area shows signs of deformation since May 2015 (coinciding with the initiation of Area 2) and decorrelation over the entire area in all interferograms since 21 June 2017 (the first acquisition after the 17 June 2017 rock avalanche) (Fig. 5). Localized rockfalls are seen in Sentinel-2 images and during the field visit. It has an overall hummocky surface in recent ArcticDEM strips and a broken up internal fabric was observed in the  
320 field (Fig. 7B) indicating significant internal strain. Upslope the area seems to be defined by the western continuation of the backscarp of the Karrat 2017 rock avalanche and it is reasonable to assume that it is sliding on the same basal sliding plane. This area is described here for the first time. We infer activity in Area 3 to have started in May 2015 and increased considerably after 17 June 2017 as the block dislocated in the Karrat 2017 rock avalanche would have supported the area and prevented it from moving. The volume is constrained by using the western continuation of the back scarp and the

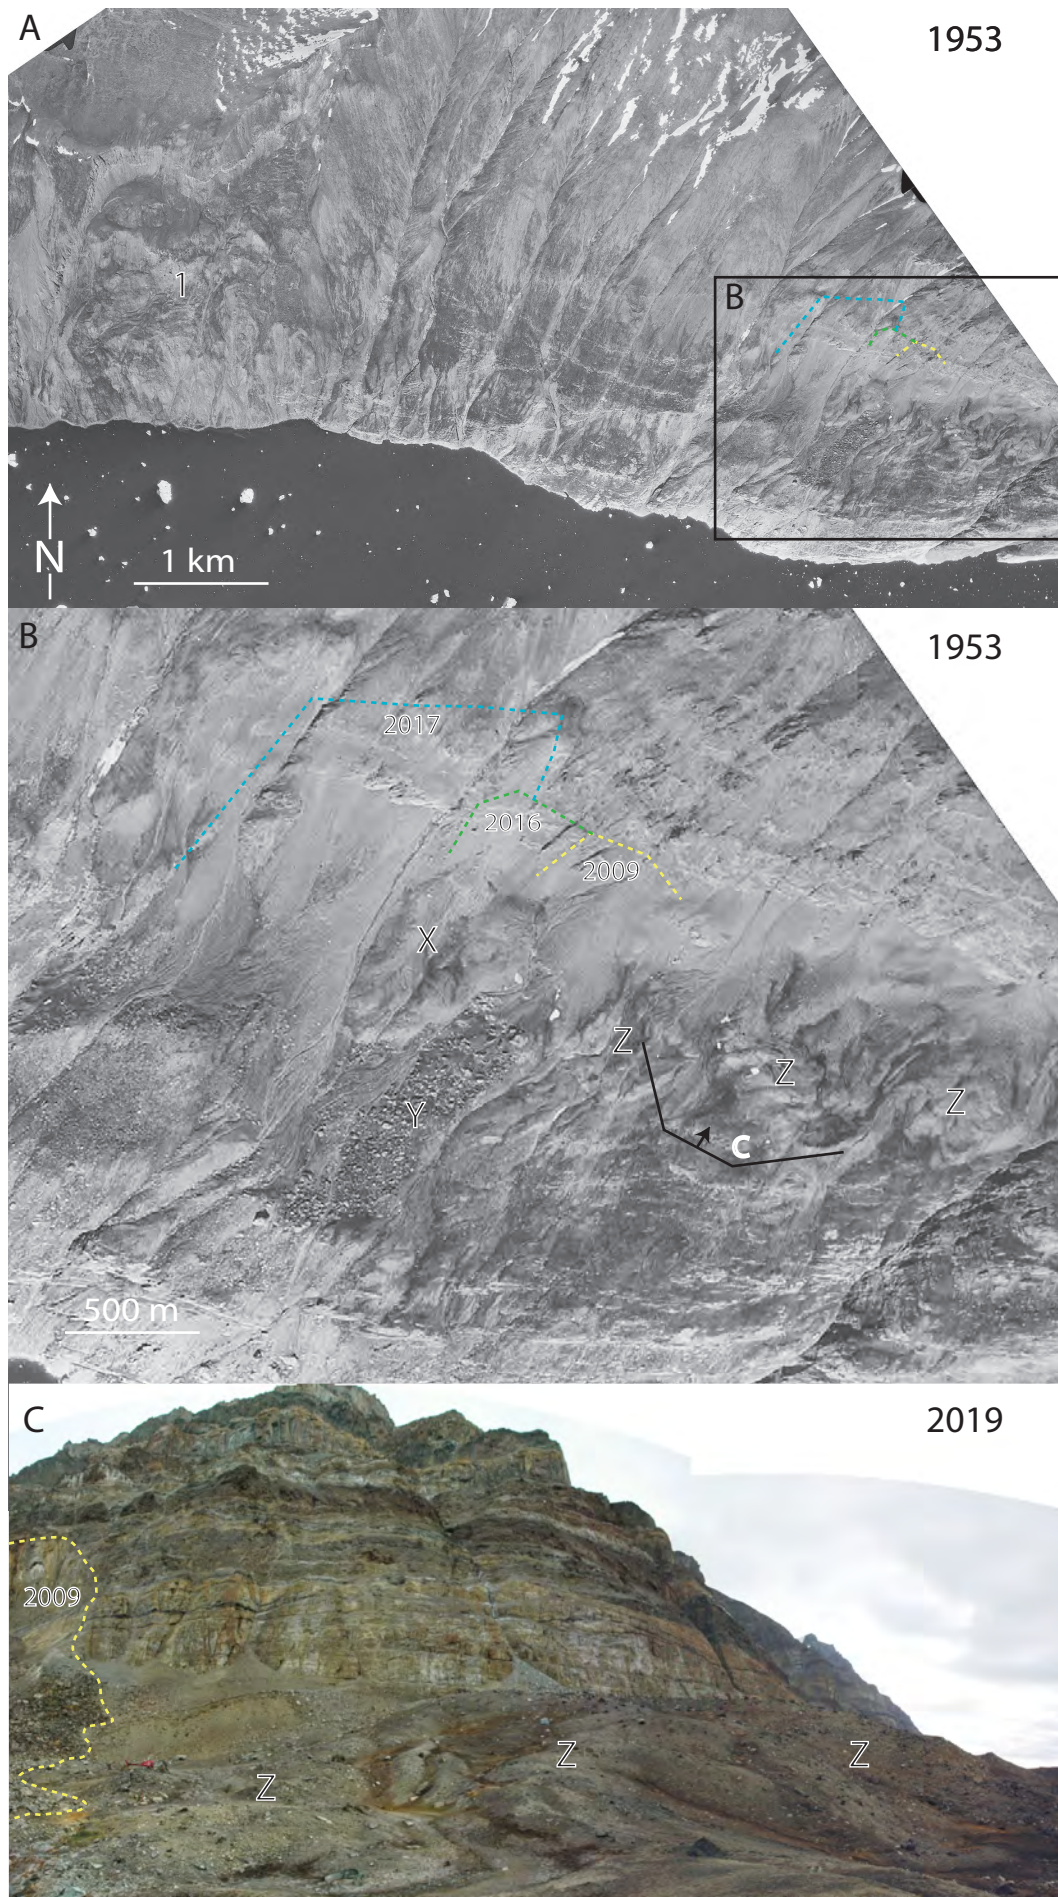
Fig. 2

655 east show the positions of the scarps of the future rock avalanches (colours match Fig. 1B). B: Details of A with the  
 stippled lines indicating the positions of the scarps of the future rock avalanches. Notice the lobate morphology (X) and  
 boulder field (Y) indicating older rock slope failures along with the hummocky topography to the E (Z). C: Photomosaic  
 of field photos from the summer of 2019 taken just E of the 2009 rock avalanche. The scarp and lobe of the 2009 rock  
 avalanche is indicated with a stippled yellow line. The lobate hummocky topography interpreted to be deposits of past  
 660 rock slope failures are indicated with (Z). Red helicopter for scale.

In satellite images and aerial photos from 1953 a 0.10 km<sup>2</sup> lobe shaped feature below the area of the future scarp of the Karrat 2016 and 2017 rock avalanche is interpreted as the lobe of a minor rock slope failure modified as a rock glacier or debris flow. A conspicuous boulder field just below this feature adds to this interpretation (Fig 2A,B). The recent rock avalanches have now erased these features. East of the lobes of the recent rock avalanches, hummocky boulder fields

were observed and are here interpreted also to be older rock avalanche deposits, although the individual back scarps and lobes of these are not readily identified (Fig. 2C).

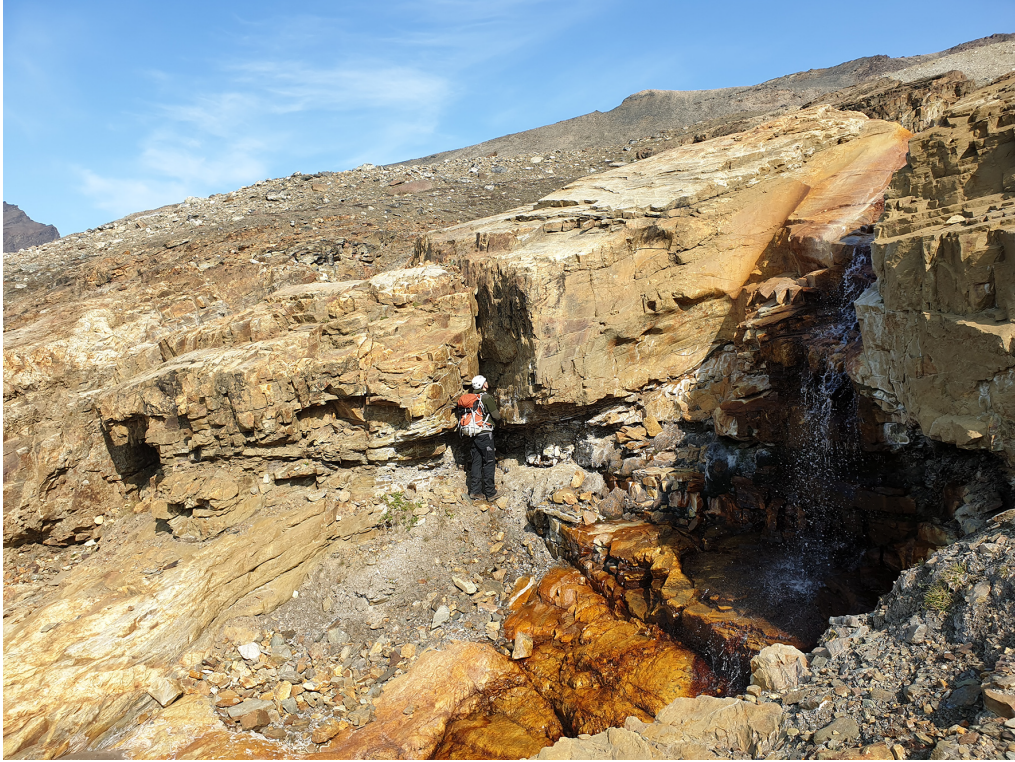
**Fig. 3**

Field photo of the bedrock geology of the coastal slope 1.5 km west of Area 1. View is towards the west. Sub vertical  
 jointing and S0 foliation dipping 20-30° towards the fjord are prominent. The geologist is standing next to a vertical open  
 665 fracture with a small normal offset (20-30 cm) apparent on the surface that could be a model for the development of the  
 backscarp of the rock avalanches. Photo by Simon Mose Thaarup, GEUS.

In addition, E-W orientated vertical penetrative open fractures with a normal offset are observed locally on the slope (Fig. 3).

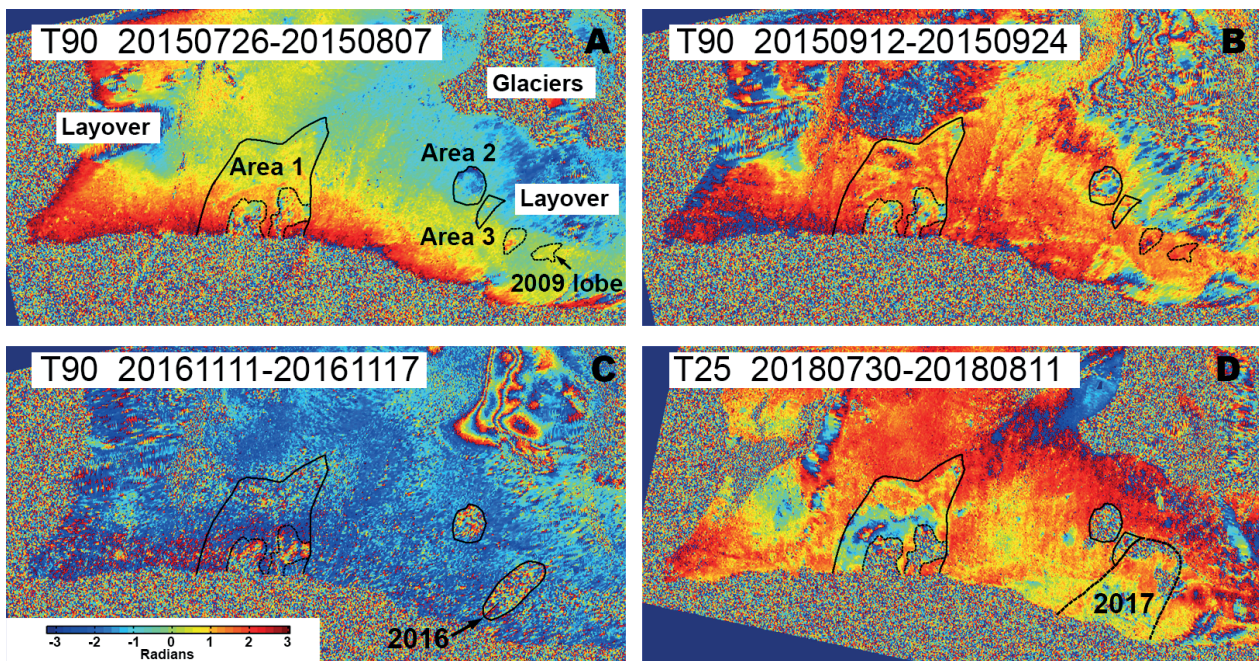
Fig. 5

305 represent the exact time of the first major displacement of the area. Deformation of the outer boundary of the area is clearly visible in all InSAR images from end of May 2015 with movement on the order of 1 mm/day (Fig. 5A). After September 2015 and up to the present day the entire area shows loss of coherence in InSAR which can be due to fast motion or change in surface properties, both of which suggest an acceleration in activity (Fig. 5B-D). This is in agreement with the very broken up fabric observed in the field (Fig. 7A), indicating both fast movement and change of surface  
310 properties. Assuming that the height of the back scarp represents the minimum average thickness of the unstable mass, we tentatively model the volume of Area 2 to be at least  $13 \times 10^6 \text{ m}^3$  (by multiplying the area of 260 000  $\text{m}^2$  by an average thickness 50 m). Paris et al. (2019) used volumes between  $2 \times 10^6$  and  $38 \times 10^6 \text{ m}^3$  for the area for tsunami modelling mentioning that the  $38 \times 10^6 \text{ m}^3$  is the more realistic estimate.

area 2 and 3 started to show signs of deformation in InSAR and optical imagery from May 2015 (Fig. 5A), followed by the Karrat 2016 rock avalanche, a seismic event with signature of a rock slope failure on 1 June 2017, and culminating with the major rock avalanche on 17 June 2017. A number of seismic events interpreted to activity in the Karrat Landslide Complex were recorded during 2018 and 2019, of which some correlated with rock slope deformation observed in all other considered datasets 2018 (e.g. Svennevig et al., 2019). These events show that the unstable slopes in the Karrat Landslide Complex continue to be active and may pose a continued threat of catastrophic failure.

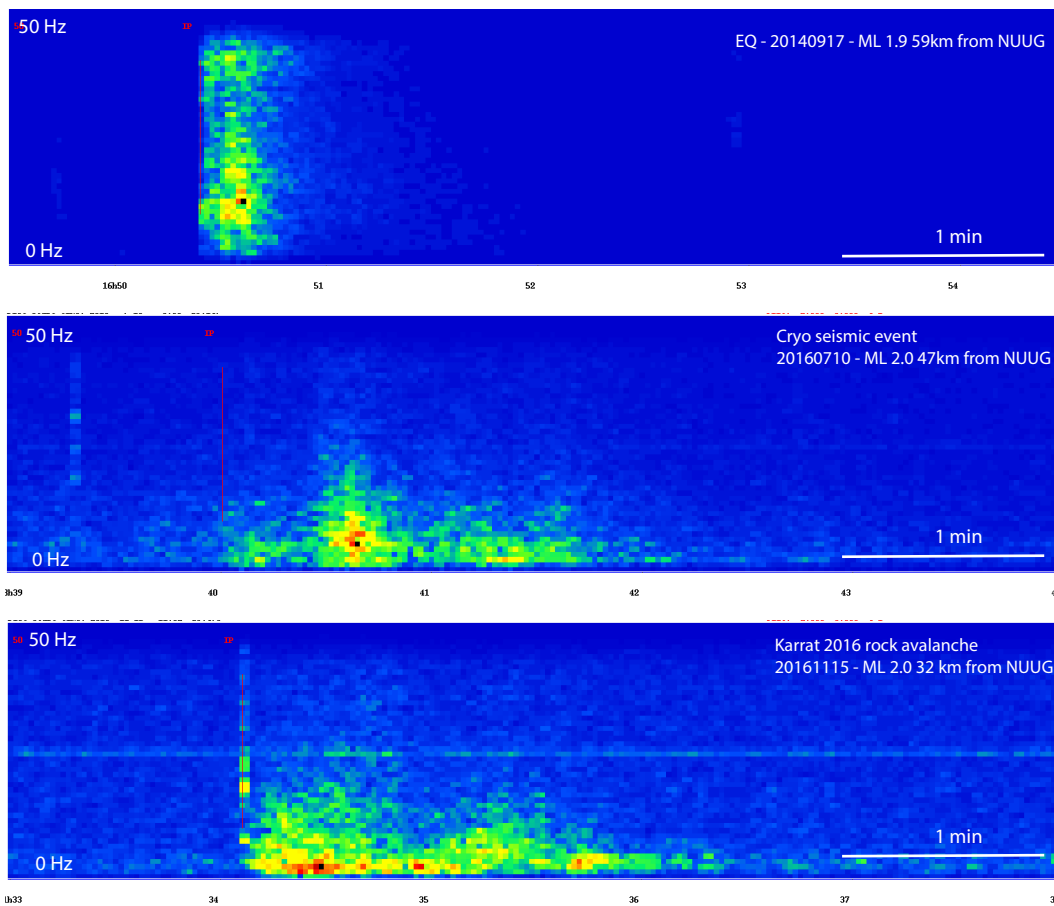
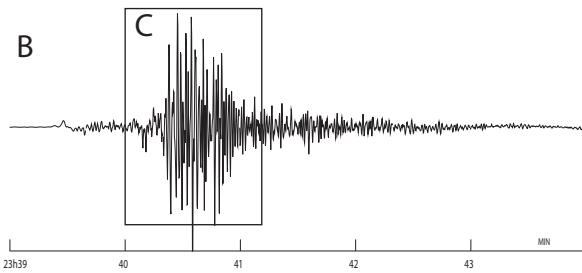
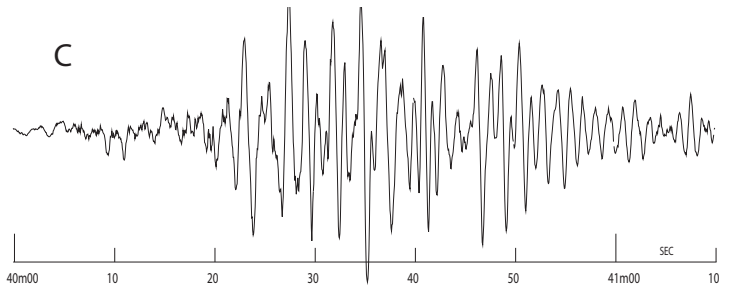
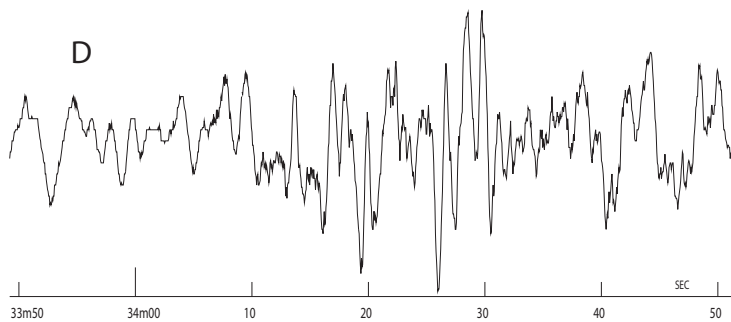
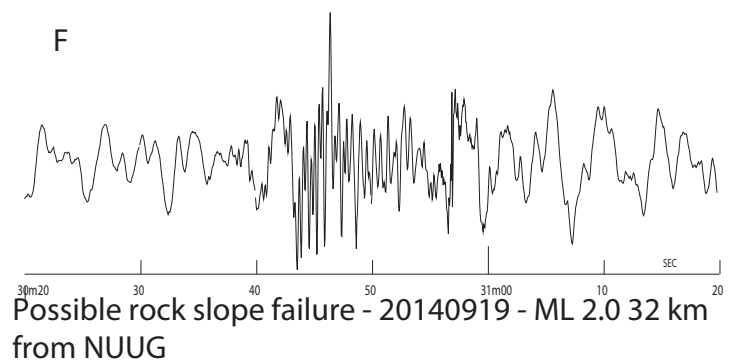
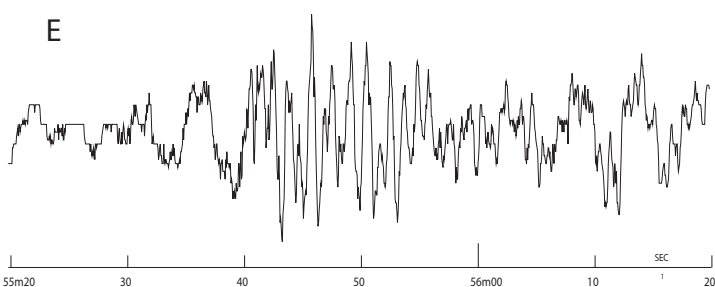
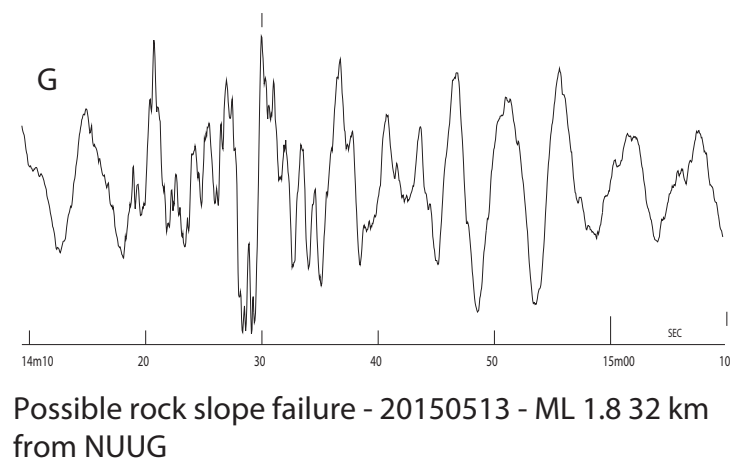
We have chosen to show the data in Figure 6 without filtering. Although we use different bandpass filters when analysing the data for location, the very different frequency content of the different events (tectonic, glacial and rock slope failures) are best seen with no filter, highlighting the differences.

The causes of non-tectonic events are several. For example, events with epicentre located near an outlet glacier (cryo-  
330 seismic events) often contain a low frequency component, and are usually much longer in duration than tectonic

earthquakes (Fig. 6), and are interpreted to be caused by calving of glaciers (Ekström et al., 2003; Nettles et al., 2008). Other non-tectonic events, in Western Greenland, are mainly caused by sea ice breakup, glacier or sea ice movements on bedrock, but other types are also present see e.g. Podolskiy and Walter (2016). Rapid rock slope failures also produce a seismic signal. The Karrat 2017 rock avalanche was seen globally as a Ms 4.2 event (U.S. Geological Survey, 2020), and the 2000 Paatuut rock avalanche was seen throughout Greenland (Dahl-Jensen et al., 2004). Smaller events associated with known rock slope failures (this paper) are only seen more locally (Fig. 6).

However, distinguishing a rock slope failure signal from other non-tectonic events, such as events associated with glaciers, is not straightforward. The seismic signature from two very large rock slope failure events, the 2000 Paatuut landslide (Dahl-Jensen et al., 2004) and the 2017 Karrat rock avalanche have long lasting tremor signals and a strong low frequency component. For smaller rock slope failures the tremor component will be smaller in duration and amplitude. Many aspects of smaller known rock slope failures are similar to cryo-seismic events (Fig. 6).

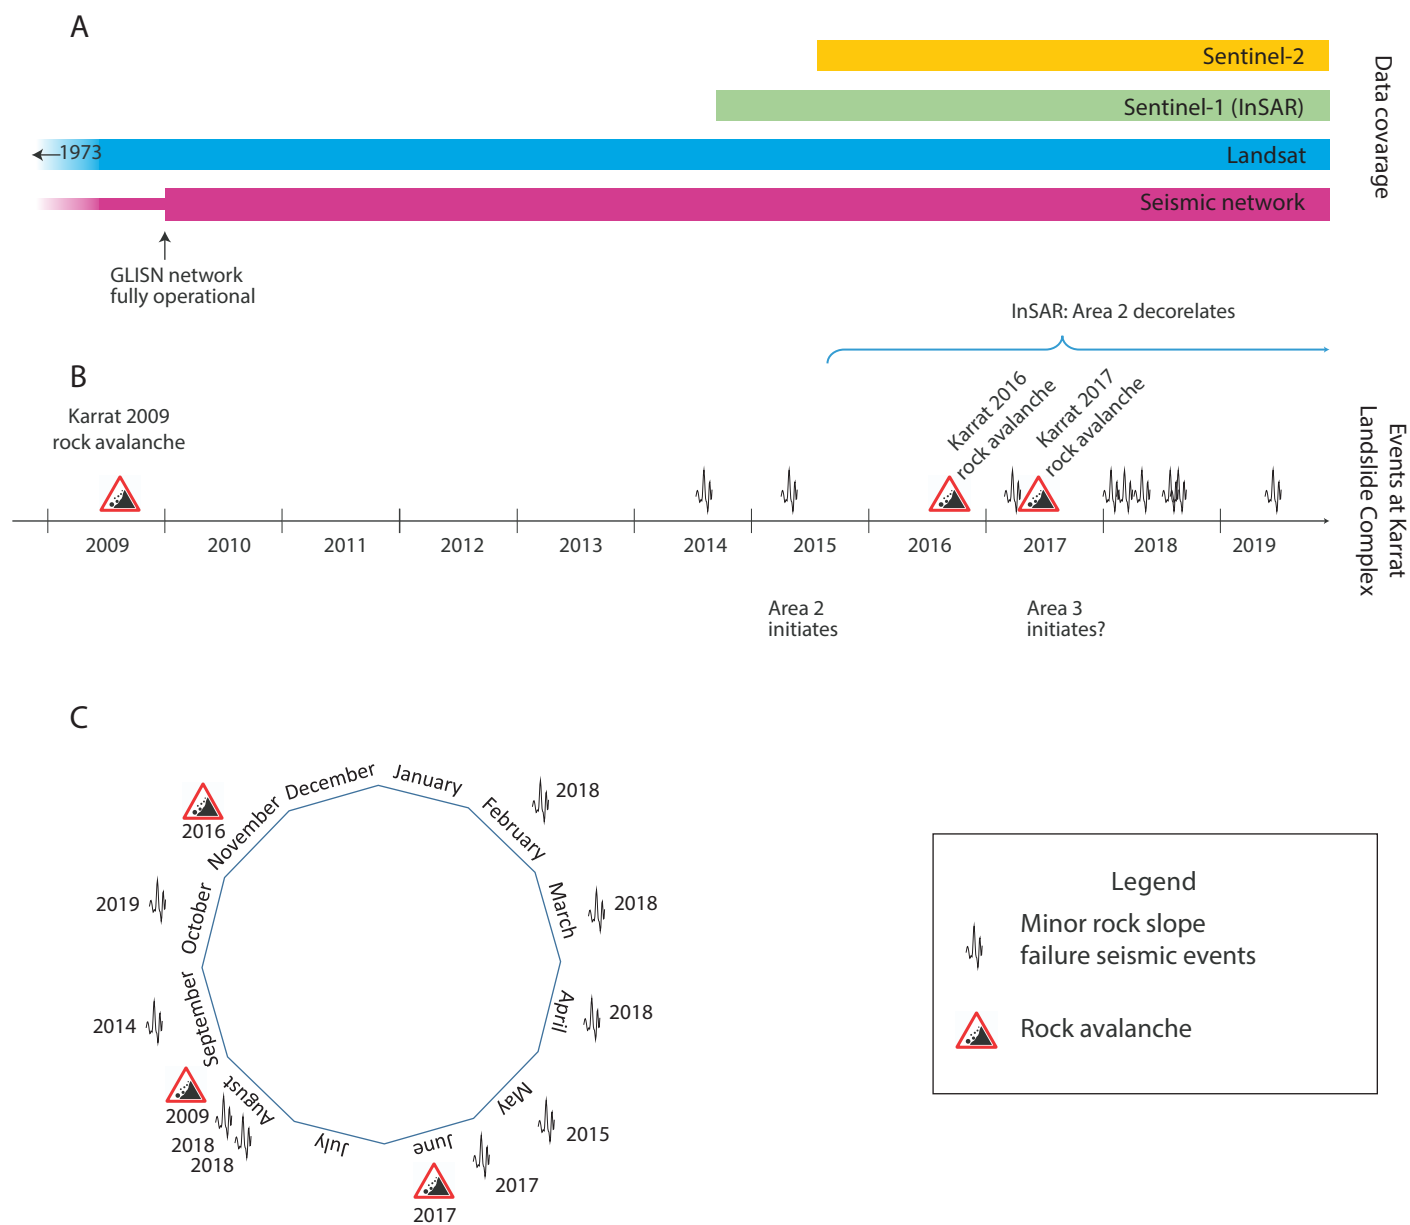
Fig. 8

705 **Figure 8**

A: Data coverage, B: timeline of recent events in the Karrat Landside Complex and C: yearly distribution of rock slope failures and seismic events.

As our compilation of results shows, the Karrat 2017 rock avalanche was not an isolated event, but part of an ongoing process of successive rock slope failures focused in the Karrat Landslide Complex, (Figs. 1, 8). The activity can be subdivided into one or more previous phases (prior to 2009, Fig. 3) and a recent phase initiating with the 2009 rock avalanche and so far culminating with the 2017 rock avalanche (Figs. 4, 5, 6).
