# Water level fluctuations drive bank instability in a hypertidal estuary

**Abstract.** Hypertidal estuaries are very dynamic environments characterised by high tidal ranges (>6 m) that can experience rapid rates of bank retreat. Whilst a large body of work on the processes, rates, patterns and factors driving bank erosion has been undertaken in fluvial environments, the process mechanics affecting the stability of the banks with respect to mass failure in hypertidal settings are not well documented. In this study, the processes and trends leading to bank failure and consequent retreat in hypertidal estuaries are treated within the context of the Severn Estuary (UK) by employing a combination of numerical models and field-based observations. Our results highlight that the periodic fluctuations in water level associated with the hypertidal environment drive regular fluctuations in the hydrostatic pressure exerted on the incipient failure surfaces that range from a confinement pressure of 0 kPa (at low tide) to ~100 kPa (at high tide). However, the relatively low transmissivity of the fine-grained banks (that are typical of estuarine environments) results in low seepage inflow/outfl

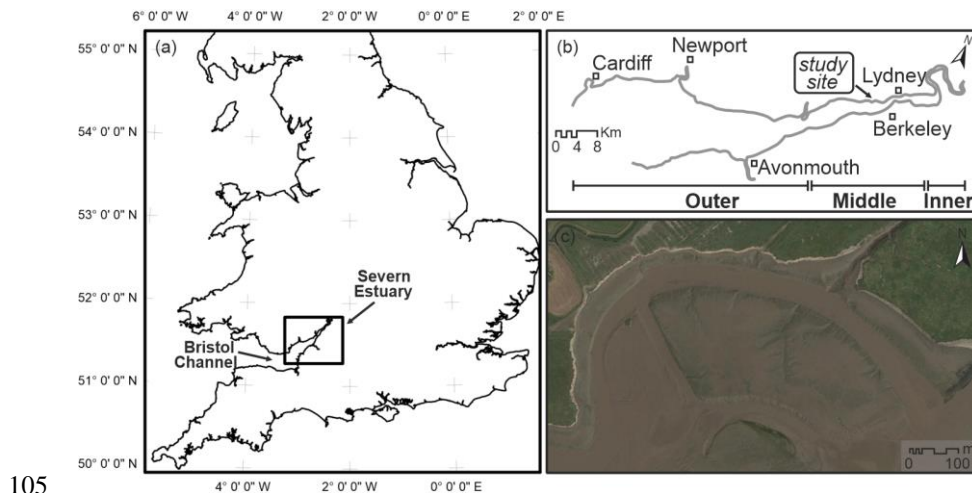
**Figure 1: Location: (a) The Severn Estuary in south-west Britain (map © Ordnance Survey 2021). (b) Subdivision of the estuary into inner, middle, and outer sectors based on geomorphological features. (c) Google Earth image of the study site in the middle estuary (image © Google Earth July 2021).**

The focus of this research is centred on a site located in the middle estuary south of Lydney in the Plusterwine area (UK National Grid reference: ST 612995) (Fig. 1b and c) where erosive trends have been well-documented in recent decades (Allen, 2001). To elucidate the detailed mechanics governing these observed mass wasting events, a combination of high-resolution monitoring and numerical modelling was implemented. A summary of the techniques used for the quantification of the parameters used in the bank stability modelling, the monitoring periods, and the identification and validation of the bank failure mechanics contributing to the observed bank retreat are reported in Table 1.

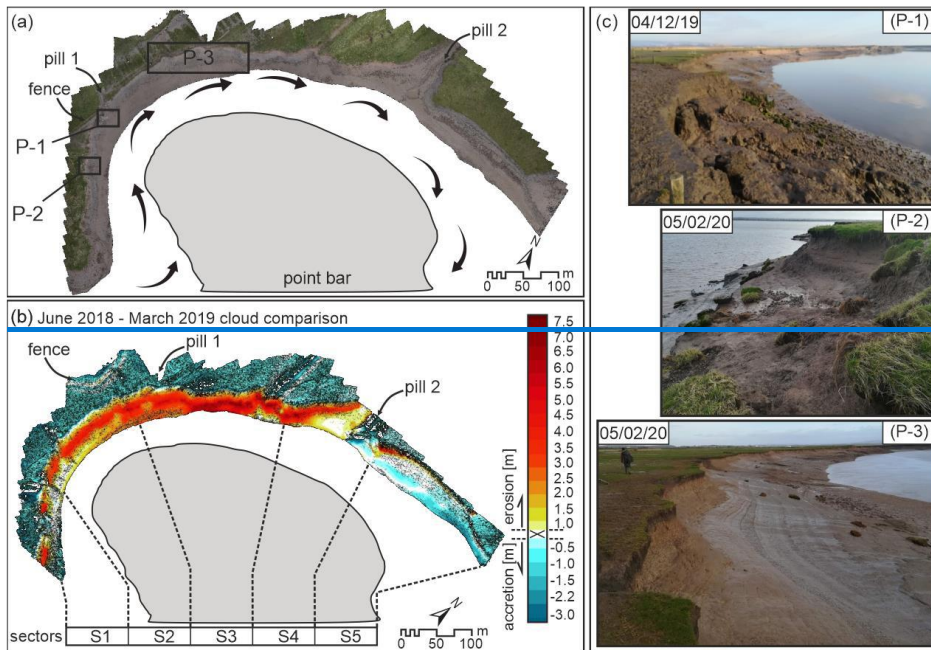
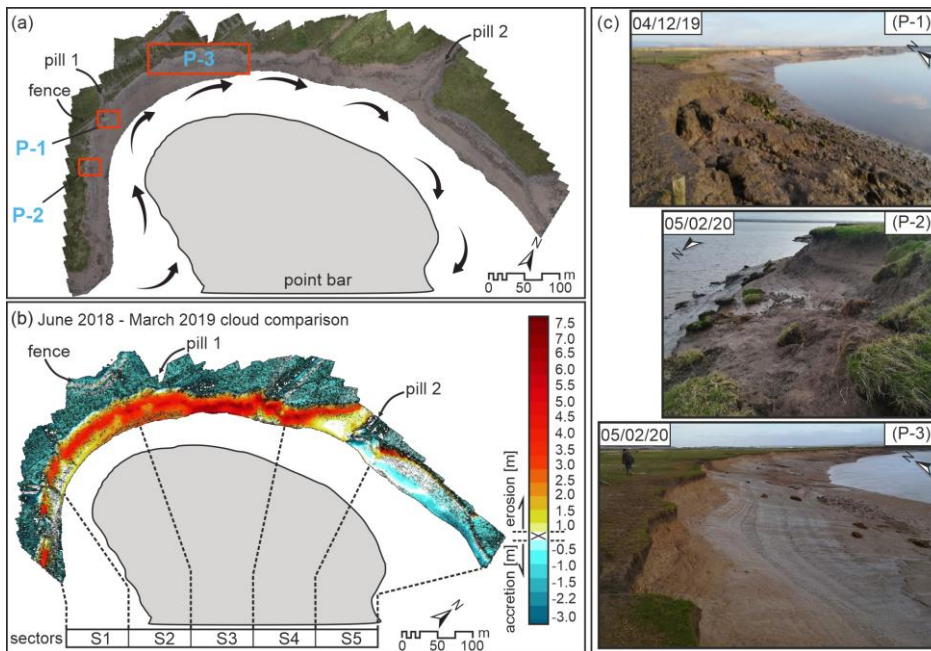
**Figure 2. Embayment details (a) Studied embayment (mosaic of images), with inferred flood tidal flow represented by the black arrows; (b) point cloud difference between the June 2018 and March 2019 surveys and site subdivision into sectors, and (c) photographs of three representative areas of the study site shown in the black boxes on (a).**

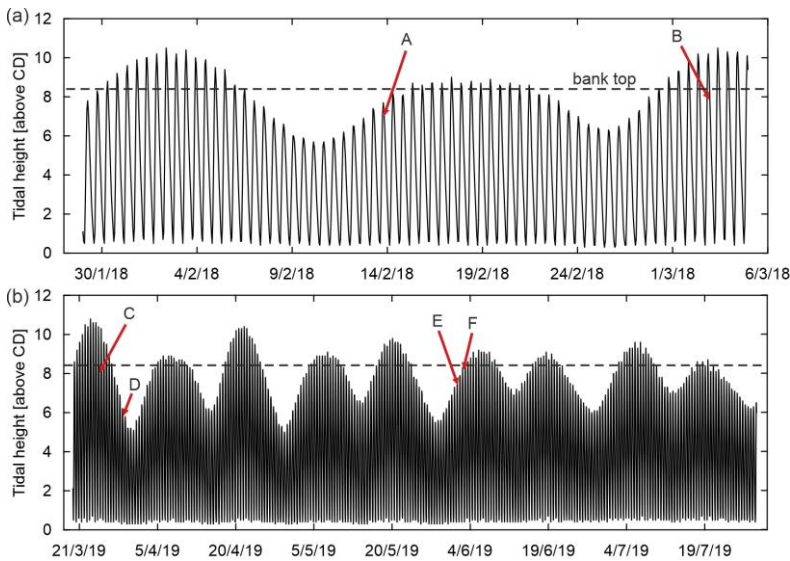
Figure 3. Tidal cycle for the two fixed camera survey periods: (a) 30/01/2018-05/03/2018; (b) 19/03/2019-28/07/2019 (data from UK Admiralty Total Tide software). Red arrows indicate the most substantial bank collapse events (A to F) identified during the monitoring periods (see Figure 4).

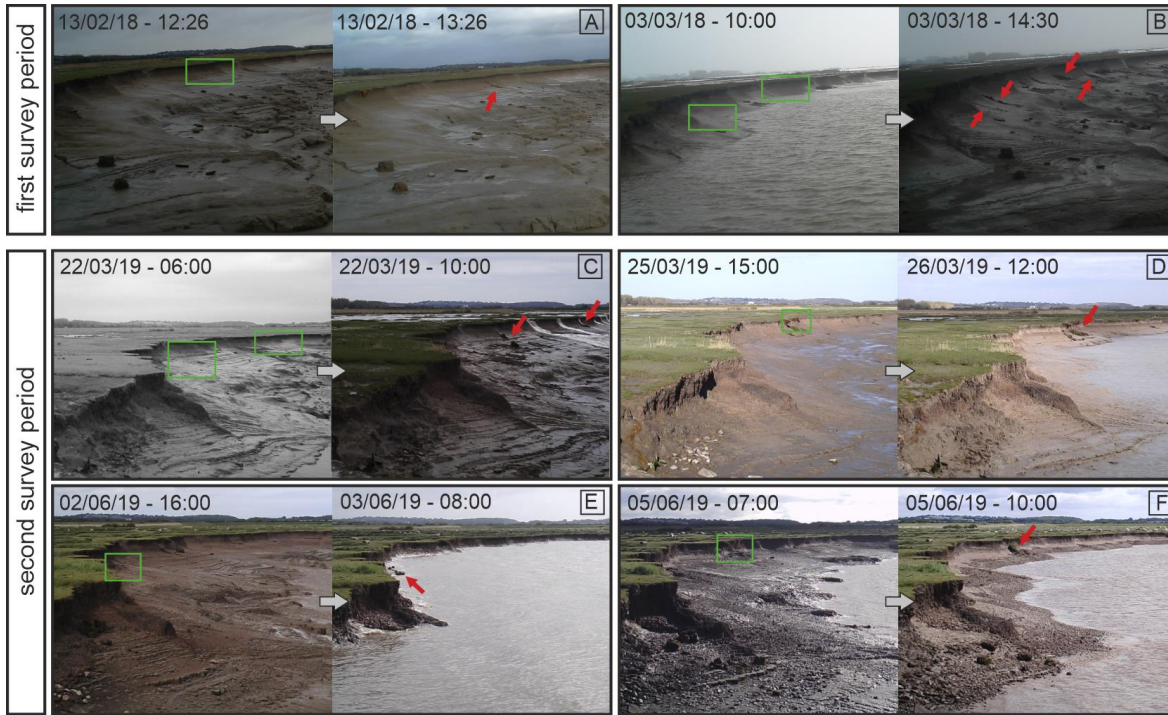
Figure 4. Time sequences of notable mass failure events identified at the study site during the two periods of deployment of the fixed camera. Red arrows in the photographs indicate the collapse events; green boxes highlight the site of the bank where successive collapses occur. Photographs connected by white arrows are successive (very close) in time. The failure events are also highlighted in the tidal range charts in Figure 3.

The photographs were also used to validate the variations in tidal water stages obtained from the Admiralty Total Tide tables and their association with both timing and nature of discrete mass wasting events. A clear identification of all the mass wasting events that occurred during the monitoring period was not possible because minor failures (smaller than  $\sim 40 \text{ cm}^2$ ) could not be identified on the images. Also, large collapses located farther than 20-30 m from the location of the camera were not identifiable. In total 25 major failure events were identified and some of the most substantial are shown in Figure 4.

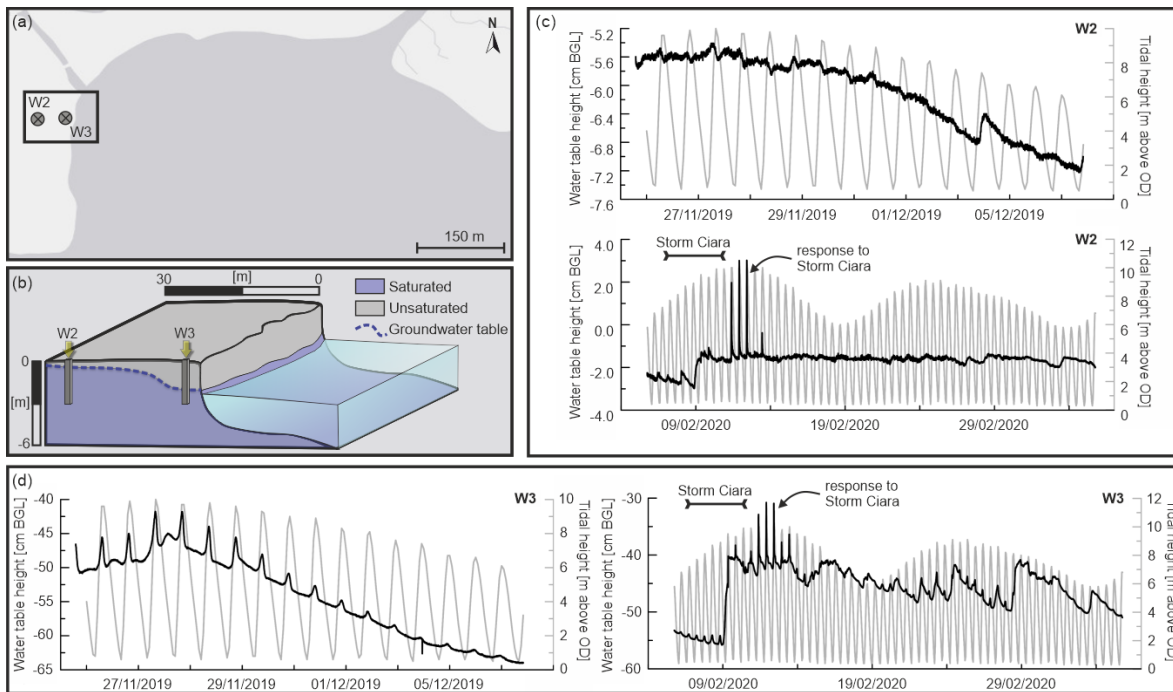
**Figure 5. Groundwater monitoring:** (a) Location of the groundwater monitoring system (image © Esri World Light Gray Base July 2021). (b) Material layering and position of wells on the bank (bank top level = 8.4m above datum). (c) Groundwater table fluctuations for the first and second monitoring periods for the bank distal monitoring well W2. (d) and the bank proximal monitoring well W3. High peaks in the water table level present in the February/March 2020 plots are linked to storm Ciara which effected western UK in early February 2020. The two monitoring wells (W2 and W3) were used in the modelling. (Storm data retrieved from <https://www.metoffice.gov.uk/weather/warnings-and-advice/uk-stormcentre/uk-storm-season-2019-20>).

The impact that tidal variations have on groundwater fluctuations and thus pore-water pressures within the bank materials was assessed by implementing a monitoring system in the central-western part of the study site (Fig. 5) where two monitoring wells (60 mm of internal diameter) were drilled to a depth of 3 m using a percussion auger. Within each well, PVC pipes with a diameter of 40 mm were inserted and the cavity between the external part of the pipe and the wall of the borehole was filled with fine pebbles to filter the water and prevent the ingress of fine-grained sediment into the well. Water table fluctuations within each well were monitored every 2 minutes using logging pressure transducers (LevelSCOUT probes; absolute depth range: 25 m, pressure in-depth accuracy:  $\pm 0.05\%$  FoS (at  $20^\circ$ )) during two separate periods (25 November-4 December 2019; and 5 February-3 March 2020) (Fig. 5).

The ground water fluctuations recorded during the monitoring periods (Fig. 5) confirm that the sediments of the studied bank have a relatively low level of transmissivity such that the groundwater response to the tidal oscillations is damped relative to the variations in hydrostatic confining pressure driven by the tidal level fluctuations. While the distal monitoring well (i.e. W2) is much less affected by variations in the tidal water level attaining an average water table elevation (below local ground-level) of c. 6 cm, the bank-proximal monitoring well (i.e. W3) shows a higher responsiveness to tidal oscillations (average water depth 50 cm). The system is therefore affected by tidal variations predominantly in the bank face fringing zone (within a distance of 3-5 m from the bank face).

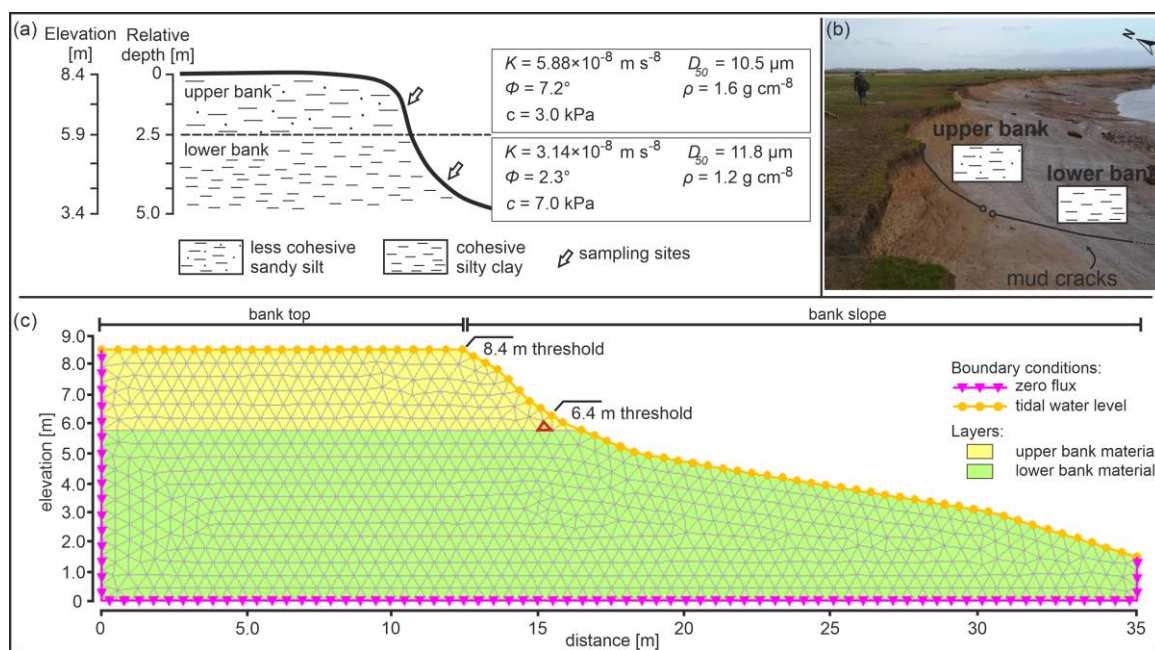
290 **Figure 6. (a) Representation of the investigated bank at the study site illustrating the most important geotechnical characteristics of the two sedimentary layers ( $K$  = conductivity,  $\Phi$  = angle of internal friction,  $c$  = cohesion,  $D_{50}$  = geotechnical grain size distribution, and  $\rho$  = dry bulk density). (b) Photograph of the central part of the study site showing the progressive change in grain size. (c) Representation of the mesh characteristics used in the bank stability model. The cell used to represent the temporal variations of the pore water pressure (see Figure 9 and 10) is highlighted in red. The different boundary conditions employed in the simulations**

are indicated. Note that the boundary condition indicated in yellow indicates the surface at which the tidal level interacts with the bank (with the entire bank slope in this specific example of high tide).

295 The model was driven with time-varying boundary conditions along the fringes of the finite element grid. For the gently degrading bank slope and the vertical face of the bank, a total head versus time function was used to represent the tidally driven oscillations in water level. Given the repetitive nature of the overbank inundation of the study site, the same total head versus time boundary conditions were also applied to the nodes along the bank-top profile. A null-flux condition was applied along the remaining vertical and horizontal boundaries.

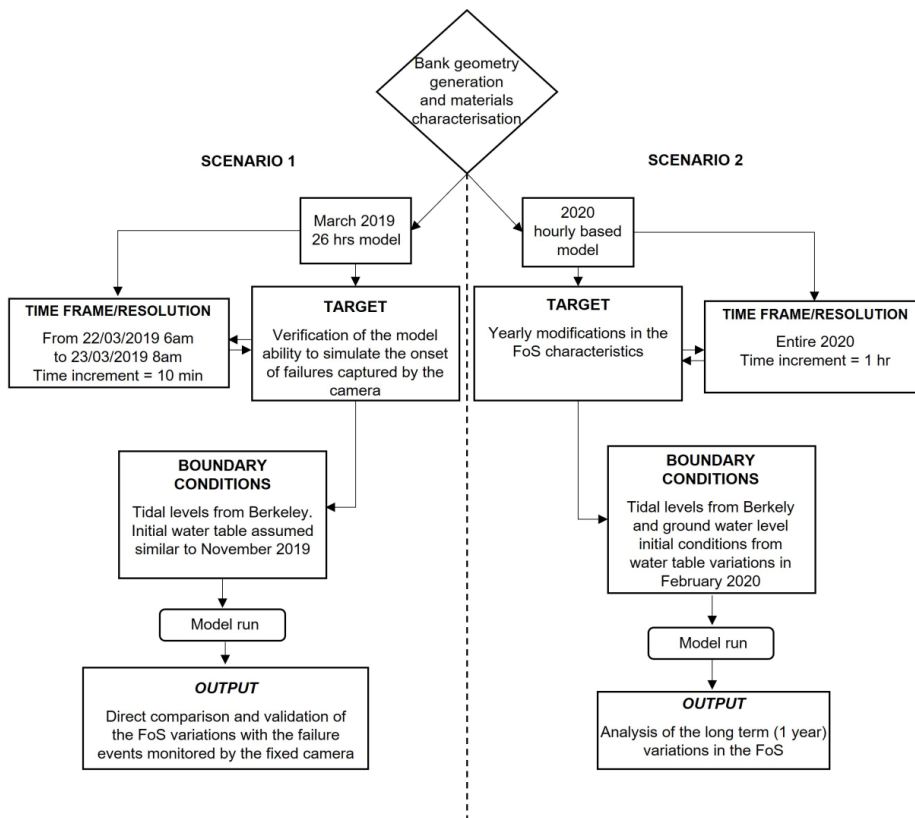
**Figure 7. Summary of the two modelling scenarios.**

Two separate simulation scenarios were defined (Fig. 7). The first scenario employs a 10-minute time increment for a shorter duration simulation (22 March 2019 06:00 – 23 March 2019 08:00), and a second scenario simulates the entire calendar year of 2020 at a 1 hour time-step. The first scenario was selected to ensure an overlap with the field monitoring observations and focused on seeking to understand the factors (these factors include gullyng, basal removal, and tidally-driven fluctuations in  
315 pore-water and hydrostatic confinement pressures, as summarised on Fig. 8) triggering the observed mass wasting events in this specific period and as a form of model validation. The initial groundwater table conditions were defined using the water table level from the bank-edge proximal monitoring well W3 data from November 2019, when conditions were not dissimilar to those in March 2019. The second simulation scenario was used to study the factors influencing seasonal variations in bank stability (as indicated by the Factor of Safety, here after FoS). This second simulation scenario was initialised based on water

320 table conditions observed in the monitoring well W3 in February 2020 and was forced using the time-varying tidal water levels as observed at Berkeley.

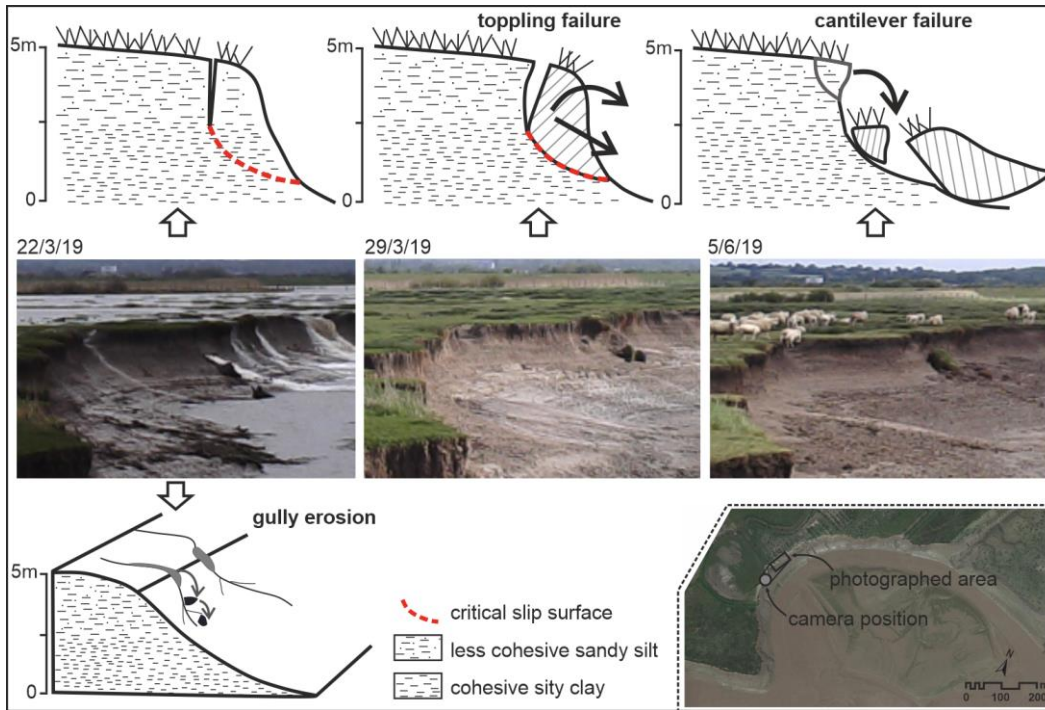
**Figure 8. The typical collapse mechanisms observed at the study site (note that the photographs indicated refer to those presented in Figure 4). Image © Google Earth July 2021.**

Through the deployment of a fixed camera in the central part of the study site, 25 failure episodes in the bank zone close to (distance  $<30 \text{ m}$ ) the camera location were identified, enabling analysis of the type of mechanisms involved (Fig. 3 and 4). It is evident that the identified bank failures all take place during the receding phase of the tidal cycle. Specifically, seven collapses occurred on the receding stage just after the high water peak, while the other 18 occurred later, closer to the low water stages. The largest collapses are all linked to very high tidal stages overtopping the bankline (i.e. tidal peaks  $>8.4 \text{ m}$ ). During the tidal ebb phase following these high tides, the bank is susceptible to the combined effects of two forces that promote failure: (i) the combined force of internal pore water pressure of the saturated bank materials and the lack of a holding pressure, and (ii) the presence of a hydraulic flow that is activated during the initial stages of the tidal recession phase when the tidal waters drop below the bank edge, triggering gullying along the floodplain margin. These intense drainage flows are clearly visible on some of the images (Fig. 4 photograph C) and they not only prepare the face for successive large block failures, but they also directly affect the detachment and transport of bank materials toward the bank toe (Fig. 8). Gullies, such as those observed here, have been mentioned before in earlier studies of the Severn Estuary (Crowther et al., 2008) but they were never directly recorded and linked to other erosive mechanisms in the bank destabilisation process. The photographs reveal that such gullies overlap with other failure mechanisms such as toppling and cantilever bank failures (Fig. 8); toppling occurs in the

earlier stages of the collapse process when the top-portion of the bankline slides along the critical slip surface during the tidal ebb phase; in a second phase of the collapse, the bankline is characterised by a reshape of its face whereby the uppermost part of the bank slope forms a cantilever. This specific style of failure likely reflects the specific stratigraphy of the studied area where two layers of fine material are stacked. The nature of the layers, and specifically the positioning of the incipient failure plane at the interface between the layers, suggests that these stratigraphic discontinuities can play a key role in the failure modalities.

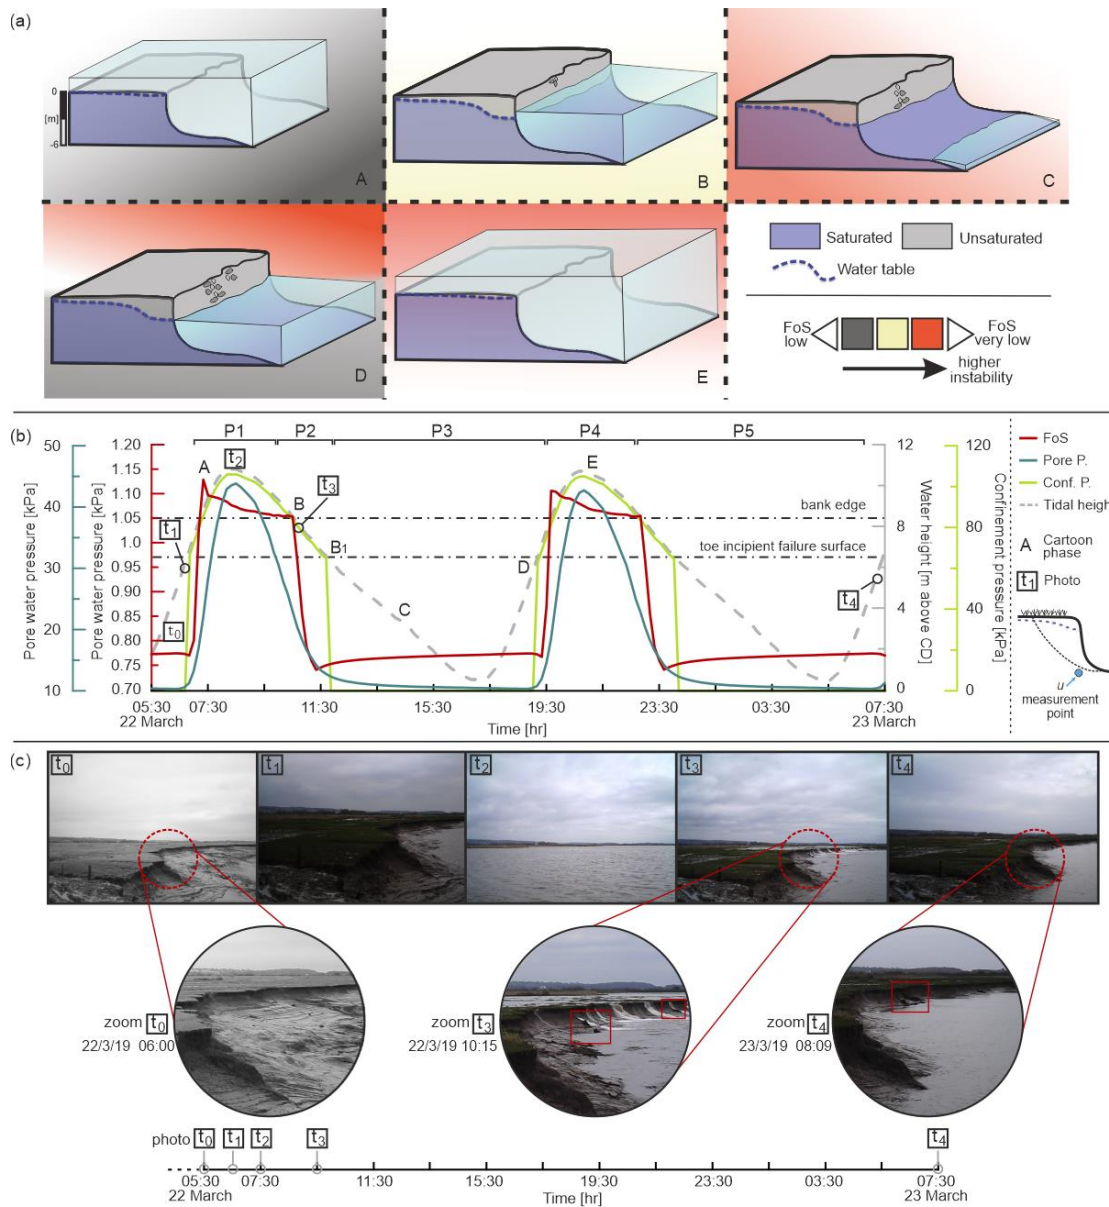
450 **Figure 9. Simulated and observed (from fixed camera images) bank stability conditions at the Plusterwine study area during a 26 hrs time lapse (22-23 March 2019).** (a) Cartoon of the studied bank and related conditions; (b) physical conditions of the bank. The letters refer to stages of evolution indicated on panel (a) and markers to photographs in panel (c).

The Scenario 1 simulation results (Fig. 9) represent a very high-resolution model (10 minutes time increment) that provides a detailed visualisation of the bank failure processes observed in March 2019 during a 1-day monitoring window. In contrast, Scenario 2 focuses predominantly on the semidiurnal nature of the tidal cycle in the mid Severn Estuary, studying variations in stability over a much longer timeframe (the calendar year 2020), which allows for the effects of variations associated with the differences between spring and neap tidal cycles to be taken into consideration. These results were compared with and combined with real-world observations (from the fixed camera photographs) leading to a detailed analysis of the failure mechanics. The evolution of the bank was subdivided into phases (denoted P1, P2, P3, etc), and some additional specific time points corresponding to specific exemplar photographs were marked. Figure 9 (panel a) sketches the tidal cycle represented in the model; the different boxes exhibit different colours highlighting the relative Factor of Safety (FoS) of the bank. In the last panel of Figure 9, some images linked to specific moments in the simulation have been further analysed with three supplementary zooms related to the pre-failure ( $t_0$ ), failure ( $t_3$ ), and a secondary failure phase (additional minor collapses) ( $t_4$ ).

In the first part of phase P1 (Figure 9b point A, corresponding to photograph  $t_2$  on the last panel), the tide is at peak level and the entire tidal flat is inundated (22 March 2019, 07:30-08:00). The groundwater table is therefore almost at ground level. Under these conditions, even though the elevated positive pore pressure (~43 kPa at 08:10) promotes bank instability, the simulation results indicate a rising FoS (i.e. increasing stability) (from a value of 0.77 at  $t_0$  to a value of 1.14 at 07:20) due to the high hydrostatic confining pressure (~100 kPa). After the peak in the tidal level is surpassed (mid-phase P1 at 08:40), the pore water pressure also begins to decline. Thus, even as the hydrostatic confining pressure is reducing with the retreat of the tidal waters (106 kPa at the peak at 08:30, 100 kPa at 08:50), the soil saturation remains high (~40 kPa at 08:50) favouring the decrease in the FoS (FoS = 1.07). Toward the end of phase P1 (c. 09:40), the retreat of the tidal waters generates a considerable and fast reduction in the hydrostatic confining pressure (from ~100 kPa to ~88 kPa at the end of P1). This rapidity, together with the elevated pore water pressure associated with the earlier rising tide that led to a saturation of the bank deposits (the peak in the saturation corresponds to the peak in tidal level), creates a condition in which the bank begins to experience a decline in the FoS (albeit the bank is not yet unstable).

23:40 to zero at 23:50 when the pore pressure is still  $\sim 8 \text{ kPa}$  and the FoS is 0.75). Note that phases 4 and 5 both occurred  
during hours of darkness and the fixed camera was therefore unable to yield images that could constrain precisely the observed  
435 timing of the predicted failure. Nevertheless, it is noteworthy that a new mass wasting event was apparent in the first image  
captured in daylight after the simulated collapse (photograph  $t_4$ , taken at 08:09 on 23 March 2019, Fig. 9d).

It should be noted that the model simulations are forced using water-level data from Berkeley, which is located  $\sim 5 \text{ km}$  up-  
estuary from the study site. This locational discrepancy means that: (i) the actual tidal wave would be experienced  $\sim 30$  minutes  
earlier at the Plusterwine field site than in the model and (ii) there will be a slight mismatch (underestimate) in the tidal levels  
440 used to force the model versus those actually experienced at the study site. It may, therefore, be expected that the model  
simulated FoS is both slightly underestimated (i.e. simulated FoS values are lower than in reality) and out of phase (the  
simulated FoS would precede the actual FoS trend by  $\sim 30$  minutes) with the true factor of safety. Nevertheless, it is instructive  
to note that the observed bank failure occurs in the four-hour window between images  $t_2$  and  $t_3$  on Figure 9 (panel b) during

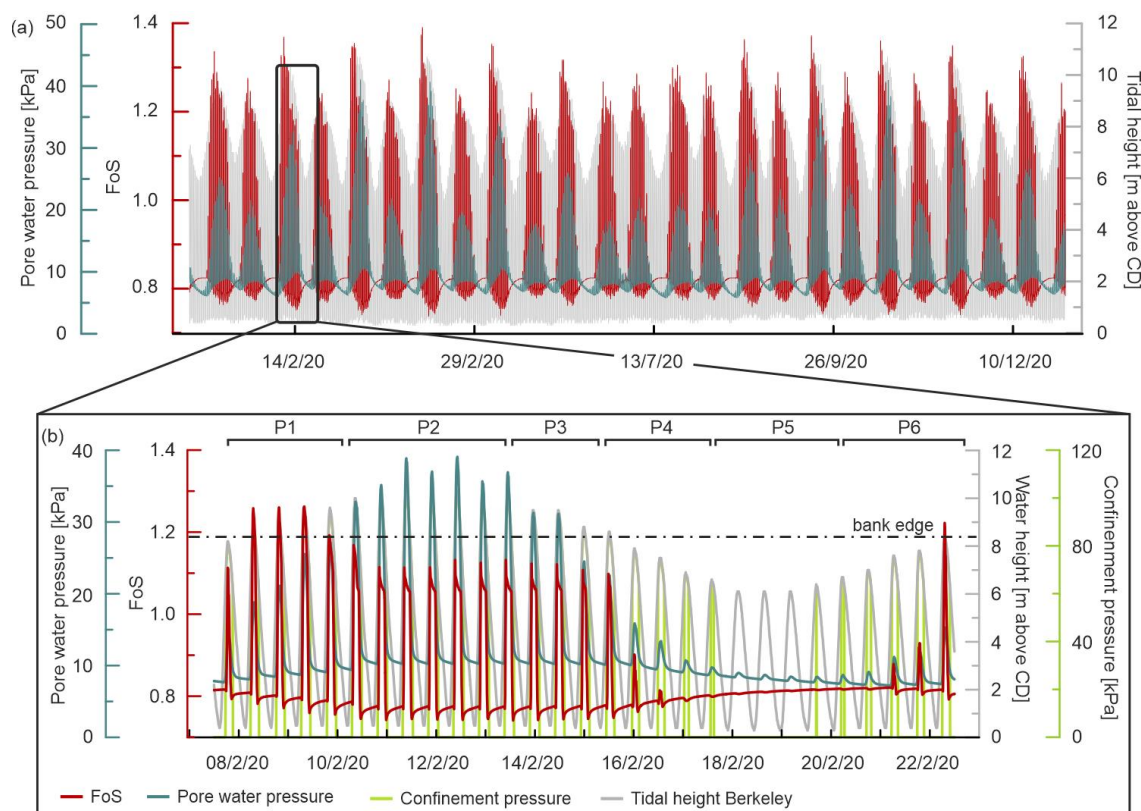
**Figure 10. (a) Computed bank stability analysis for the year 2020 (b) Zoom into the period covered by the groundwater table monitoring in February 2020. This second plot is subdivided into different Phases (P1, P2, P3, etc) and pore water pressures are plotted for a representative cell the location of which is highlighted on Figure 6.**

While the results of the first scenario focused predominantly on the semidiurnal nature of the tidal cycle in the mid Severn Estuary, the results of the second scenario (Fig. 10) focus on fluctuations in stability over a longer timeframe, which allows

for the effects of variations associated with the differences between spring and neap tidal cycles to be taken into consideration. This simulation (Fig. 10) represents the whole of the year 2020 at a temporal resolution of 1 hour, but with a detailed focus on the period of February-March 2020, as this is the time interval that matches the groundwater table monitoring window. Through this entire 1-year modelled timeframe, it is possible to appreciate how the FoS oscillates above and below stable conditions (FoS>1, FoS<1, respectively). Even though the fine-grained, cohesive, nature of the alluvial deposits should promote a high degree of stability, the simulated bank is clearly close to the critical condition. This marginal stability status appears broadly consistent with the observations made with the field surveys that highlight the erosive activity in the study area.

To better describe the long-term effects of the destabilising forces and their mutual interactions with the stabilising forces, the dynamics occurring over a period of 16 days (07 February 2020 12:00 – 22 February 2020 12:00) is represented (Fig. 10b) and discussed. In this longer duration analysis, Phase P1 covers a time period in which the tidal conditions are moving from neap to spring tide, therefore from a state where the bank top is not subject to daily inundations (the high waters only lap the bank edge) toward a state where the bank is regularly flooded (peak tides higher than 8.4 m). In P1, the FoS fluctuates in response to the variations in the hydrostatic confining pressure (driven by the tidal water body in the channel) but with a

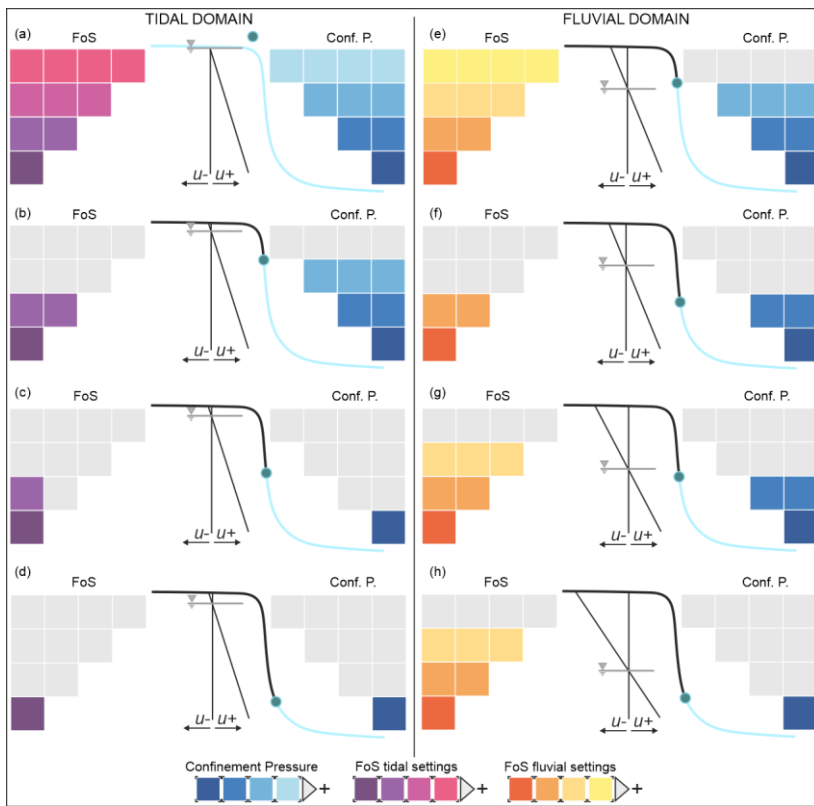
**Figure 11. Conceptual model of the factors controlling the onset of bank instability in fine grained tide-dominated hypertidal settings (such as the Severn estuary) versus fluvial-dominated environments.**

560 destabilising effect remains high, but the stabilising confining pressure is markedly reduced (Fig. 11c). At this point, and specifically when the water level falls below the incipient failure surface threshold elevation of 6.4 m at which the confining pressure falls to zero (for the specific case of the study site), the imbalance between the destabilising pore water pressure and stabilising confining pressure is maximised and the  $FoS$  therefore drops swiftly (Fig. 11d). As demonstrated in this study, the drawdown phase after an overbank flow condition is also often followed by intense drainage from the floodplain. Such drainage
