# Water level fluctuations drive bank instability in a hypertidal estuary

Andrea Gasparotto<sup>1,2</sup>, Stephen E. Darby<sup>2</sup>, Julian Leyland<sup>2</sup>, Paul A. Carling<sup>2</sup>

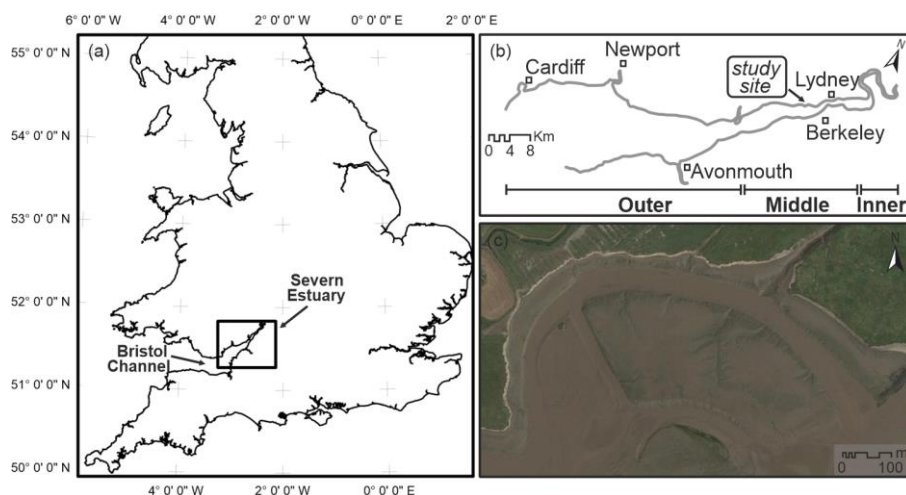
**Figure 1: Location: (a) The Severn Estuary in south-west Britain (map © Ordnance Survey 2021). (b) Subdivision of the estuary into inner, middle, and outer sectors based on geomorphological features. (c) Google Earth image of the study site in the middle estuary (image © Google Earth July 2021).**

The focus of this research is centred on a site located in the middle estuary south of Lydney in the Plusterwine area (UK National Grid reference: ST 612995) (Fig. 1b and c) where erosive trends have been well-documented in recent decades (Allen,

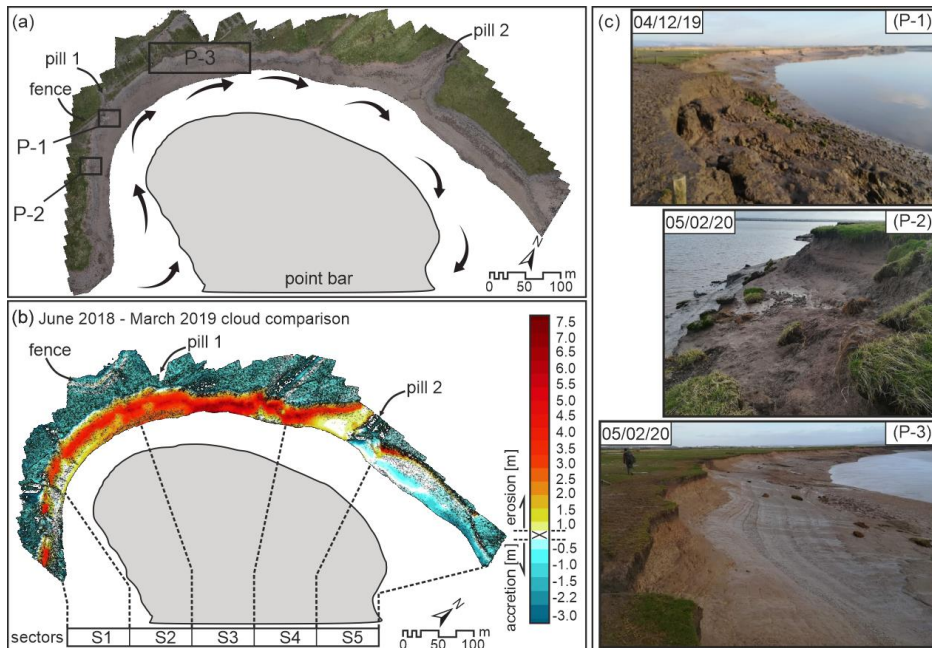
140 **Figure 2. Embayment details (a) Studied embayment (mosaic of images), with inferred flood tidal flow represented by the black arrows; (b) point cloud difference between the June 2018 and March 2019 surveys and site subdivision into sectors, and (c) photographs of three representative areas of the study site shown in the black boxes on (a).**

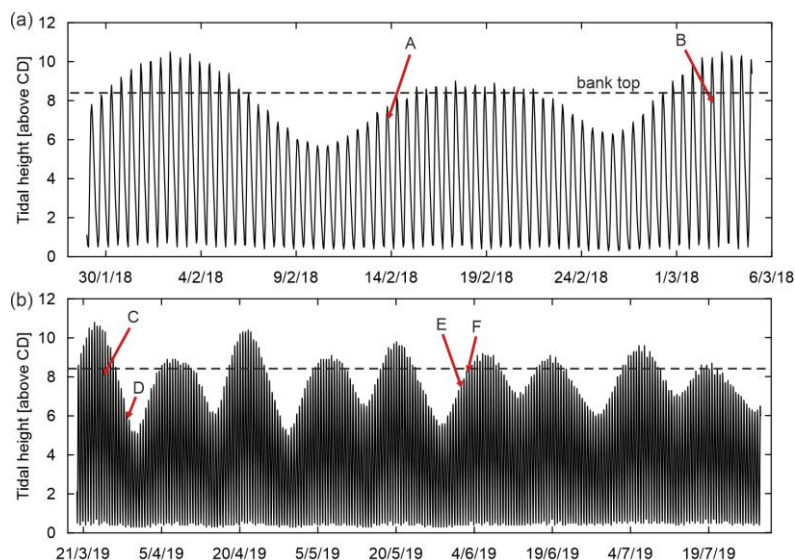
165 **Figure 3. Tidal cycle for the two fixed camera survey periods: (a) 30/01/2018-05/03/2018; (b) 19/03/2019-28/07/2019 (data from UK Admiralty Total Tide software). Red arrows indicate the most substantial bank collapse events (A to F) identified during the monitoring periods (see Figure 4).**

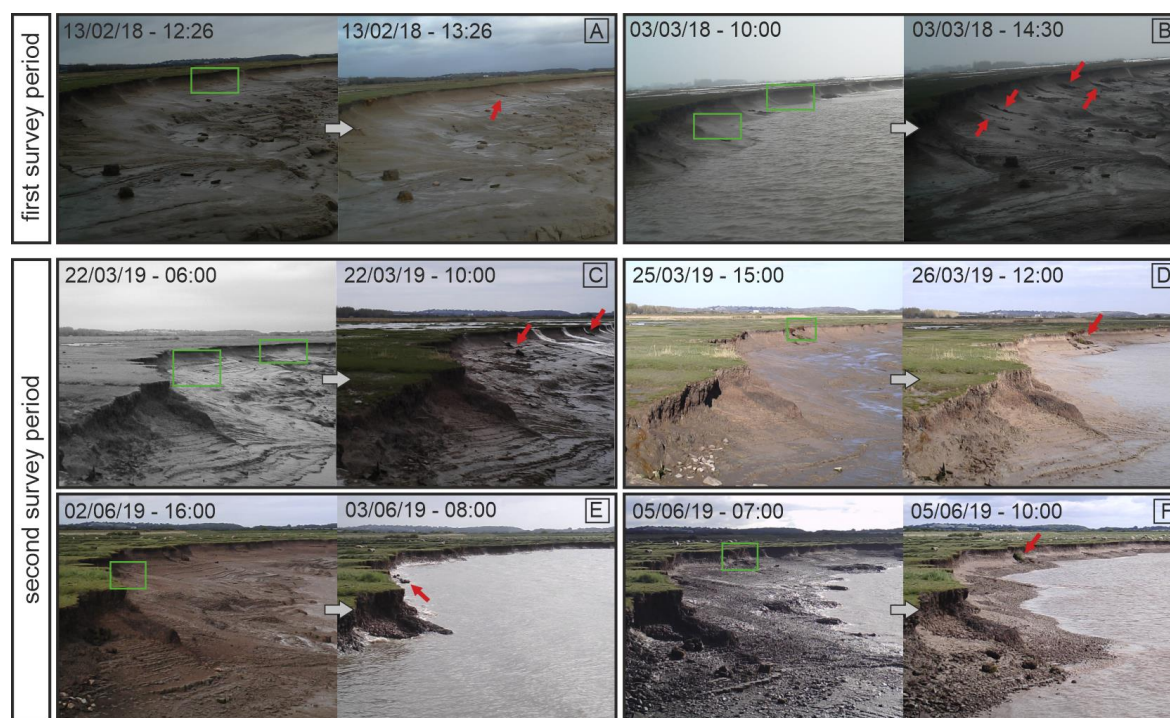
175 **Figure 4.** Time sequences of notable mass failure events identified at the study site during the two periods of deployment of the fixed camera. Red arrows in the photographs indicate the collapse events; green boxes highlight the site of the bank where successive collapses occur. Photographs connected by white arrows are successive (very close) in time. The failure events are also highlighted in the tidal range charts in Figure 3.

310 waters drop below the bank edge, triggering gully erosion along the floodplain margin. These intense drainage flows are clearly  
visible on some of the images (Fig. 4 photograph C) and they not only prepare the face for successive large block failures, but  
they also directly affect the detachment and transport of bank materials toward the bank toe (Fig. 8). Gullies, such as those  
315 observed here, have been mentioned before in earlier studies of the Severn Estuary (Crowther et al., 2008) but they were never  
directly recorded and linked to other erosive mechanisms in the bank destabilisation process. The photographs reveal that such  
gullies overlap with other failure mechanisms such as toppling and cantilever bank failures (Fig. 8); toppling occurs in the  
earlier stages of the collapse process when the top-portion of the bankline slides along the critical slip surface during the tidal

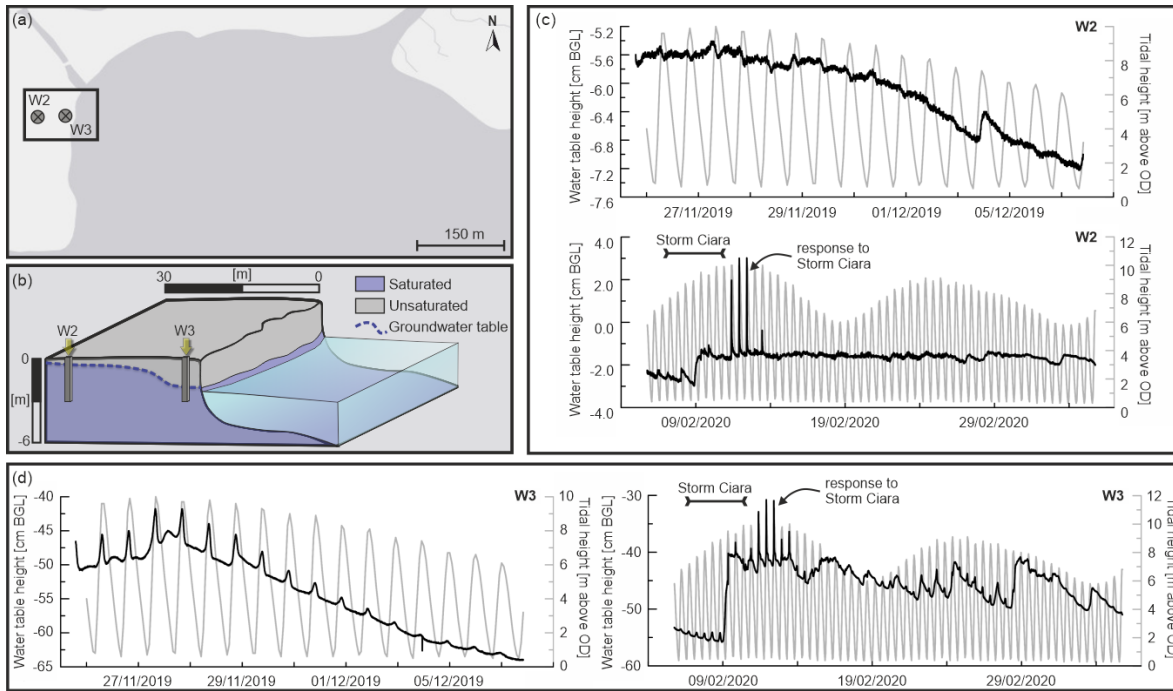
**Figure 5. Groundwater monitoring:** (a) Location of the groundwater monitoring system (image © Esri World Light Gray Base July 2021). (b) Material layering and position of wells on the bank (bank top level = 8.4m above datum). (c) Groundwater table fluctuations for the first and second monitoring periods for the bank distal monitoring well W2. (d) and the bank proximal monitoring well W3. High peaks in the water table level present in the February/March 2020 plots are linked to storm Ciara which effected western UK in early February 2020. The two monitoring wells (W2 and W3) were used in the modelling.

180 The impact that tidal variations have on groundwater fluctuations and thus pore-water pressures within the bank materials was assessed by implementing a monitoring system in the central-western part of the study site (Fig. 5) where two monitoring wells (60 mm of internal diameter) were drilled to a depth of 3 m using a percussion auger. Within each well, PVC pipes with a diameter of 40 mm were inserted and the cavity between the external part of the pipe and the wall of the borehole was filled with fine pebbles to filter the water and prevent the ingress of fine-grained sediment into the well. Water table fluctuations within each well were monitored every 2 minutes using logging pressure transducers (LevelSCOUT probes; absolute depth range: 25 m, pressure in-depth accuracy:  $\pm 0.05\%$  FoS (at  $20^\circ$ )) during two separate periods (25 November-4 December 2019; and 5 February-3 March 2020) (Fig. 5).

The ground water fluctuations recorded during the monitoring periods (Fig. 5) confirm that the sediments of the studied bank have a relatively low level of transmissivity such that the groundwater response to the tidal oscillations is damped relative to the variations in hydrostatic confining pressure driven by the tidal level fluctuations. While the distal monitoring well (i.e. W2)  
325 is much less affected by variations in the tidal water level attaining an average water table elevation (below local ground-level)

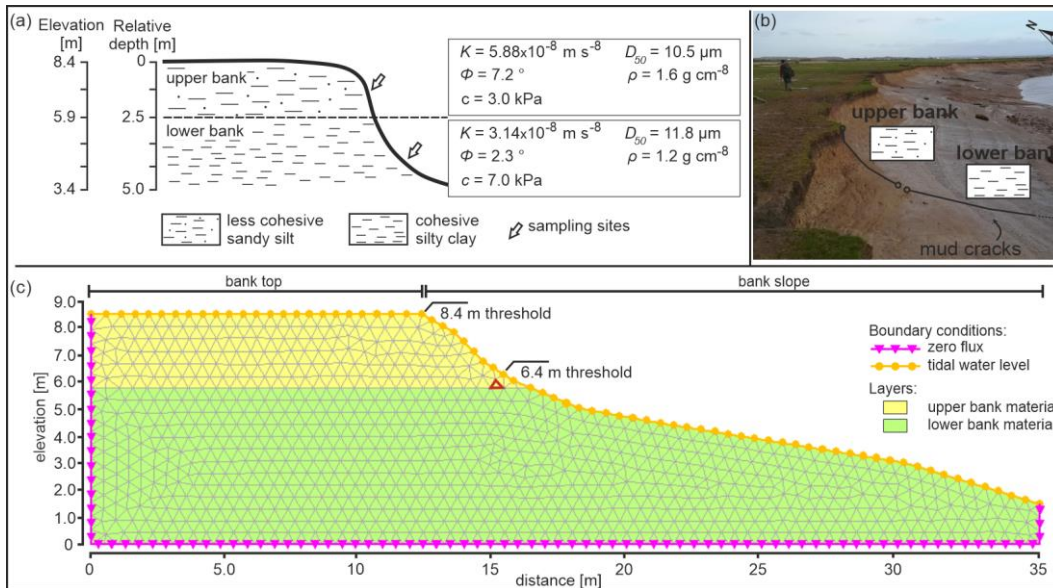
240 **Figure 6. (a) Representation of the investigated bank at the study site illustrating the most important geotechnical characteristics of the two sedimentary layers ( $K$  = conductivity,  $\Phi$  = angle of internal friction,  $c$  = cohesion,  $D_{50}$  = geotechnical grain size distribution, and  $\rho$  = dry bulk density). (b) Photograph of the central part of the study site showing the progressive change in grain size. (c) Representation of the mesh characteristics used in the bank stability model. The cell used to represent the temporal variations of the pore water pressure (see Figure 9 and 10) is highlighted in red. The different boundary conditions employed in the simulations are indicated. Note that the boundary condition indicated in yellow indicates the surface at which the tidal level interacts with the bank (with the entire bank slope in this specific example of high tide).**

Preliminary tests, that aimed to characterise the density of the soil samples under dry and ambient conditions, were conducted on multiple blocks of sediment extracted from two layers (Fig. 6) of the bank at three locations in the central part of the study site. The two layers from which samples were extracted were defined based on observations of the stratigraphic sequences, combined with detailed observations of changes in grain size properties as measured in the cores extracted from the monitoring well W3 and from the bank face. The two maximum effective stresses  $\sigma'1$  and  $\sigma'3$  were calculated from the triaxial tests and

225 The bank stability simulations were developed by coupling a 2D finite element seepage analysis (to simulate the evolution of the pore water pressures in the simulated bank) and a limit equilibrium stability analysis based on the Morgenstern-Price method (Morgenstern and Price, 1965). The model setup procedure comprised four steps: (i) the delineation of a simplified geometry to represent the bank morphology (based on the topographic surveys and SfM model of the study site); (ii) the discretisation of the different sedimentary horizons of the bank into different layers based on their geotechnical properties; (iii) the establishment of the time-varying boundary conditions that force the model simulations, here represented by the water  
 230 level fluctuations recorded at Berkeley (Fig. 1b); and (iv) the temporal integration of the transient analysis. Following this process, the investigated bank was discretised into a c. 0.5 m resolution irregular triangular grid composed of 1792 elements subdivided into two bank material layers (Upper and Lower bank deposits) (Fig. 6c). The different parameters used to represent the properties of the materials in these two layers are reported in Figure 6a.

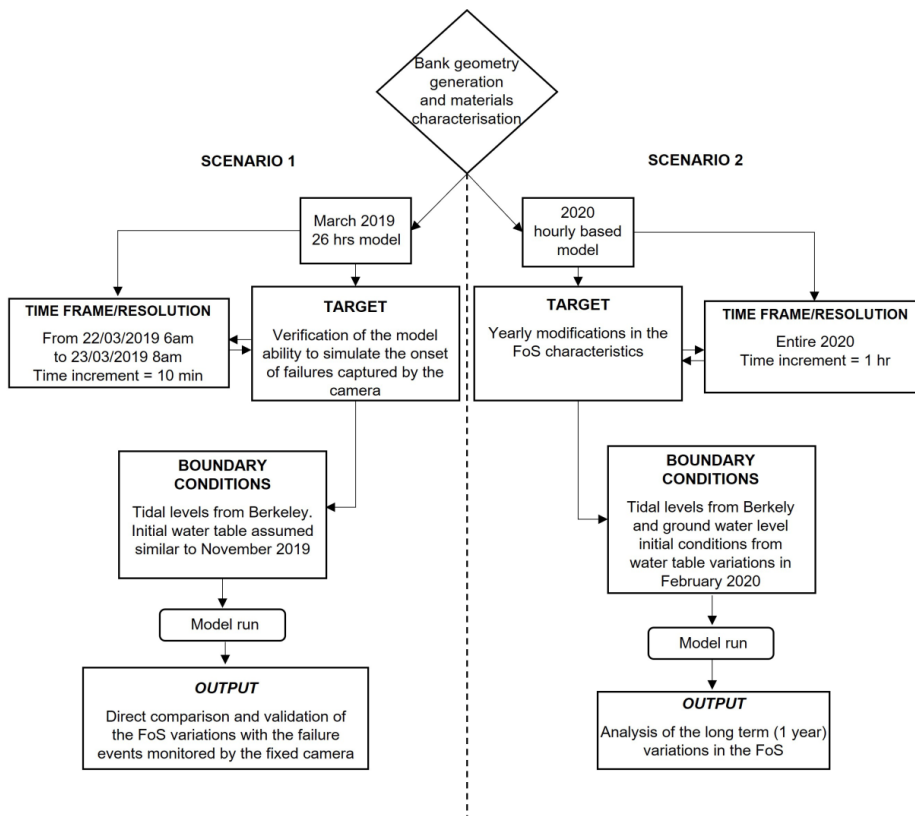
270 **Figure 7. Summary of the two modelling scenarios.**

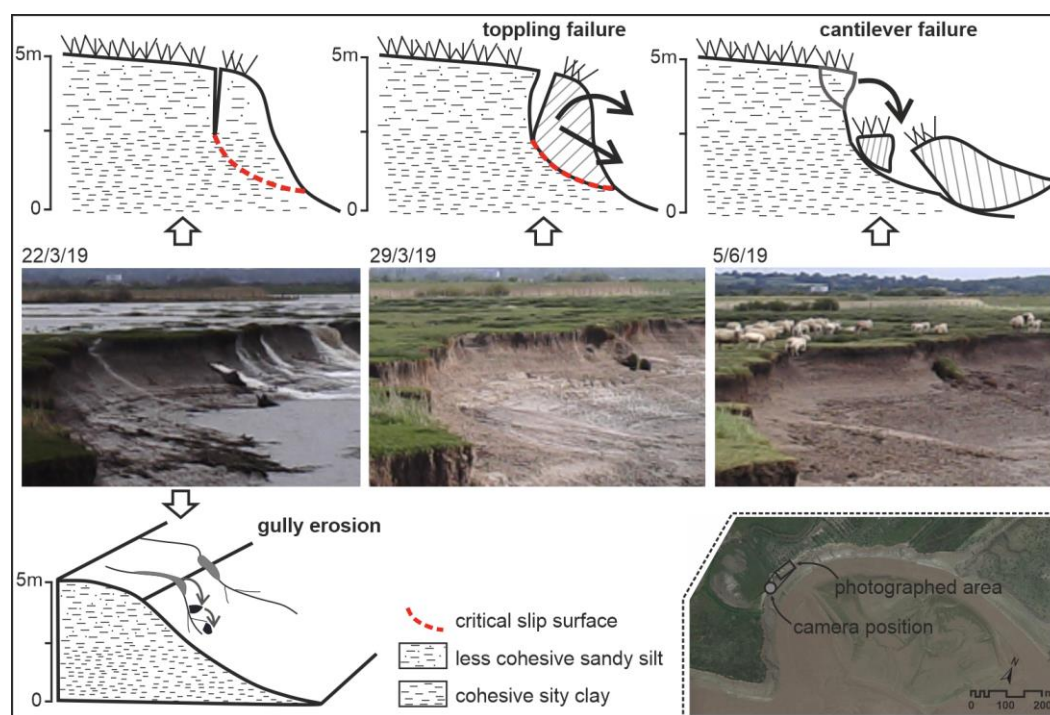
320 **Figure 8. The typical collapse mechanisms observed at the study site (note that the photographs indicated refer to those presented in Figure 4). Image © Google Earth July 2021.**

ebb phase; in a second phase of the collapse, the bankline is characterised by a reshape of its face whereby the uppermost part  
320 of the bank slope forms a cantilever. This specific style of failure likely reflects the specific stratigraphy of the studied area  
where two layers of fine material are stacked. The nature of the layers, and specifically the positioning of the incipient failure  
plane at the interface between the layers, suggests that these stratigraphic discontinuities can play a key role in the failure  
modalities.

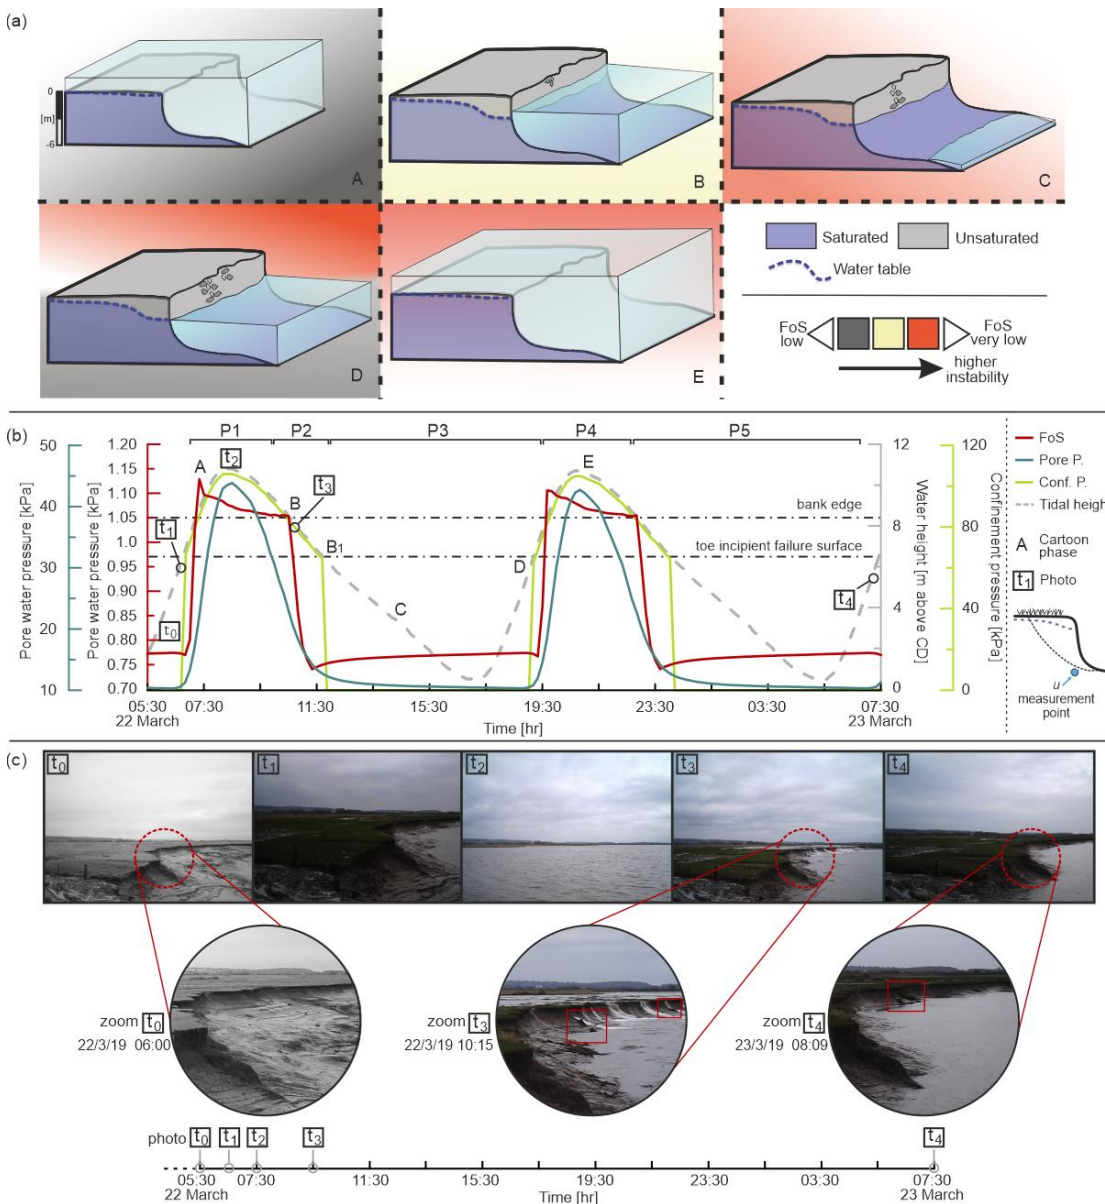
395 **Figure 9. Simulated and observed (from fixed camera images) bank stability conditions at the Plusterwine study area during a 26 hrs time lapse (22-23 March 2019).** (a) Cartoon of the studied bank and related conditions; (b) physical conditions of the bank. The letters refer to stages of evolution indicated on panel (a) and markers to photographs in panel (c).

330 The Scenario 1 simulation results (Fig. 9) represent a very high-resolution model (10 minutes time increment) that provides a detailed visualisation of the bank failure processes observed in March 2019 during a 1-day monitoring window. In contrast, Scenario 2 focuses predominantly on the semidiurnal nature of the tidal cycle in the mid Severn Estuary, studying variations in stability over a much longer timeframe (the calendar year 2020), which allows for the effects of variations associated with the differences between spring and neap tidal cycles to be taken into consideration. These results were compared with and  
335 combined with real-world observations (from the fixed camera photographs) leading to a detailed analysis of the failure mechanics. The evolution of the bank was subdivided into phases (denoted P1, P2, P3, etc), and some additional specific time points corresponding to specific exemplar photographs were marked. Figure 9 (panel a) sketches the tidal cycle represented in the model; the different boxes exhibit different colours highlighting the relative Factor of Safety (FoS) of the bank. In the last panel of Figure 9, some images linked to specific moments in the simulation have been further analysed with three

In the first part of phase P1 (Figure 9b point A, corresponding to photograph  $t_2$  on the last panel), the tide is at peak level and the entire tidal flat is inundated (22 March 2019, 07:30-08:00). The groundwater table is therefore almost at ground level. Under these conditions, even though the elevated positive pore pressure ( $\sim 43$  kPa at 08:10) promotes bank instability, the simulation results indicate a rising FoS (i.e. increasing stability) (from a value of 0.77 at  $t_0$  to a value of 1.14 at 07:20) due to  
345 the high hydrostatic confining pressure ( $\sim 100$  kPa). After the peak in the tidal level is surpassed (mid-phase P1 at 08:40), the pore water pressure also begins to decline. Thus, even as the hydrostatic confining pressure is reducing with the retreat of the tidal waters (106 kPa at the peak at 08:30, 100 kPa at 08:50), the soil saturation remains high ( $\sim 40$  kPa at 08:50) favouring the decrease in the FoS (FoS = 1.07). Toward the end of phase P1 (c. 09:40), the retreat of the tidal waters generates a considerable and fast reduction in the hydrostatic confining pressure (from  $\sim 100$  kPa to  $\sim 88$  kPa at the end of P1). This rapidity, together

The decrease in the FoS continues also in phase P2. From point B onwards, the stabilising effect of the hydrostatic confining pressure exerted by the flow in the tidal channel is rapidly reduced as the tidal level starts to fall below the elevation of the  
355 bank top (i.e. once it falls below the 8.4 m elevation of the bank top) and the FoS drops rapidly, changing the bank from a stable to unstable state (from a FoS of 1.05 at 09:45 to 0.9 at c. 10:00; photograph  $t_3$ ). During this phase the pore water pressure

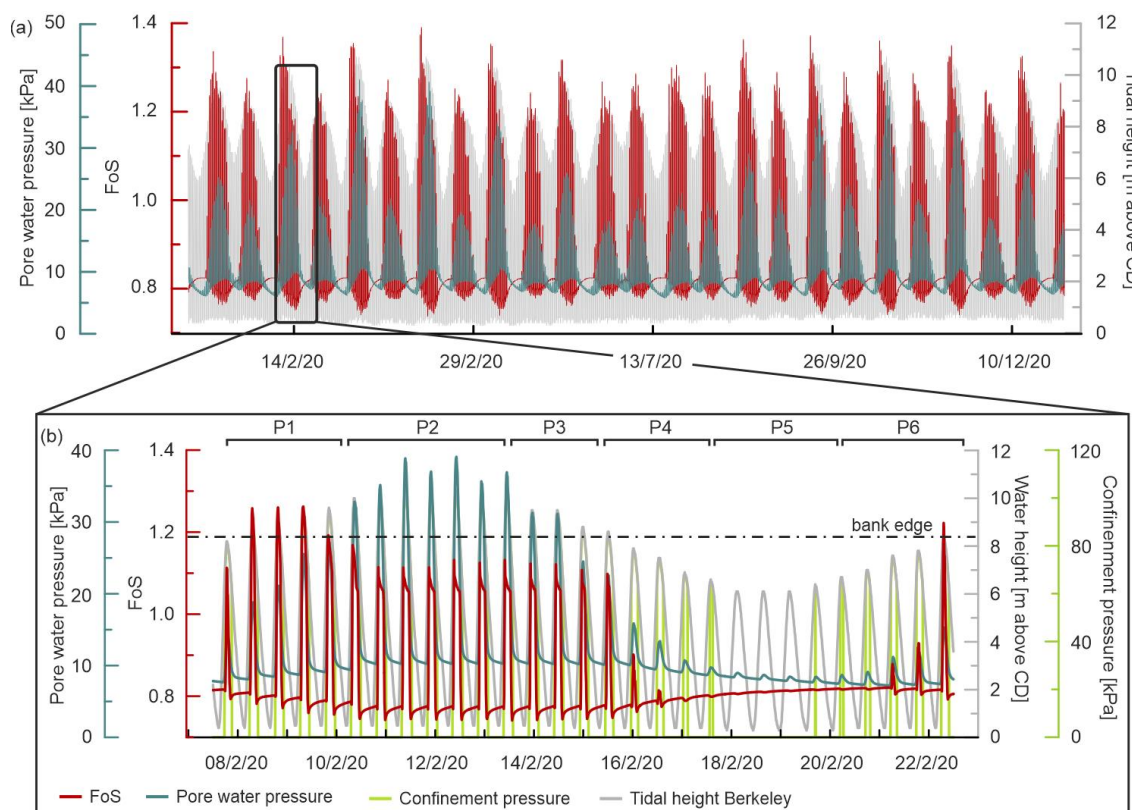
410 **Figure 10. (a) Computed bank stability analysis for the year 2020 (b) Zoom into the period covered by the groundwater table monitoring in February 2020. This second plot is subdivided into different Phases (P1, P2, P3, etc) and pore water pressures are plotted for a representative cell the location of which is highlighted on Figure 6.**

While the results of the first scenario focused predominantly on the semidiurnal nature of the tidal cycle in the mid Severn Estuary, the results of the second scenario (Fig. 10) focus on fluctuations in stability over a longer timeframe, which allows for the effects of variations associated with the differences between spring and neap tidal cycles to be taken into consideration. This simulation (Fig. 10) represents the whole of the year 2020 at a temporal resolution of 1 hour, but with a detailed focus on the period of February-March 2020, as this is the time interval that matches the groundwater table monitoring window. Through this entire 1-year modelled timeframe, it is possible to appreciate how the FoS oscillates above and below stable conditions (FoS>1, FoS<1, respectively). Even though the fine-grained, cohesive, nature of the alluvial deposits should promote a high degree of stability, the simulated bank is clearly close to the critical condition. This marginal stability status appears broadly consistent with the observations made with the field surveys that highlight the erosive activity in the study area.

To better describe the long-term effects of the destabilising forces and their mutual interactions with the stabilising forces, the dynamics occurring over a period of 16 days (07 February 2020 12:00 – 22 February 2020 12:00) is represented (Fig. 10b) and discussed. In this longer duration analysis, Phase P1 covers a time period in which the tidal conditions are moving from neap to spring tide, therefore from a state where the bank top is not subject to daily inundations (the high waters only lap the

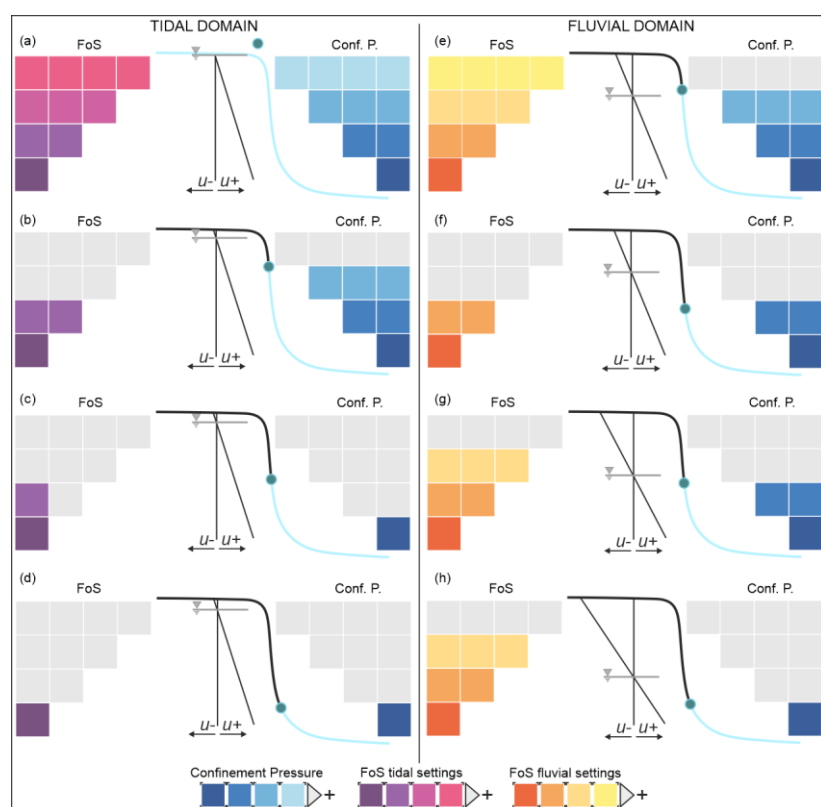
515 **Figure 11. Conceptual model of the factors controlling the onset of bank instability in fine grained tide-dominated hypertidal settings (such as the Severn estuary) versus fluvial-dominated environments.**
