Earth Surf. Dynam., 4, 885–894, 2016 www.earth-surf-dynam.net/4/885/2016/ doi:10.5194/esurf-4-885-2016 © Author(s) 2016. CC Attribution 3.0 License.

Graffiti for science – erosion painting reveals spatially variable erosivity of sediment-laden flows

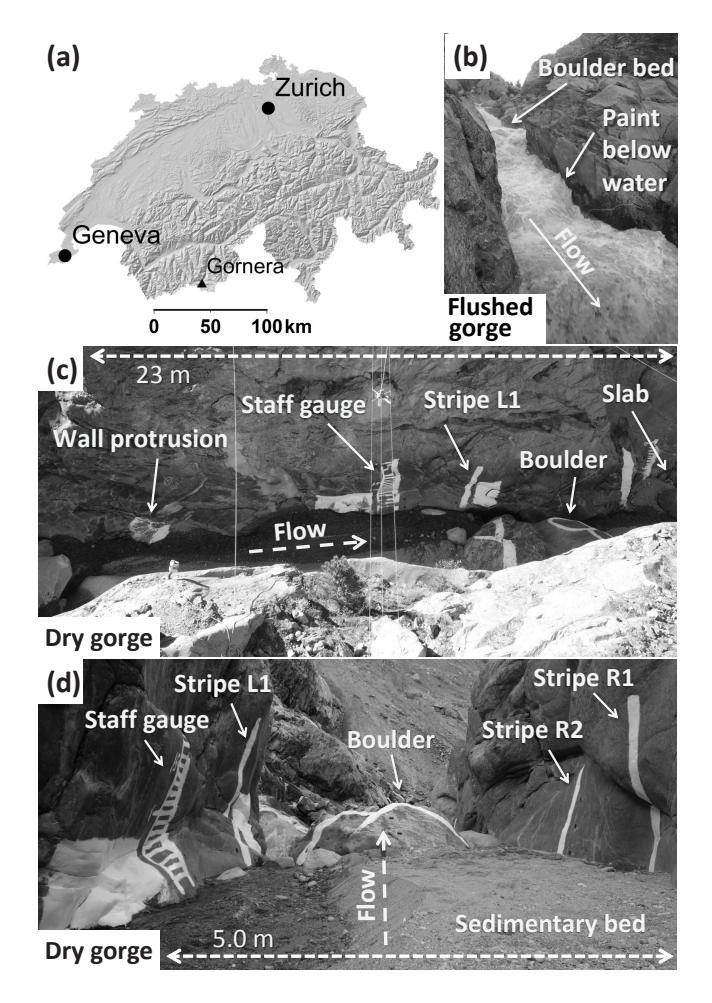
Figure 1. The demonstration field site for bedrock erosion painting: (a) the location of the Gornera proglacial stream, Switzerland, (b) lateral view of the bedrock gorge reach during flushing of the sediment retention basin upstream, (c) top view of the gorge reach during dry conditions, showing some eroded painted surfaces on the left wall and in the stream bed, and (d) downstream view in the gorge reach under dry conditions, showing some of the refreshed painted surfaces. Only the paint areas that are indicated and named are used for analysis here.

The field site for this study was a 30 m long and 5 m wide semi-alluvial bedrock gorge of the Gornera glacial meltwater stream above Zermatt, Switzerland (Fig. 1). The local bedrock is serpentinite, and the bed sediment consists of both serpentinite and gneiss. The gorge is regularly flushed with up to 3 m deep sediment-laden flows due to hydropower operations upstream (Fig. 1b). In between these flushing events of 15–30 min length each, there is negligible discharge in the gorge (Fig. 1c and d). Due to the characteristics of the flushing operations (i.e. short, steep hydrographs and evacuation of previously accumulated sediment), the mean transported bedload grain size (D^{50}) likely varies considerably during each flushing event and between individual flushing events. The D^{50} of the natural stream bed upstream of the hydropower water intake is $\sim 4 \text{ cm}$ at low flows, but it is unknown whether the average sediment load (including high flows) is finer or coarser than this. The sediment bed surface in the gorge returns to roughly the same height following each flushing event, but it likely varies strongly during the flushings themselves (Beer et al., 2016).

We repeatedly painted several patches of the gorge's bedrock surface over a period of 3 years and photodocumented the resulting spatial patterns of eroded paint, renewing the paint as needed. To visualize variations of erosion with height above the stream bed, we painted several vertical stripes of 0.15 m width and 2.0 m height on two opposing straight and smooth bedrock walls, starting at the sediment bed surface (Fig. 1c and d; we unfortunately could not paint below the sediment surface due to standing water in the sediment body). On the left gorge wall we connected two of these vertical stripes by horizontal lines to create a simple staff gauge, acting as a reference for a water surface altimeter positioned above the gorge. For analysis of the spatial bedrock erosion distribution across the stream bed, we further painted a 2.5 m² wall section that laterally protruded into the streamflow, as well as the 20 m^2 top surface of a smooth bedrock boulder and the 3.2 m² smooth upstream face of a vertical bedrock slab (Fig. 1c and d), both of which protruded from the stream bed. We validated the inferred patterns of bedrock erosion by comparing photos of worn paint to contemporaneous quantitative erosion analyses based on repeated high-resolution terrestrial laser scanning (TLS) surveys of the same surfaces (Beer et al., 2016). We also compared paint erosion patterns on the opposing bedrock walls to draw inferences on spatial patterns of sediment transport during the flushings.

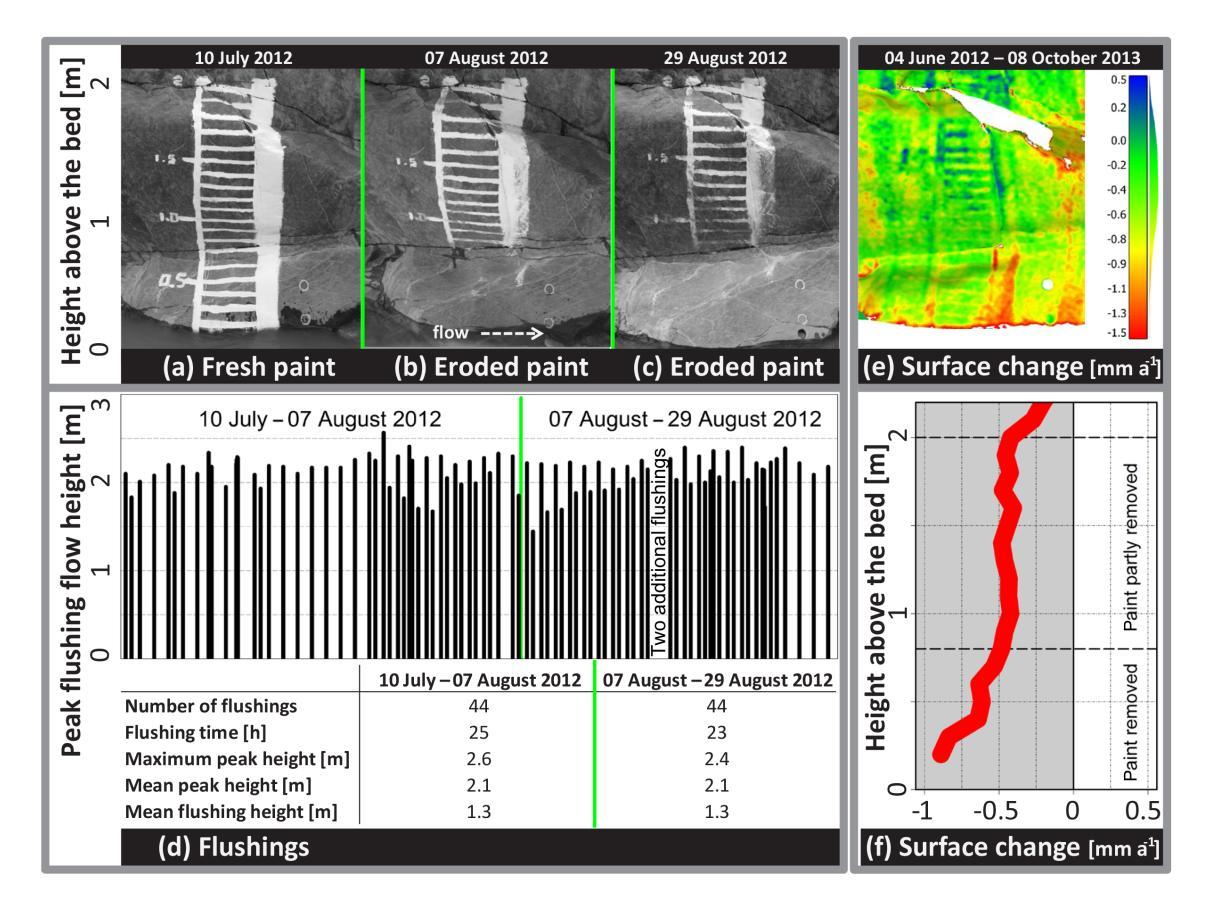
Figure 2. The erosion pattern on the painted staff gauge on the left gorge wall (cf. Fig. 1c and d) indicated a region above the stream bed in which the sediment tools effect leads to accelerated lateral erosion: (a) the freshly painted staff gauge, (b) the eroded staff gauge after a period of 44 flushing events, (c) the eroded staff gauge (not repainted on 7 August 2012) after an additional period of 44 flushing events, (d) time series of the flushing event peak flow heights for both periods, (e) mean at-a-point bedrock change detection values (more than 2 million points) from repeated terrestrial laser scanning over the 2 years 2012–2013 (the time span 4 June 2012 to 8 October 2013 includes nearly all flushing events in these years; for data and calculation, see Beer et al., 2016), and (f) variation in bedrock erosion rates with height over the stream bed. For two flushings of the second painting period, no flushing height data exist (see the data gap in d), but the flushing discharge was comparable to the adjacent flushings. Paint erosion and additional paint coating at different positions in between the scanning dates led to some of the extreme change detection values in (e) that reflect the painted gauge pattern (see the text for details). The vertical erosion profile in (f) is based on the mean values of horizontally binned at-a-point erosion rates given in (f), with a bin height of 0.1 m. This profile is only slightly distorted by the erroneous extreme change values from paint erosion (see e), due to the huge number of TLS measurements included. The grey background area in (f) symbolizes the region of the bedrock wall, with the change value of 0 mm a⁻¹ defining its original surface, and erosion penetrating into it. Note the different *y* axes of the individual figures.

Even over short periods (i.e. a few flushing events), paint erosion was visible over most of the studied bedrock gorge section. The painted stripes on the opposing smooth bedrock walls revealed different erosion patterns: on the left gorge wall, the painted staff gauge (cf. Fig. 1d) was completely eroded up to 0.8 m above the stream bed during a first study period of nearly 1 month with 44 flushing events (Fig. 2a and b). The staff gauge's paint was not renewed, and in the following 3-week study period, a comparable flushing series ran through the gorge (Fig. 2d). The pattern of the eroded paint in the second period changed only slightly compared to the one observed in the first period, revealing slow paint erosion above 0.8 m on the painted staff gauge (compare the right vertical paint stripe in Fig. 2b and c). The qualitative erosion pattern of the staff gauge's paint is consistent with the quantitative bedrock surface change detection TLS data of Beer et al. (2016), which show decreasing erosion rates with height over the stream bed at this location (Fig. 2e and f present average erosion rates over the longer time frame of 4 June 2012 to 8 August 2013, with around 200 flushing events of varying lengths, varying flushed volumes, and probably varying grain size distributions, comprising the bulk of the erosive events in both of these years). Relationships between these bedrock surface changes and paint erosion are further detailed in the discussion section.

The paint erosion pattern at the staff gauge (Fig. 2b and c) clearly indicated erosion by sediment impacts (i.e. the sediment tools effect) and its decreasing strength with height above the bed due to a decreasing concentration of abrasive tools (as discussed by Fuller et al., 2016; Beer et al., 2016). Below 0.8 m, erosion was strong enough to completely remove the paint during the first study period (Fig. 2a to b). Paint erosion at this level also reflects the slight inclination of the wall, resulting in surfaces that face slightly upward. Here, erosive sediment impacts from deflected grains falling through the water column have likely driven lateral erosion (cf. Fuller et al., 2016; Beer et al., 2016). Above 0.8 m, fewer sediment impacts due to lower sediment concentrations could be inferred from the incomplete removal of paint over both study periods (Fig. 2a-c), indicating the low erosivity of the flow at these heights above the bed.

Quantitative TLS-based spatial bedrock erosion measurements (over 2 years with more than 200 flushing events of various discharges, lengths, and volumes; see Fig. 2e and f) confirmed the decrease in sediment impacts with height above the bed, as qualitatively inferred from erosion painting. The uncertainty in the individual TLS change detection values was 2.2 mm over the biennial comparison and thus was in the same order of magnitude as the detected change rates. However, the huge numbers of TLS measurements permit a stable general impression of surface changes, assuming their measurement errors are not spatially correlated (Beer et al., 2016). Mean erosion rates of 1 mm a^{-1} near the bed gradually decreased to 0.5 mm a^{-1} at 0.8 m height (Fig. 2f). Between heights of 1.0 and 2.0 m erosion rates were more or less constant at 0.5 mm a^{-1} , and at higher elevations they quickly approached zero (at 2.7 m; not shown in Fig. 2f). This bedrock erosion pattern reflects the distribution of flushing heights (Fig. 2d), with only brief flushing event peaks exceeding water depths of 2 m, thus delivering few erosive tools to these heights. During the longer time frame of the TLS study, the staff gauge's paint was eroded and repainted several times. Since successive layers of paint were not located exactly on top of one another, and some locations had more paint during the second scan than during the first, there appears to be an apparent positive surface change (Fig. 2e), which is simply the added thickness of the paint (cf. the blue stripes at heights between 1.0 and 2.0 m). Likewise, high apparent bedrock erosion rates are indicated at the bottom of the staff gauge (cf. the vertical red stripe pattern below 0.5 m in Fig. 2e), marking regions where paint was present during the first scan but had eroded before the second scan. Thus the calculated erosion rates in Fig. 2e reflect the erosion of both the paint and the bedrock. These distortions of the TLS-based

erosion patterns provide a further proof of concept of the erosion painting technique, by showing that removal of the paint corresponds to detectable rates of surface erosion. However, they do not distort the general pattern in the erosion profile (Fig. 2f), since that profile is binned over the entire width of the analysed site (cf. Fig. 2e), and thus the influence of the paint is minimized.

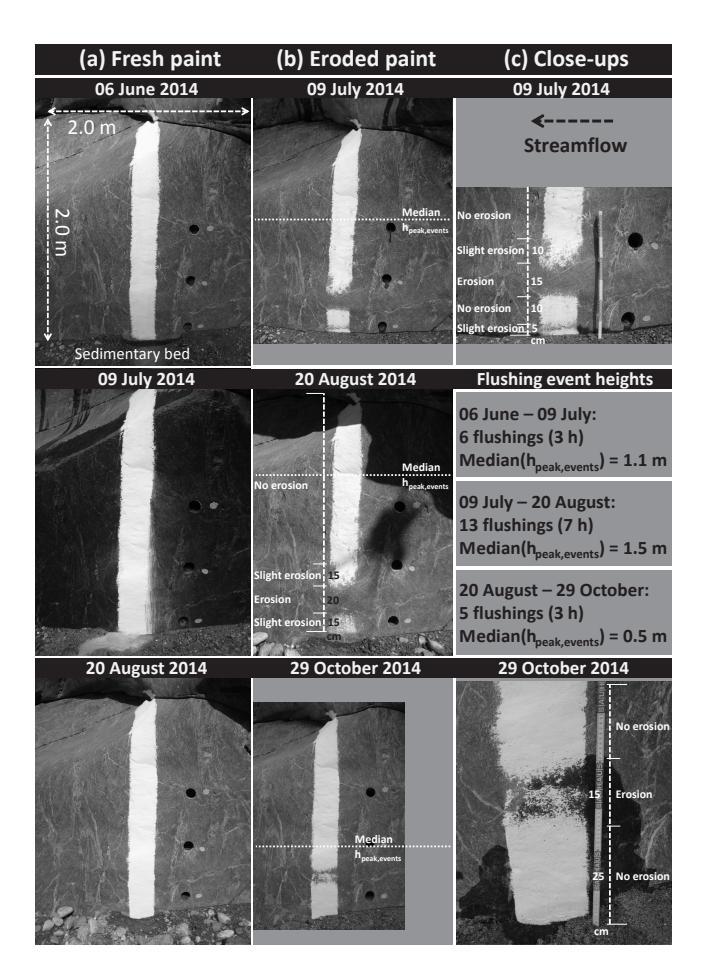
Figure 3. Painted stripe R2 on the right gorge wall (cf. Fig. 1d), indicating a zone of complete paint erosion at \sim 15–40 cm above the stream bed, suggesting a temporary sediment cover effect at the bottom due to bed aggregation during flushings and a constrained sediment tools effect on top, causing lateral erosion: column (**a**) shows stripe R2 freshly painted on three dates, column (**b**) shows the same stripe after 4–10 weeks of flushing events, and column (**c**) shows close-up views of the erosion zone along with information on the flushing events for each of the three time periods. The dotted lines in column (**b**) locate the median of peak flushing heights per period (median $h_{\text{peak,events}}$).

On the right gorge wall, both painted vertical stripes R1 and R2 (cf. Fig. 1d) consistently and repeatedly indicated stable, spatially localized zones of paint erosion, as shown in Fig. 3 for stripe R2. These zones of completely eroded paint were found roughly 15–40 cm above the stream bed during dry conditions. Above and below this erosion band, the paint generally remained intact, but showed zones that were slightly eroded during periods with higher flushing frequencies or flushing intensities (compare the first and the second rows to the third row shown in Fig. 3).

At the right gorge wall, both stripes R1 and R2 were eroded in only a restricted band situated more than 15 cm above the bed (Fig. 3 for R2). This observation can be explained by the sediment bed aggrading up to this level during flushings and thus shielding the lower levels of the wall from paint erosion (i.e. the sediment cover effect). The paint was eroded only near the top of this temporary cover in the restricted zone where moving sediment grains (tools) were most abundant (see Turowski et al., 2008). Above and below this restricted zone of complete erosion, only small patchy areas of paint were removed (indicated as "slight erosion" zones; cf. Fig. 3b and c). This patchy erosion can be attributed to selective abrasion of the paint by less frequent sediment impacts than in the zones of full paint erosion. The lower patch of minimal erosion implies that the bed aggraded rapidly at the beginning of flushing events and degraded rapidly at their ends, leaving little time for paint abrasion. The upper patch of minimal erosion implies rapidly decreasing sediment concentrations in the water column above the temporarily raised sediment bed and thus generally low sediment transport rates at this location.

Notably, the erosion pattern on the right gorge wall could be detected repeatedly (cf. the three time periods in Fig. 3), and the zone of focused erosion on the wall occurred at a consistent height. This suggests that there were only minor fluctuations of bed height and sediment transport on the right side of the gorge, despite differences in flushing durations, in flushing heights (see the information given in Fig. 3c), and probably also in sediment concentrations and grain sizes. The paint erosion pattern on the right gorge wall (Fig. 3b and c) was not visible in the TLS bedrock change detection study (the right wall is not shown in Beer et al., 2016). Also, the right wall appeared very smooth and did not show any visual evidence of increased abrasion in the zone of complete paint erosion, consistent with low transport rates at this location (as inferred in the previous paragraph). These observations suggest that bedrock erosion rates here were too slow to be detected by the TLS surveys, despite visually obvious removal of the (much more erodible) paint. Thus, the erosion painting method may be able to qualitatively detect variations in erosion rates, even when these rates are too low to be measured quantitatively with more sophisticated techniques.

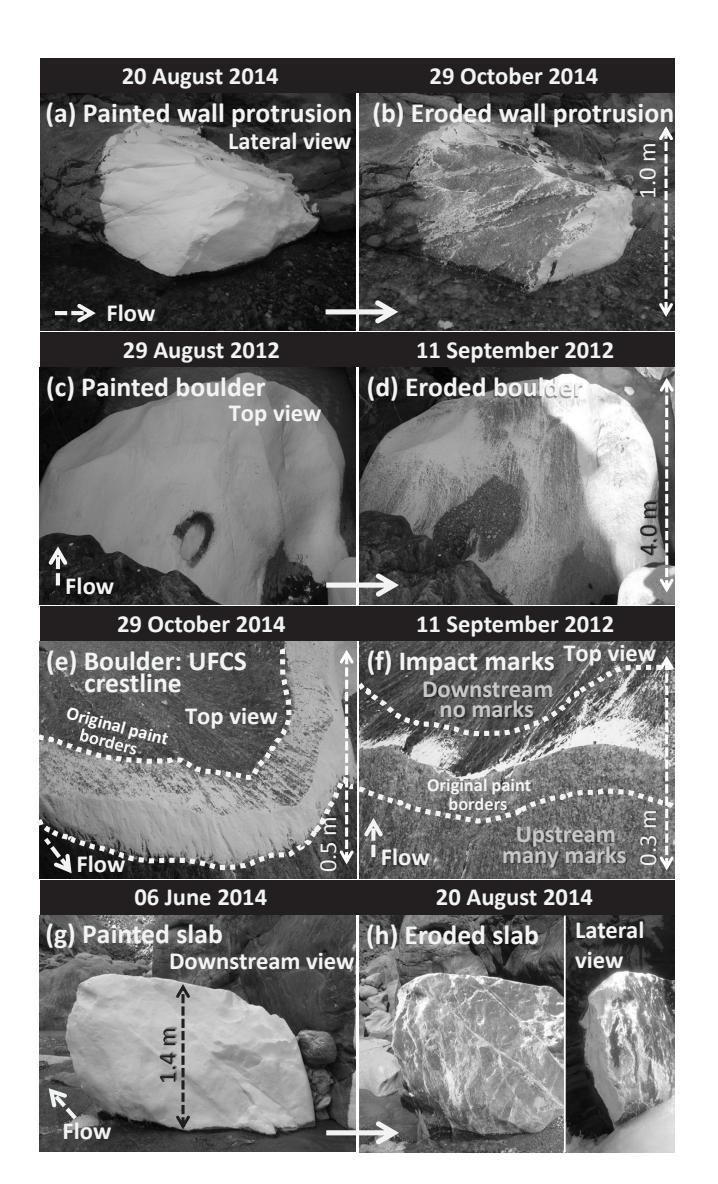
Figure 4. Patterns of eroded paint at several sites in the gorge (cf. Fig. 1c and d), illustrating how erosion depends on local surface orientation: (a) lateral view of the painted protruding wall section, (b) eroded paint on that wall section, (c) top view of the painted boulder, (d) eroded paint on that boulder, (e) top view of a boulder crest line that was previously painted on both sides and now only shows erosion on its upstream-facing side, (f) close-up view of a previously painted boulder crest line like in (e), demonstrating sediment impact marks on the upstream side and a lack of impact marks on the downstream side, (g) downstream view of the painted slab, and (h) the eroded paint on the upstream-facing side of that slab, with an additional lateral view of the painted margins of the slab facing upward, downward, and laterally (inset on the right). Note the original borders of painting indicated in (e) and (f) by the dotted lines. Bedrock colour differences in (f) are due to the abundant impact marks upstream of the crest line.

Characteristic spatial patterns of eroded paint were observed at the laterally protruding wall section and at the boulder and slab protruding from the stream bed (Fig. 4; cf. Fig. 1c and d). The protruding wall section was predominantly eroded on its upstream-facing and upward-facing sides (Fig. 4a to b), i.e. on those faces most prone to sediment impacts. The eroded paint on the boulder showed spatial patterns that are typical for the formation of upstream facing convex surfaces (UFCSs; cf. Richardson and Carling, 2005; Wilson et al., 2013): (i) vertical erosion on planar surfaces in line with the stream bed (i.e. incision; Fig. 4c to d), (ii) downstream-directed erosion on upstream-facing regions with abundant impact marks (Fig. 4e and f), (iii) no erosion on downstream-facing regions with nearly no impact marks (Fig. 4e and f), and (iv) a distinct crest line separating both regions (Fig. 4e and f). The vertical standing bedrock slab, which was overflowed by at least some of the flushings, revealed a spatially homogeneous pattern of downstreamdirected erosion on its upstream face (Fig. 4g to h). Only a few small parts of the upstream face of the slab were not eroded because they were oriented away from the general direction of streamflow and sediment transport. Slab surfaces facing laterally, upward, and downstream did not show any paint erosion over all 3 years studied (cf. the inset in Fig. 4h).

The erosion patterns of the painted surfaces in Fig. 4 illustrate how erosion depends on surface orientation and exposure to impacting particles (the tools effect; Beer et al., 2016) and on the spatial erosivity of the sediment-laden flow. Zones of focused bedrock erosion, visually inferred from both impact marks and crest lines on the boulder, were con-

firmed by the distribution of paint erosion: the heavily impacted surfaces were paint-free, and the crest lines formed sharp boundaries delimiting impact-free surfaces that were still paint-covered (Fig. 4a-f, cf. Wilson et al., 2013; Wilson and Lave, 2014). The paint-free upstream face of the slab (Fig. 4h) reflected abundant sediment impacts on this in-stream obstacle (cf. Beer et al., 2016). Indeed, most of the few upstream-facing white areas visible in Fig. 4h appear white due to quartz inclusions rather than paint. However, the painted parts of the slab that faced laterally, upward, and downstream (cf. the inset in Fig. 4h) were protected from sediment impacts due to the diversion of sediment tools by the slab (Beer et al., 2016). This indicates the crucial role of stream bed topography in guiding streamflow and sediment flux (Johnson and Whipple, 2007, 2010; Cook et al., 2014; Fuller et al., 2016; Beer et al., 2016).

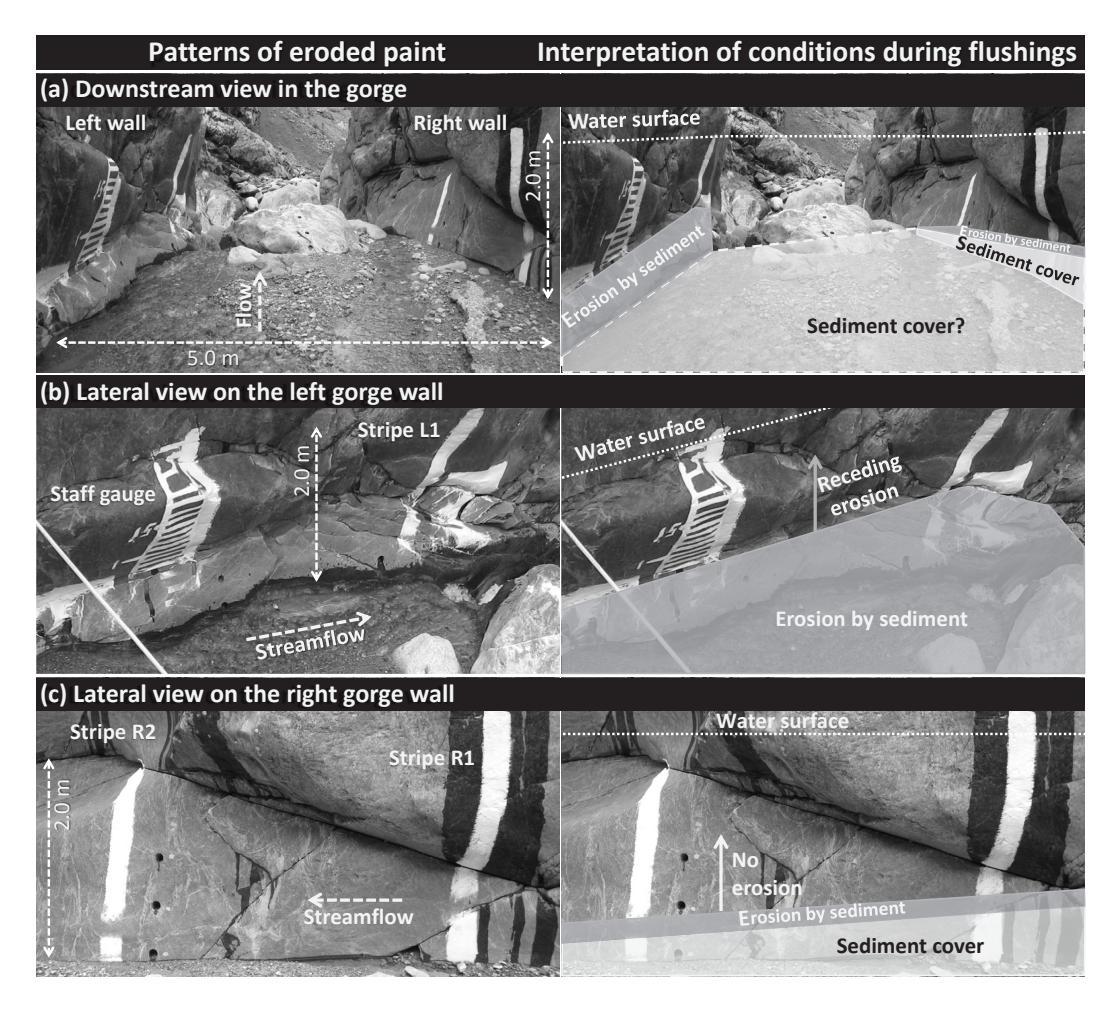
Figure 5. Erosion patterns on the painted stripes in the gorge (left column) reflect likely cross-stream variations in the sediment tools and cover effects during flushings (as indicated by interpretive diagrams in the right column): (a) downstream view into the gorge with four painted stripes visible (cf. Fig. 1d), (b) lateral view of the left bedrock wall, and (c) lateral view of the right bedrock wall. All pictures show paint erosion over the period of 6 June to 9 July 2014. The dark areas in (a) and (c) are wet rock sections due to seepage from above.

A comparative view on the erosion patterns of all the painted stripes on the opposite bedrock walls (Fig. 5a, left panel, for the period of 6 June to 9 July 2014; cf. Fig. 1d) revealed strong cross-sectional differences in the relative importance of the sediment tools and cover effects. Flushed discharge through the gorge carries substantial volumes of sediment that has previously accumulated in the upstream sediment retention basin (Beer et al., 2016). Since both the staff gauge and stripe L1 on the left wall were mostly eroded up to 0.7 m above the bed (at least for surfaces facing upstream; Fig. 5b, left panel), erosive tools likely abraded the whole left wall with diminishing intensity with height above the bed (Fig. 5b, right panel). In contrast, on the right gorge wall (Fig. 5c, left panel), both stripes R1 and R2 showed a very restricted band of erosion (cf. Fig. 3), suggesting that here the stream bed aggraded up to the same level through multiple flushing events, with only a narrow erosion zone on top of it (Fig. 5c, right panel).

Together, these interpretations indicate a strong difference in sediment transport concentration across the gorge (Fig. 5a, right panel): high-velocity transport of large volumes of sediment on the left side and slower transport of smaller volumes of sediment on the right side, where the sediment bed is elevated due to lower transport capacity. This large difference in sediment transport across a channel width of only 5 m would not have been predicted from the straight channel geometry, from the flat channel bed cross section at low flows (Fig. 5a, left panel), or from the reasonably homogeneous water surface across the gorge during flushing events, as observed by eye, in videos, and in pictures (cf. Fig. 1b). The driving mechanism of this laterally focused sediment transport was probably the coarse boulder bed of the channel upstream of the gorge (Fig. 1b) that likely deflected the sediment flow. Directly upstream of the inspected wall section (to the left of Fig. 1c), there are rock blocks of 2 m size in the stream bed that leave a passage on the gorge's left side. This passage may channelize the sediment flow even when these blocks are submerged by the flushing water. Further, secondary currents due to turbulence induced by the boulders are also likely to have influenced the sediment distribution (Venditti et al., 2014). We do not have direct measurements of the spatial sediment transport distribution during the flushings, but the erosion painting technique was able to document the crucial influence of sediment routing in setting local erosion rates.
