# Bank erosion processes measured with UAV-SfM along complex banklines of a straight mid-sized river reach

We apply Structure from Motion (SfM) photogrammetry with imagery from an Unmanned Aerial Vehicle (UAV) to measure bank erosion processes along a mid-sized river reach. This technique offers a unique set of characteristics compared to previously used methods to monitor banks, such as high resolution and relatively fast deployment in the field. We analyse the retreat of a 1.2 km restored bank of the Meuse River which has complex vertical scarps laying on a straight reach, features that present specific challenges to the UAV-SfM application. We surveyed eight times within a year with a simple approach, combining different photograph perspectives and overlaps to identify an effective UAV flight. The accuracy of the

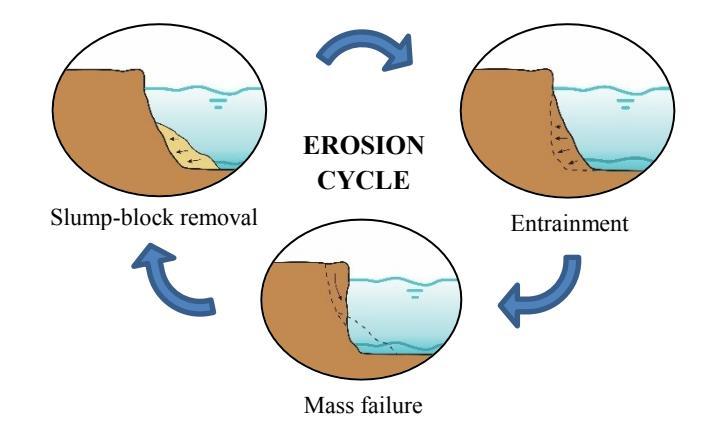
Figure 1: Schematic bank erosion phases: Slump-block removal (left), entrainment of bare bank (right) and incipient mass failure (centre)

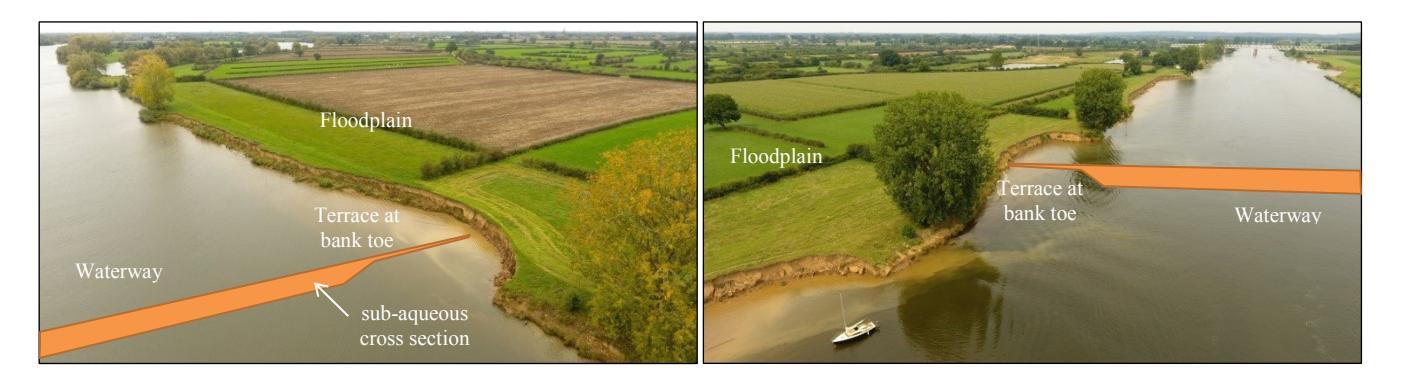
Figure 2: Restored bank in the Meuse River, upstream view of first 300 m (left) and downstream view of middle 500 m (right). Bank erosion has caused a series of bays in the 1,200 meter restored reach. Note eroded bank sediment in suspension.

- The study site is the left bank of a 1200 m long straight reach (Fig. 2) located between the Sambeek and Grave 20 weirs in southeast Netherlands. Seven years after restoration, this reach presents different bank retreat patterns, with subreaches of rather uniform erosion and others with embayments of different lengths. Grassy fields used for grazing cover the riparian zone, followed by crop fields across the floodplain. In the near-bank area there are poplar trees every 100 m, some of which have been dislodged during the erosion progression, which is possible to appreciate in Fig. 2 (left) considering the ~200 m embayment between the foreground tree and the next in the background.

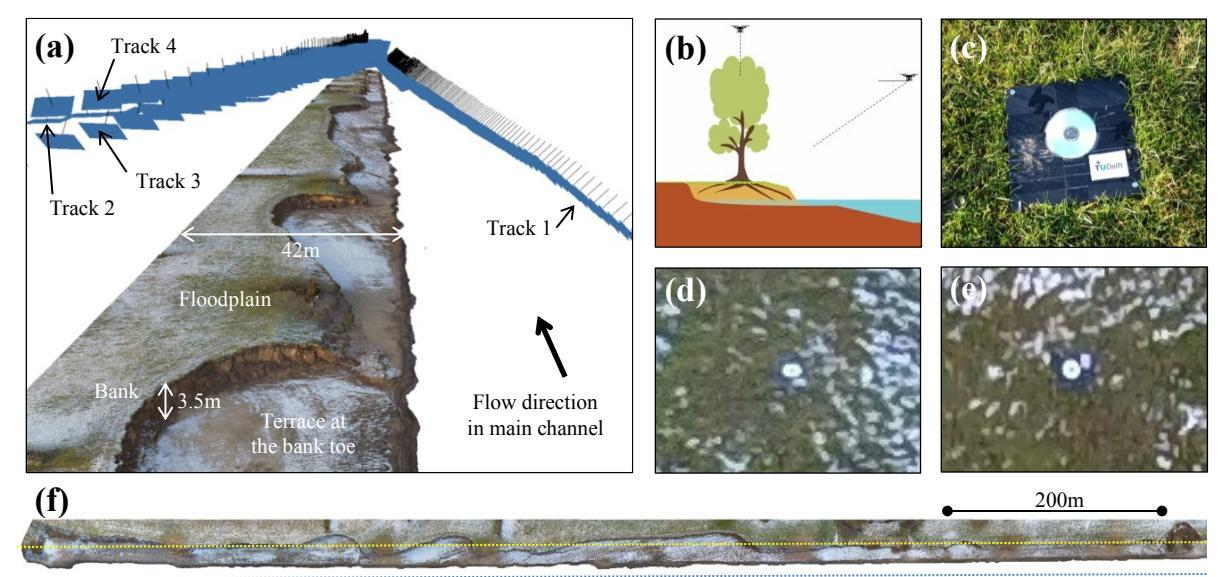
**Figure 3:** a) Camera positions and orientations in perspective view. The digital surface model shows the low-water condition during January 2017, which exposed a terrace at the bank toe. b) Cross-sectional scheme of UAV paths. c) Ceramic plaque with CD as ground-control point on the floodplain. d) GCP in photograph from track 1. e) Same GCP from track 2. f) Top view of DSM with UAV track 1 in blue and tracks 2-4 in yellow.

We used Agisoft PhotoScan software to process the imagery. The camera yaw, pitch and roll recorded during the UAV flight from different perspectives (Table 1) were input to ensure that the image matching assigned all photos into a single model (Stöcker et al., 2015). For this step we used three GCPs along the reach, two at the extremes and one at the middle, all close to the bank and easily visible from tracks 1 and 2. These approximate orientations and a priori known ground points helped obtaining a consistent sparse point cloud of the bank along the entire reach. The resulting camera positions and orientations of the photo alignment are visible in Fig. 3a, evidencing the UAV tracks. This figure also shows the DSM textured with colours from the photographs, in which the green area on the left side with white patches corresponds to the floodplain partially covered with snow (see also Fig. 3d-f) and the right brownish area is the terrace at the bank toe, with snow remains as well.

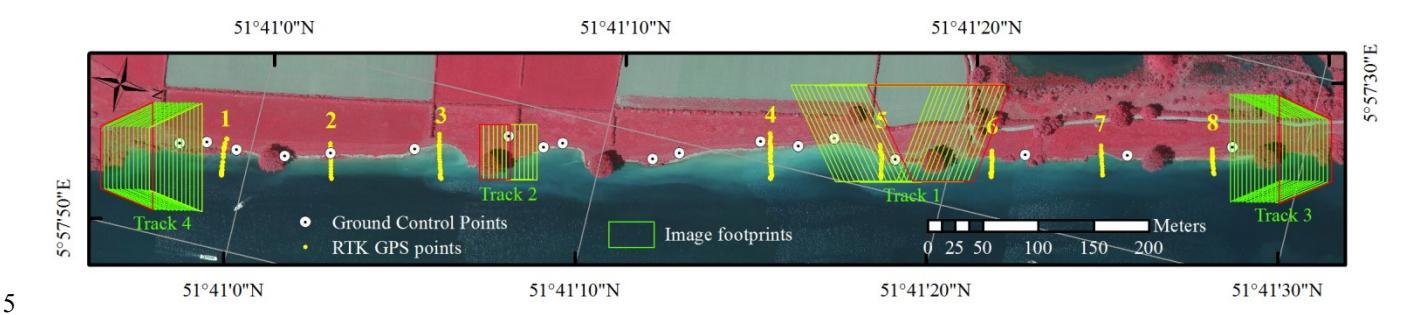
Figure 4: Study reach of the Meuse River with GCPs, RTK GPS measurements with cross-section locations and numbers, and some image footprints for all UAV tracks.

After obtaining the sparse point cloud, we identified the remaining 15 GCPs (Fig. 4) in the photographs, helped by their estimated locations in the model. Then, we refined the camera parameters by minimizing the sum of GCP reprojection and misalignment errors, i.e., using the camera optimization option in PhotoScan. This adjusts the estimated point cloud by reducing non-linear deformations. Once the dense point cloud was computed, we removed the points outside the area of

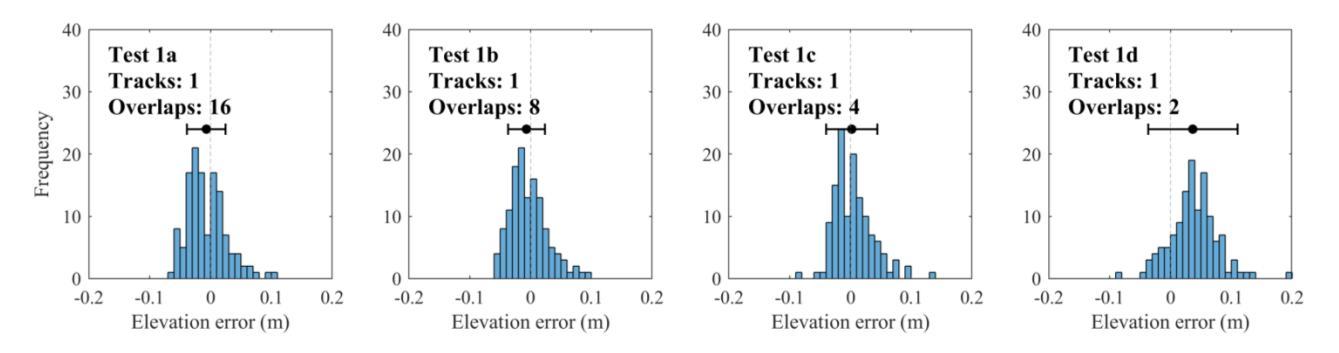
Figure 5: Elevation error distributions for SfM tests *la*, *lb*, *lc*, and *ld*, assuming that the RTK points are correct and without error. Indicated overlaps are the minimum.

- respectively (Table 2, row 6). Then, tests *1a* and *1b* had the highest precisions and showed little error differences between them: less than 1 cm for all values in Table 2. Consequently, test *1b* with eight photo overlaps was as effective as test *1a* with 16 overlaps to achieve the highest DSM accuracy. In addition, test *1b* fully covered the tortuous bank area in contrast to test *1c*, especially at the perpendicular stretches of embayments (Fig. 3–4), which assured the choice of 8 image overlaps

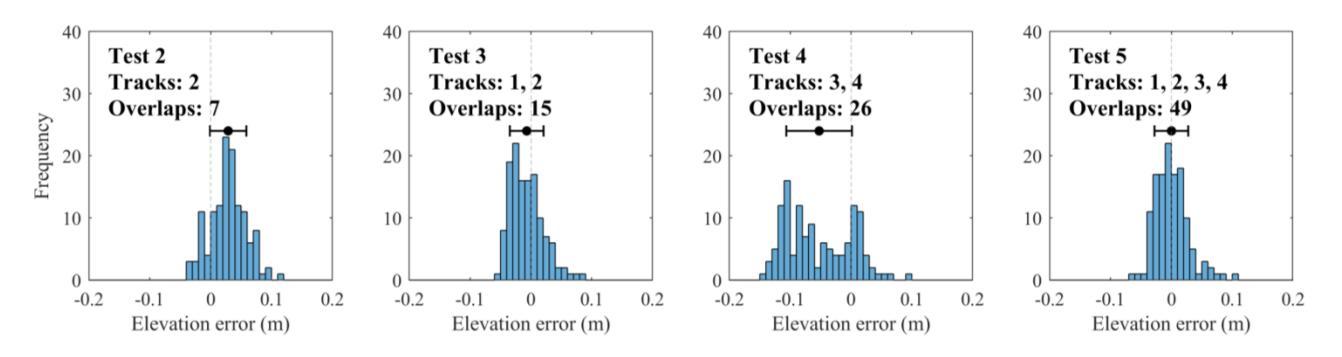
Figure 6: Elevation error distribution for tests 2, 3, 4, and 5. Ordinates indicate number of GPS points in each bin.

than 3 cm. Test 2 presented a similar SD, but the mean was biased 3 cm. This test in combination with test lb slightly reduced the SD errors of the latter (Table 2, rows 7 and 6), but without significant overall improvements. All in all, tests lb, 3 and 5 had the best performances with average errors lower than 1 cm and standard deviations within 3 cm, however with increasing number of photographs (Table 1). The most efficient one was then test lb that used the lowest number of photographs to achieve similar precision, especially on banks.

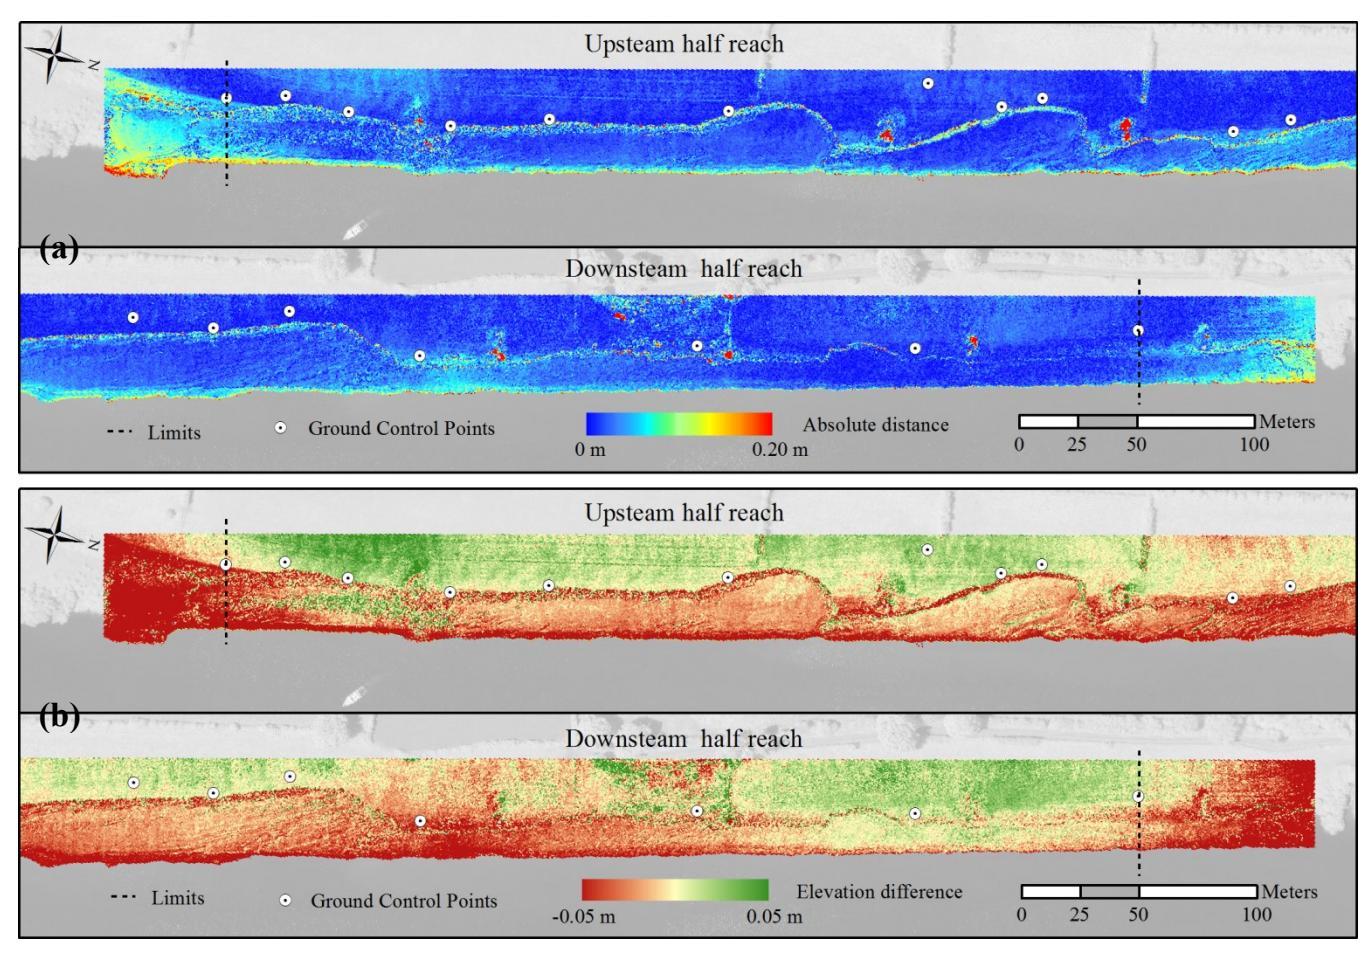
Figure 7: a) Absolute elevation differences between SfM and ALS along the reach. b) Signed elevation differences between SfM and ALS with a smaller scale range.

Compared to the ALS grid, test *3* point cloud showed a good agreement over most of the reach. This is observable from Fig. 7a, corresponding to the blue areas that indicate elevation differences lower than 5 cm. However, two notable regions surpassed this difference: the bank and the extremes of the reach. The latter were zones beyond the GCPs, where higher errors in the DSM are expected when using parallel image directions due to inaccurate correction of radial lens distortion (James and Robson, 2014; Smith et al., 2014). Consequently, the results outside the GCP limits were not considered as reliable as those within, where distortion is minimal, and thus were discarded for the subsequent statistical comparisons (beyond the dashed lines in Fig. 7). Within the GCP bounds, the bank area presented relatively high elevation differences, which makes the bankline visible in Fig. 7. Moreover, another sloped area at end of the terrace also presented higher differences than surrounding areas, which is visible as a thin light-blue line at bottom of the domain in Fig. 7a (see also Fig. 3a-b for other perspectives of this slope toward the channel bed).

Figure 7b presents signed elevation differences with a smaller scale range to highlight areas with positive and negative deviations between techniques. Green zones indicate higher ground elevations on the SfM DSM than in the ALS grid, red indicate the opposite, and yellow elevation matches. The upstream half domain presented a general tendency of SfM to overestimate elevations on the floodplain, and in turn underestimate them on the terrace. This trend is also observed in the upper part of the downstream reach. Nevertheless, these zones showed exceptions, such as a green patch at the terrace close to the dashed limit, and a red patch on the floodplain at the end of the upstream half reach. Despite the described general opposed behaviour between floodplain and terrace, the downstream reach evidenced two zones with consistent trends across the domain, covering both the floodplain and terrace. First, lower SfM elevations at the end of the largest embayment (downstream half reach), and second, SfM higher elevations at the end of the reach, before the dashed limit.

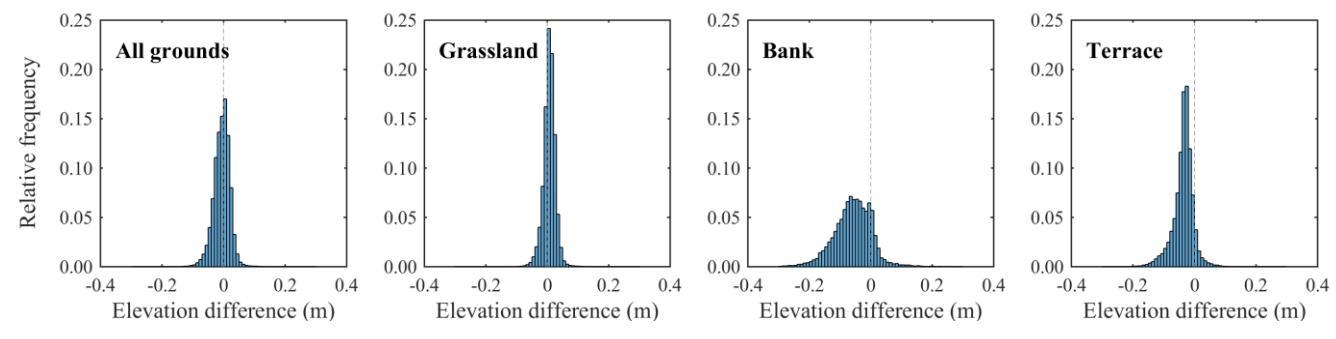
Figure 8: Comparison of elevation differences between SfM and ALS for distinct surface types

15 results (Fig. 8, centre left), with 1 cm mean difference and 2 cm of standard deviation (Table 3). In contrast, the bank had a

The elevation bias at the bank between the SfM-based DSM and the ALS grid (Fig. 8) was caused by the topographic overestimation of ALS (Table 3 and Fig. 9). This ubiquitous error is ascribed to a known limitation of ALS systems related to the laser beam divergence angle, which locates the closest feature within the laser footprint at the centre of the footprint.

The elevation differences between the methods observed for grassland (Fig. 8, centre left) were probably caused by dissimilar ground resolutions, because a larger elevation scatter is expected in the SfM-based DSM when capturing grass with 2 cm resolution, compared to the interpolated ALS samples into a 50 cm grid, even when derived from 0.16 m beam footprints. Nonetheless, the mean difference was zero (Table 3), so that both methods overestimate in the same way the real

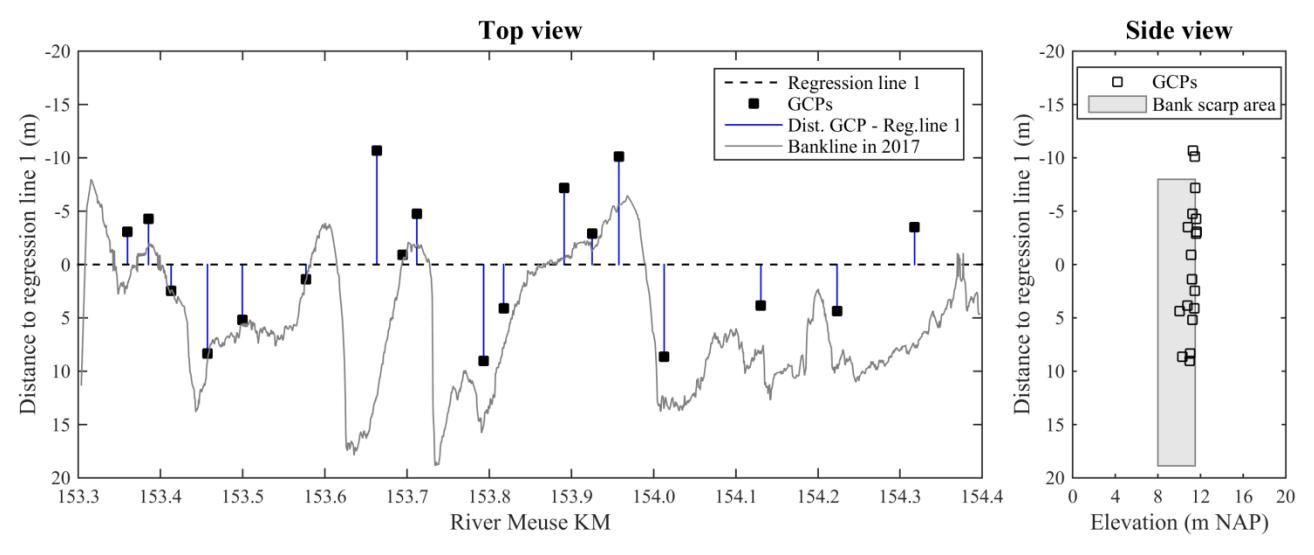
**Figure 9:** GCP horizontal distances to regression line (left) and respective positions in potential rotation plane from the regression line (right)

A regression line was computed with the locations of the GCPs to analyse with respect to this axis the rotational tendency of the model. The GCP distribution around the regression line and the bankline are shown in Fig. 9 (left). The adopted GCPs spanned 19.7 m across the reach and 1.6 m in the vertical direction (Fig. 9, right). The bank scarp along the reach, which is the target survey area, covered 26.9 m in cross-sectional direction due to the wide-ranging erosion magnitudes of the case

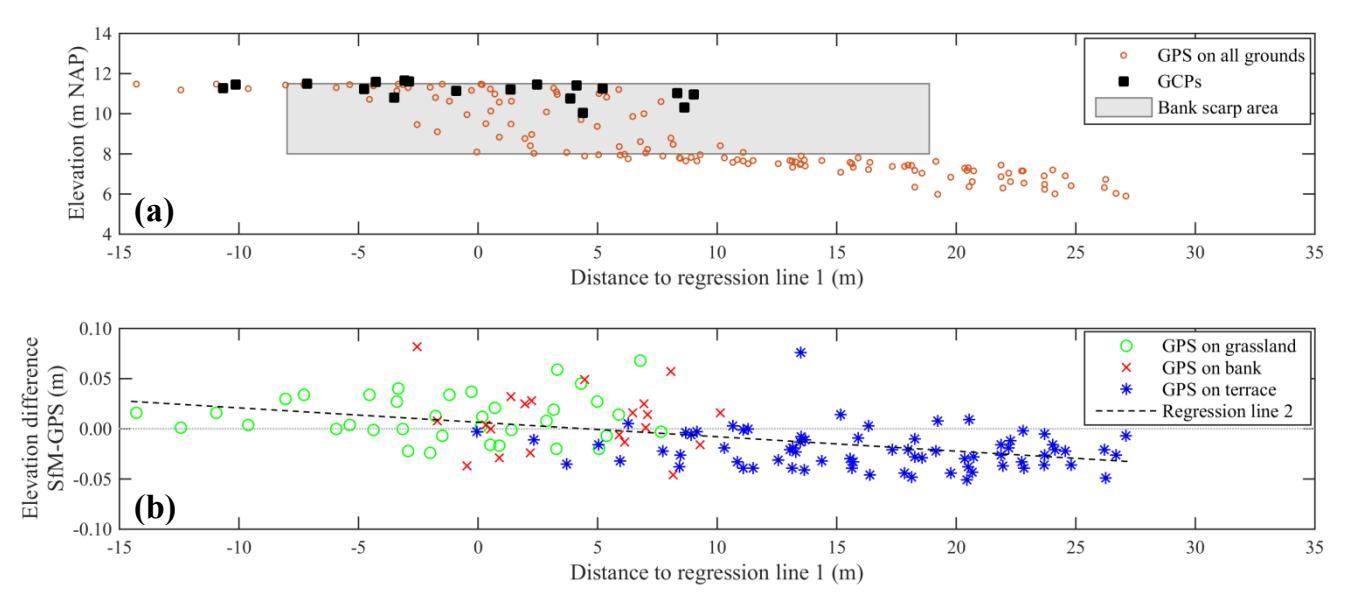
Figure 10: a) Location of GPS measurements in potential rotation plane around regression line 1. b) SfM DSM elevation errors across regression line 1, distinguished among areas of grassland, bank and terrace.

The rotation potential of the model is evaluated comparing SfM DSM elevations with those of the 129 GPS points (Fig. 4). Fig. 10a presents the locations of the GPS points used for accuracy control projected at the potential rotation plane, showing that they covered the domain across the channel (abscissa axis) and different elevations along of the scarp area (ordinate axis), resulting in a reasonable sample to assess the model georeferentiation stability. Fig. 10b presents the DSM elevation errors distributed across the regression line 1. In this plane, a second regression line was computed with all 129 points, represented with a dashed black line in Fig. 10b. This line is tilted from the horizontal suggesting that the model was rotated with a magnitude equal to the respective slope.

The GPS points corresponded to difference surface types, shown with different point markers in Fig. 10b. It is clear that on the left side to the regression line 2 down-crossing, errors mostly had a positive bias, whereas on the right they mostly presented a negative bias. At the same time, those errors with positive bias were generally over a ground covered with grass, and those with negative trend were measured on a slightly sloped bare ground (see also Table 2, column for Test 3). Then, this tendencies could also be ascribed to the overestimation of the grass cover in the former case, and a non-linear transverse deformation beyond the GCP bounds, for the latter. Regardless of the causes, the results showed an overall transverse DSM inclination with respect of the GPS points used for accuracy control. The regression line 2 when evaluated at the extremes of the bank scarp area (-7.99 m and +18.87 m) yielded an elevation difference between these points of 3.9 cm.

The analysis made for test 3 on model rotation evidenced a linear trend with increased surface elevations on the floodplain side of the domain and decreased elevations on the main channel side (Fig. 10b). This tendency was probably caused by a rotation of the DSM around co-linear GCPs that may lead to rotated solutions of the Helmert transformation (Carbonneau and Dietrich, 2017). Yet, the areal SfM-ALS comparison within  $\pm$  5 cm range (Fig. 7b), did not evidence a clear axis along the whole domain that could suggest a rigid rotation of the DSM, since the ALS did have a constant mean accuracy across all surface types (Table 3). The linear rotation tendency, then, might have been obscured by the error range that was larger across the domain (Fig. 6 centre left and 10b) than the mean rotation magnitude, whose elevation difference between the extremes of the cross-sectional domain was 6 cm, and 4 cm within the bank area. Thus, other sources of error were also present that resulted in the obtained error range.

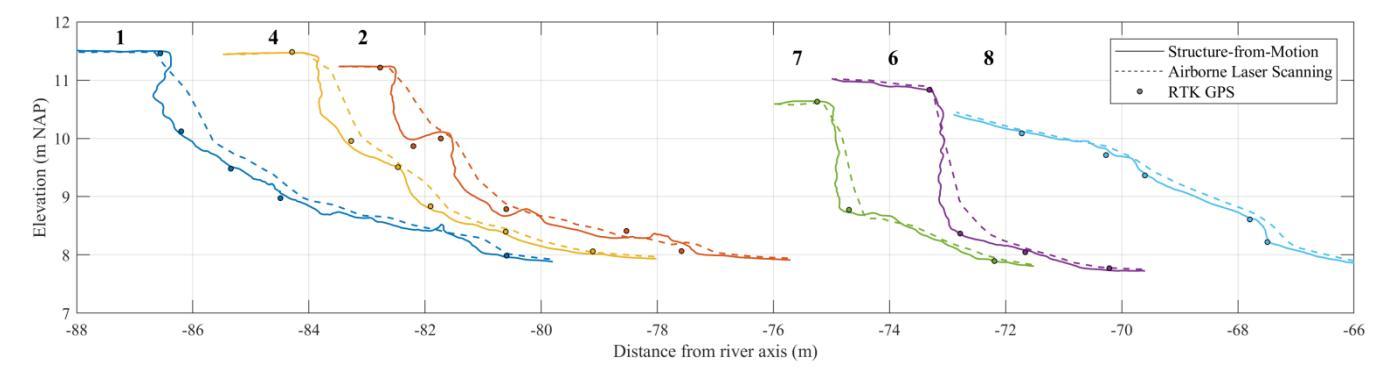
Figure 11: Banks measured with SfM (continuous lines), ALS (dashed lines) and GPS (circles) on 17–18 January 2017. Cross-sections are located from left to right, at river km. 153.4, 153.9, 153.5, 154.2, 154.1, and 154.3 (see Fig. 4 for locations).

Six bank profiles were selected among those surveyed with GPS on January 2017 (Fig. 4) to compare the bank representation with the different survey techniques. Fig. 11 shows the bank profiles at sections 1, 2, 4, 6, 7 and 8. These sections presented distinct erosion magnitudes and features after seven years of restoration, for example, section 8 (Fig. 4 and 11) appeared close to the original condition, with a mild slope and nearly no erosion, whereas sections 6 and 7 had vertical scarps. The SfM DSM profiles are represented by continuous lines, the ALS profiles with dashed lines, and GPS points with circles. The SfM representation had better proximity to the GPS points than the ALS in almost all cases. What is more, ALS generally overestimated the elevation corresponding to the GPS points, which confirms the bias observed in the comparison of bank elevations shown in Fig. 7 and 8.

SfM profiles showed detailed bank features, such as a collapsed upper bank laying at the toe (section 2), an overhang at the bank top (section 1), small-scale roughness on scarps (sections 6 and 7), and slump-block deposits (section 5 4). These features appeared as simple shapes in the profiles but they were confirmed with field observations. The ALS depicted simpler profiles, smoothed by coarser resolution, which made it difficult to identify characteristic features of the erosion cycle in them. Yet, ALS profiles had enough point spacing to capture gentle bank slopes with reasonable precision (section 8), but for steeper ones (sections 1, 2 and 4) and specially at scarps (sections 6 and 7), this technique provides lower accuracies.

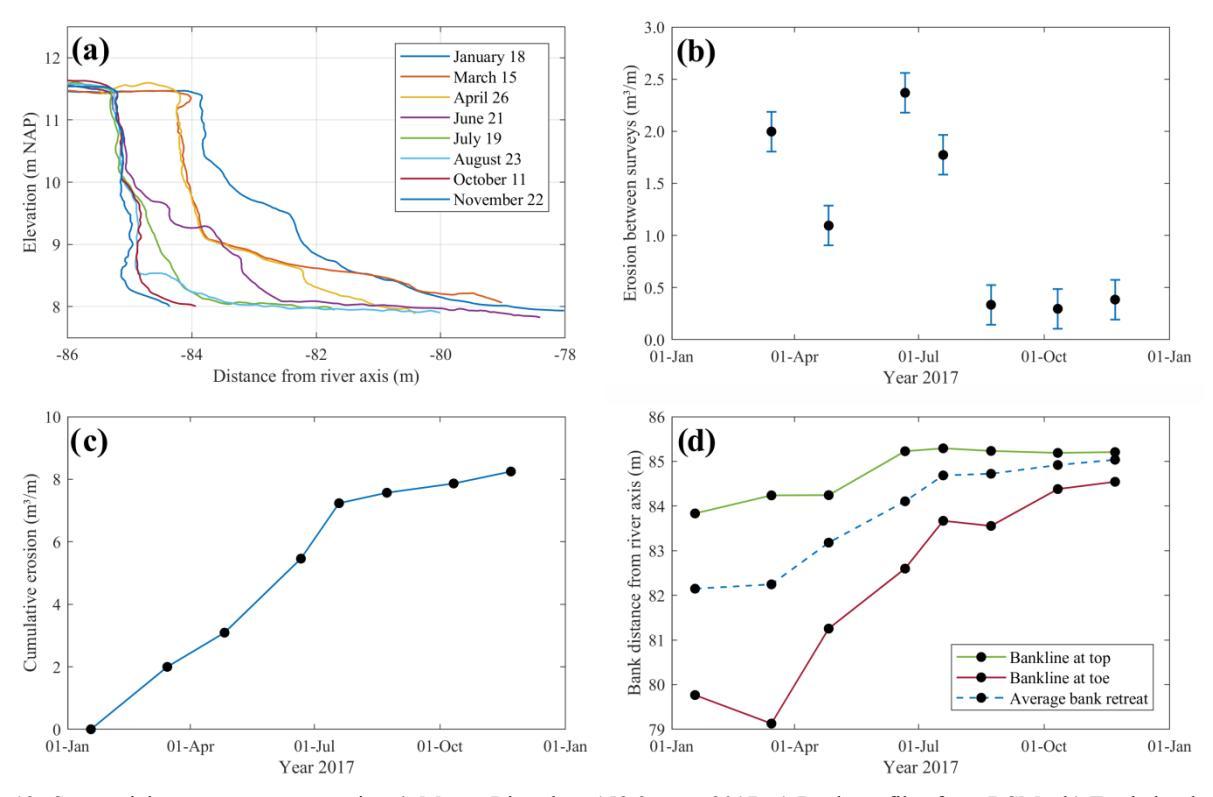
**Figure 12:** Sequential surveys at cross section 4, Meuse River km. 153.9, over 2017. a) Bank profiles from DSMs; b) Eroded volume per unit width between consecutive surveys; c) Cumulative erosion along surveys; d) Bankline locations at the top and toe of the bank.

The temporal development of section 4 (Fig. 4 and 11) is illustrated in Fig. 12a by a sequence of SfM-UAV surveys. The initial stage corresponds to the survey of Fig. 11 on 18 January 2017. The consecutive surveys showed the evolution of the vertical bank profile, through which different processes can be inferred. The bank profile, initially characterized by a top short scarp and slump blocks along the bank face, experienced a mass failure and a further removal of blocks between January 18 and March 15 2017. Between March 15 and April 26, only toe erosion occurred. By June 21, another mass failure happened, which left slump blocks along the lower half of the bank. On July 19, these blocks were removed, leaving a steep bank face. Then, further toe erosion caused a small soil failure at the lower bank whose remains laid at the toe. On October 11, this wasted material was removed. Then, until the last survey on November 22, entrainment occurred at the lower half of the bank profile, further steepening the bank. In light of the results, the methodology resolution and accuracy are high enough to identify different phases of the erosion cycle, enabling the analysis of bank erosion processes in conjunction with data on potential drivers.

In addition to process description, the quantification of eroded volumes is possible computing the net area between sequential bank profiles. For example, Fig. 12b shows eroded volumes per unit width between consecutive surveys plotted at the end of each time interval, with an error bar based on the RMSE of test 3. Evidently, there were different erosion rates during the year and the highest ones happened in the first part of it. Fig. 12c presents the respective cumulative eroded volumes per unit width, where the two trends can be distinguished: a gentle slope towards the end and higher rates of sediment yield during the first haft of the year. Given that the topographic measurements are limited to a single year, it is not possible to state whether this behaviour in recurrent on a yearly basis. However, this case exemplifies the possibilities to quantify eroded volumes throughout different phases of the erosion cycle.

15 respectively. The top bankline showed a mayor jump between April and June and a smaller one between the first two surveys, corresponding to mass failure events. The bank toe presented a more gradual retreat, with events of slumping and temporal accretion that were timely captured along the surveys. This alternative bank retreat representation provides evidence of the development of bank erosion at every survey. The contrast of bankline retreats at the top and toe of the bank illustrates how different processes on their own represent dissimilar erosion evolutions, since they constitute different phases of the erosion cycle, i.e. at the top mass failures and the toe slump block removal and entrainment. Finally, the average bankline between bank toe and top would best represent the real retreat (dashed line in Fig. 12d), despite not necessarily

indicating an actual bank location for a specific elevation. This approach logically considers all erosion phases and follows a similar trend as the cumulative erosion of Fig. 12c.

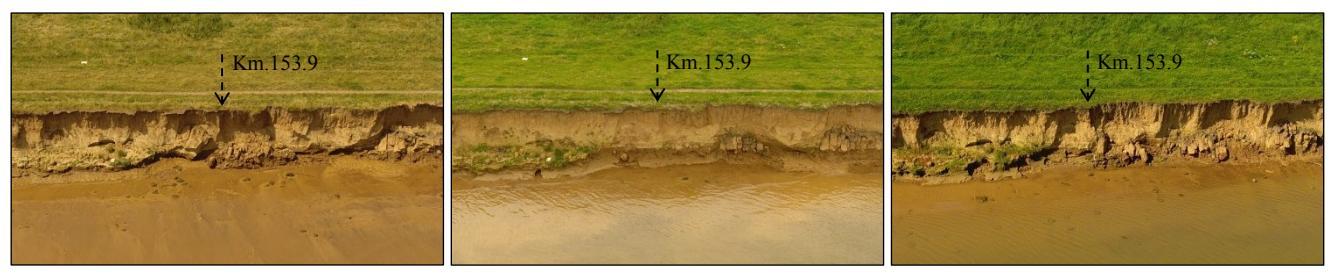
Figure 13: Zoomed-in UAV photos from track 1 at section 4, km. 153.9, showing diverse bank erosion stages: slump blocks at bank toe on June 21 (left), clean bank face after block removal on July 19 (centre), and undermining on August 23 (right).

Finally, the availability of the UAV imagery provides additional information to analyse and interpret bank evolution through direct observation. Figure 13 shows photographs from the three consecutive surveys on June 21, July 19 and August 23 at section 4, km. 153.9. At this bank area, the sequence shows on the left side of the panels only entrainment at the bank toe, and from the centre (km. 153.9) to the right, one or more erosion cycles. Cross section 4 presented on June 21 (Fig.13, left panel) slump blocks laying at the bank toe that were removed by July 19. Then on August 23, this cross section had incipient undermining at the lower bank and block deposition at the toe. The bank area at the right of section 4 experienced a second mass failure after June 21, completing one erosion cycle, and further downstream it is more difficult to keep track of the cycles due to faster erosion rates. The UAV photos also evidence the progressive growth of grass over the floodplain, especially observable next to the walking path, which was captured along the surveys (Fig. 12a).
