1 **The formation processes and development characteristics of boulder**
2 **bars due to outburst flood triggered by the overtopped landslide dam**
3 **failure**

12 **Abstract**

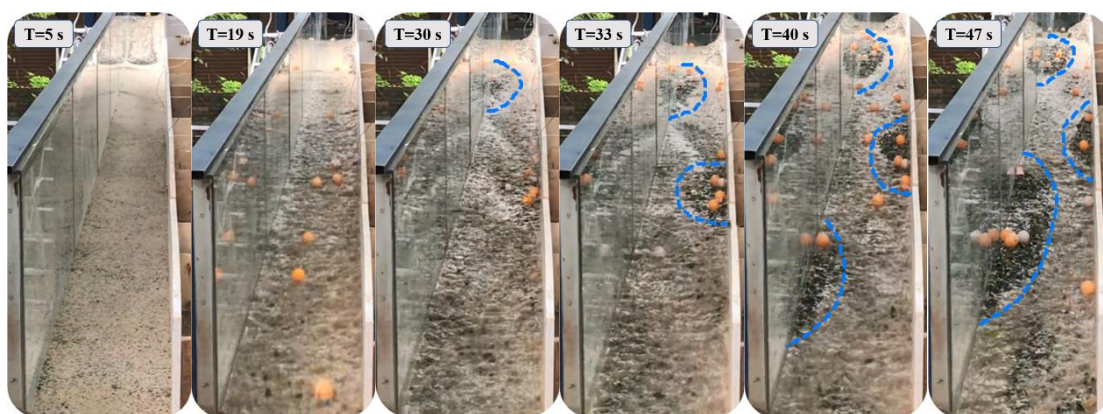
166 The formation processes of boulder bars are almost similar for all the tests.
167 Therefore, it takes the T7 test as an example to analyze below in this section, as shown
168 in Fig. 3. When the flow overtopped the dam crest, the outburst flood carried the dam
169 materials to the dam downstream slope (T=5 s) and then to the channel bed (T=19 s)
170 with outburst flow discharge increasing. It should be noted that although a large number

171 of sediments were transported on the channel bed before the peak discharge, no boulder
172 bar formed on the downstream channel bed. After the moment of peak discharge, the
173 flow discharge gradually weakened, and dam materials were transported to the position
174 near the dam toe. The flow could not transport all the sediments away, and some
175 sediments gradually silted down, then the first boulder bar occurred near the dam toe
176 (T=30 s, the boulder bar in the figure is marked with a blue dotted line). After the first
177 boulder bar was formed, the flow direction was changed when water flow bypassed the
178 boulder bar. And the moving sediments still moved along the original direction due to
179 inertia, which causes sediments piled up to form the second boulder bar on the opposite
180 side of the first boulder bar (T=33s).

181 Similarly, the first and second boulder bars affected the formation of the boulder
182 bar downstream. Eventually, boulder bars were scattered on both sides of the channel,
183 forming a meandering channel downstream (T=40 and 47 s). This phenomenon is in
184 good agreement with the field boulder bars along the Yigong river (Wu et al., 2020).

185
186 **Figure. 3** The riverbed morphology at six different moments during the boulder bars' formations
187 and growths process for the T7 experiment. The boulder bars in the figure are marked with blue
188 dotted lines.

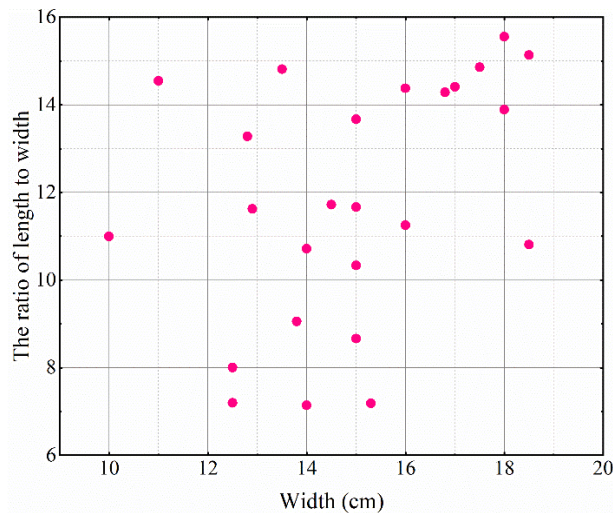
327 Wu et al. (2020) classified the boulder bars in the downstream reaches of the

328 Yigong River into three types according to their shapes and used the length to width
329 ratio as the indicator of a bar shape. The 16 boulder bars in the downstream reaches of
330 the Yigong River have a length to width ratio of 2.5-15. As can be seen from Fig. 9, the
331 length to width ratio of the boulder bar formed in this experiment is in the range of 7 to
332 16, which indicates the field data could prove the experimental results.

Figure. 9 The ratio of boulder bar length to width
