Reviewer 1

I've reviewed the manuscript by Chen et al, examining fluvial geomorphology evolution caused by the factors like earthquake and dam construction. This manuscript presents interesting study and results, and it is well-written. I only have a few comments as follows:

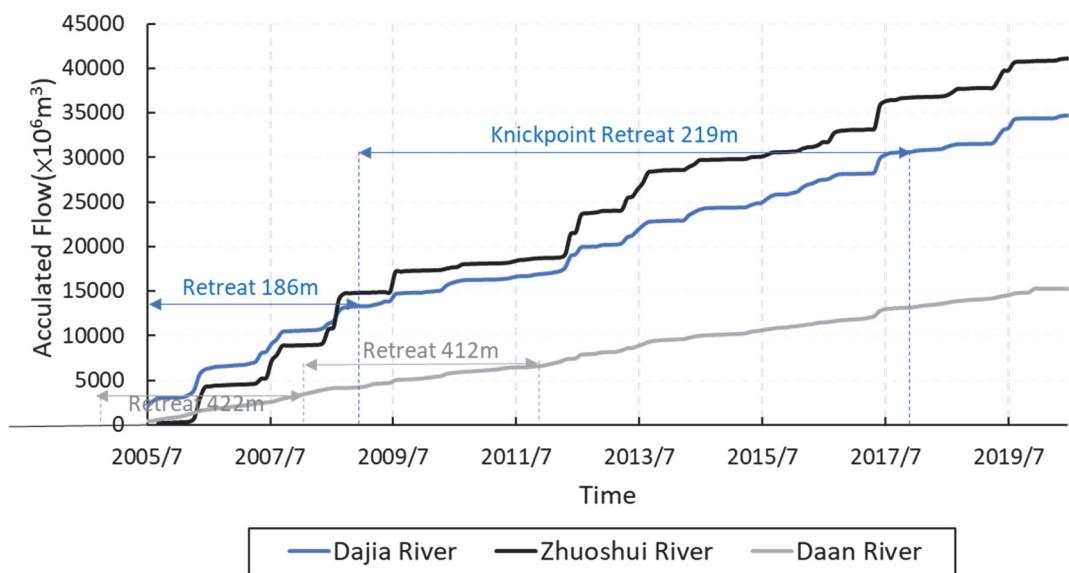
We collected the discharge data of outflow from Shigang Dam (Dajia River) and Jiji Dam (Daan River), and the flow data of the Daan River from July 2005 to December 2019. The cumulative flow results show that the increasing trends of the discharge in the Dajia and Zhuoshui Rivers are consistent (as shown in the figure below). Both dams serve the purpose of

controlling water levels for water supply and irrigation. The direct discharge is influenced by the variations in dry and rainy seasons, resulting in intermittent changes in the discharge. In contrast, the flow in the Daan River shows continuously and stable increasing. We observed a positive correlation between the knickpoints retreat distances and the cumulative discharge in the Dajia River and also in Daan River. However, the correlation between flow and retreat distance does not exist when comparing different rivers. Additionally, A relationship between discharge and the changes in channel widening or the incision depth cannot be found.

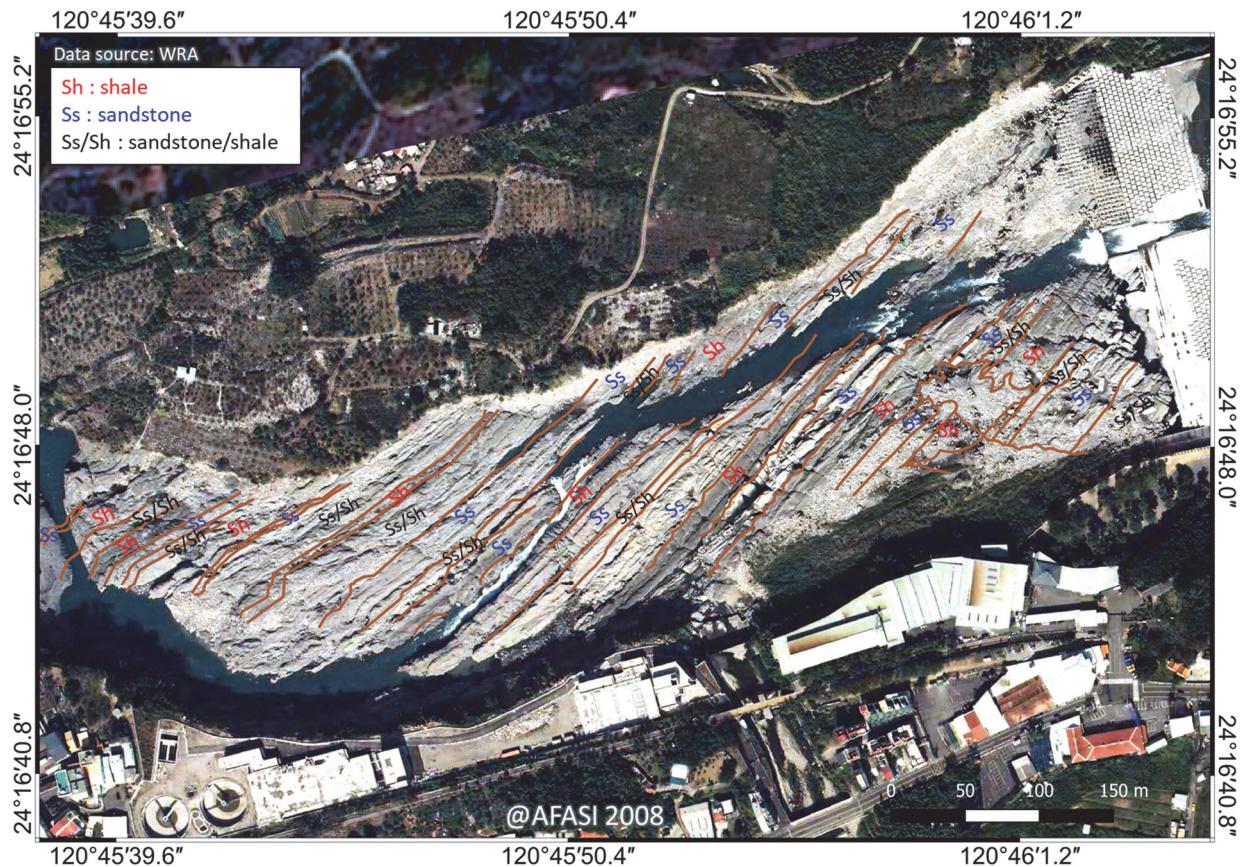
Our view is that although all three river sections have soft rock riverbeds composed of the same interbedded sandstone and shale, the knickpoint migration rates and rock distribution in these sections are not directly linked. The orientation of the rock layers may influence the position of the channel, but only locally. As seen in the example of the downstream of Shihgang Dam in the figure, where the orientation of the rock layers is visibly parallel to the local river channel in a short reach, indicating the influence of the rock layers on the river's position. Because shale has a faster erosion rate, making it easier for channels to be formed. However, in many cases, after shale erosion, the remaining isolated sandstone amplifies the impact of river flow, particle collisions, and vortexes on the isolated sandstone, causing fracturing

and accelerating the detachment of the block. Therefore, the river flow still exhibits a flow direction traverses different rock layers in most conditions.
